**STAGE 2A REPORT – STRUCTURAL AND CIVIL  
APPRAISAL AND REPORT FOR REDEVELOPMENT OF:**

**Athlone Castle  
Athlone, Co Westmeath**

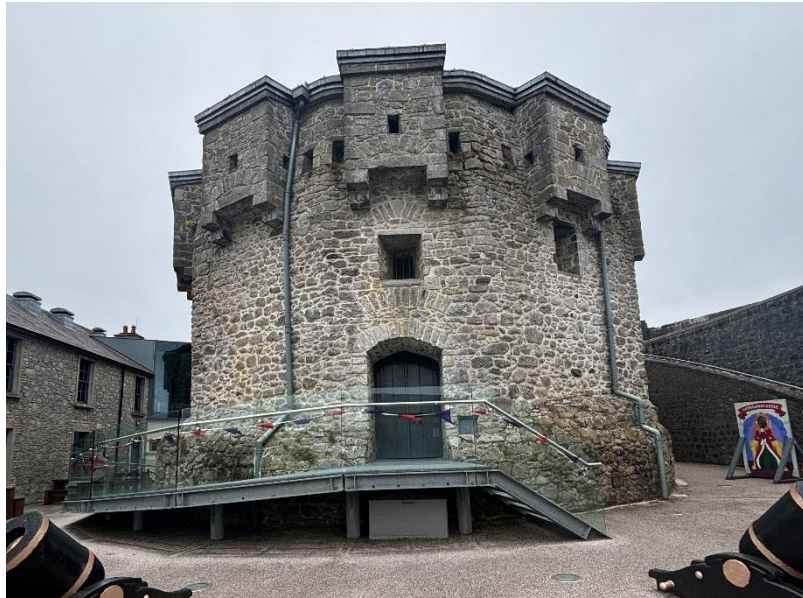
**Figure 11: Keep building**

The keep is set centrally within the castle grounds. The keep is a rubble limestone masonry structure with a rounded battered base. The internal finished floor level of the ground floor is approximately 900mm above the external castle ground level. There is an existing steel framed ramp and steps to the entrance door. Many of the steel fixings have corroded.

Externally, it is proposed to dismantle the current steel frame steps from the courtyard into the keep, retain the existing ramp and construct new steps. The existing foundations will be retained, reused and extended.

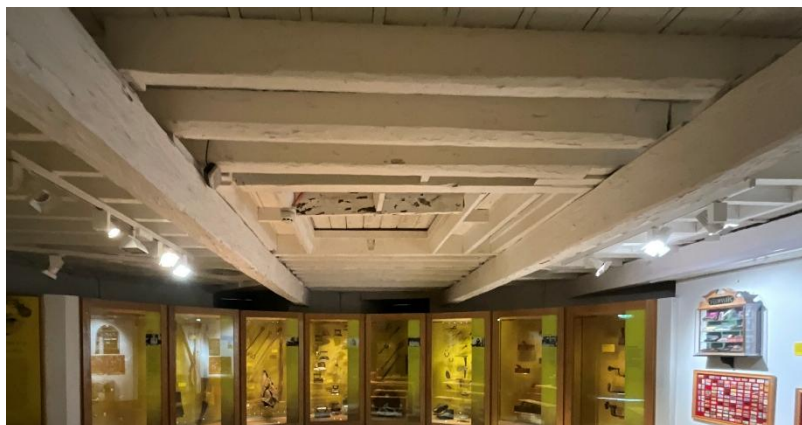
**Figure 12: Historic 1st floor**

Internally, the ground floor is finished with stone flags. The build up between the ground level and the stone flags is currently unknown. From the ground, the underside of the historic timber 1<sup>st</sup> floor can be observed. The majority of the timbers are original, with localised joist replacement where a previous stair opening has been infilled. The main ceiling beams are 270mm deep x 140mm wide. The joists, which bear an inch above the beams are 160mm deep x 80-100mm wide.

Alterations to the historic timber 1<sup>st</sup> floor are limited to the removal of some joists. All historic beams will be retained.

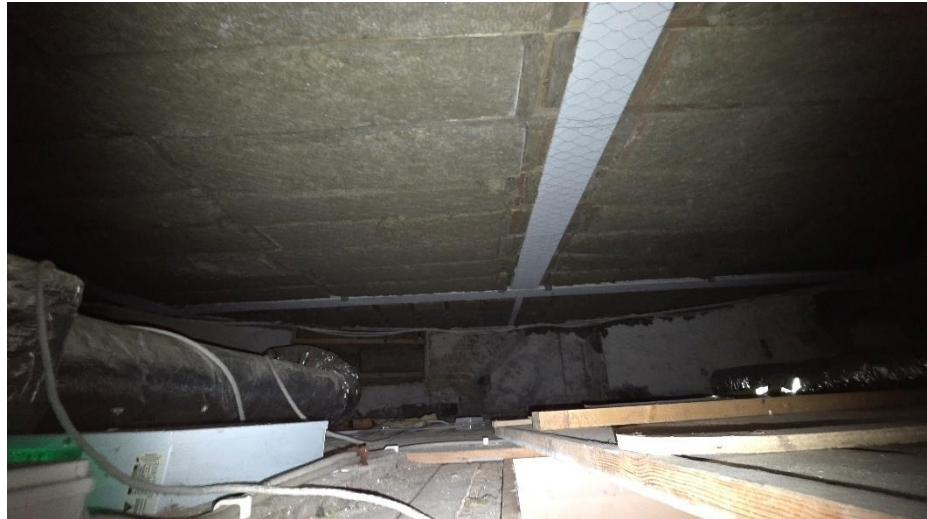
**Figure 13: View inside void of underside of 2012 floor structure**

There is a hatch in the ceiling, to which the void between the historic 1<sup>st</sup> floor and the current 1<sup>st</sup> floor can be seen. The current 1<sup>st</sup> floor was a 2012 addition, and the structure is outlined in the Structural Plans for the works. The floor structure is a steel grid of 203 x 60 UC beams infilled with 225mm deep x 44mm wide timber joists. The steel beams have intumescent paint, which can be observed from the ceiling hatch.

Alterations to the current 1<sup>st</sup> floor include cutting back of existing 2012 steel beams and removal of joists. New steel beams will be required to support trimmed beams and stairs. 2no. beams will require pocketing into existing masonry walls with padstones.

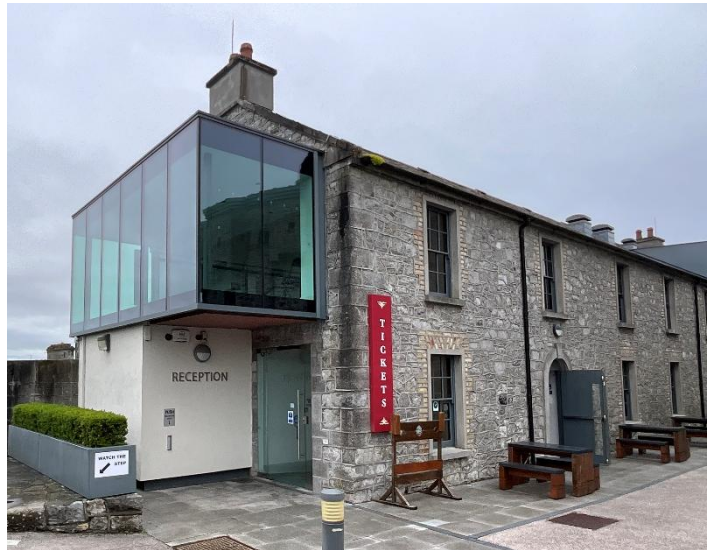
**Figure 14: Barracks and 2012 Gable**

At ground level, reinforced concrete strip foundations were introduced in the gable and at the south of the barracks for a timber stud partition. The floor was replaced with a new concrete slab with radon barrier according to the 2012 works structural plans. The first floor consists of a steel beam grid with timber joists infilled in the barracks and cantilevering reinforced concrete slab at the gable end. Note, no opening up works were carried out to confirm accuracy of the 2012 works Structural drawings and no inspection of the roof structure was carried out.

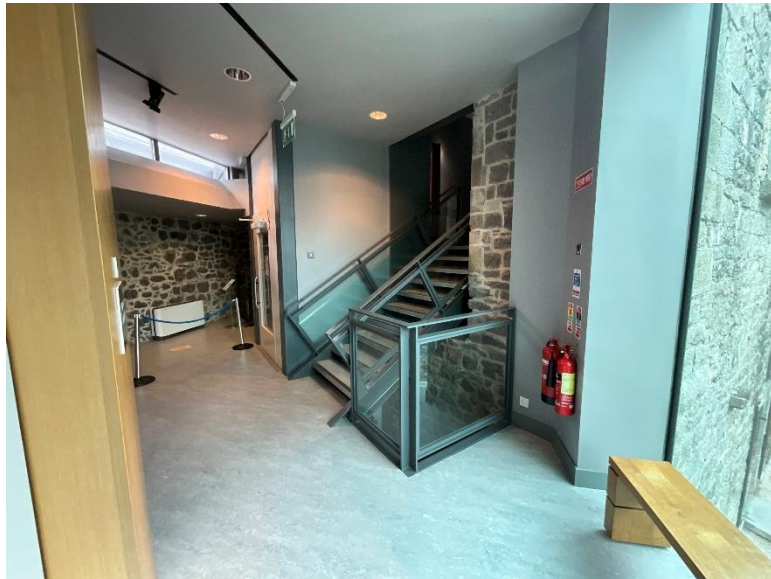
**Figure 17: Access to Armoury from 2012 Link**

Between the barracks and the Armoury, a building was constructed in the 2012 works to link the two. The link comprises of reinforced concrete foundations for a new steel stair, new blockwork lift shaft for platform lift and new blockwork external wall. The ground floor is a reinforced concrete slab with radon barrier. The first floor consists of a steel beam grid with a combination of infilled timber joist floor and reinforced concrete slab. Steel stairs were introduced to link access into the Armoury.

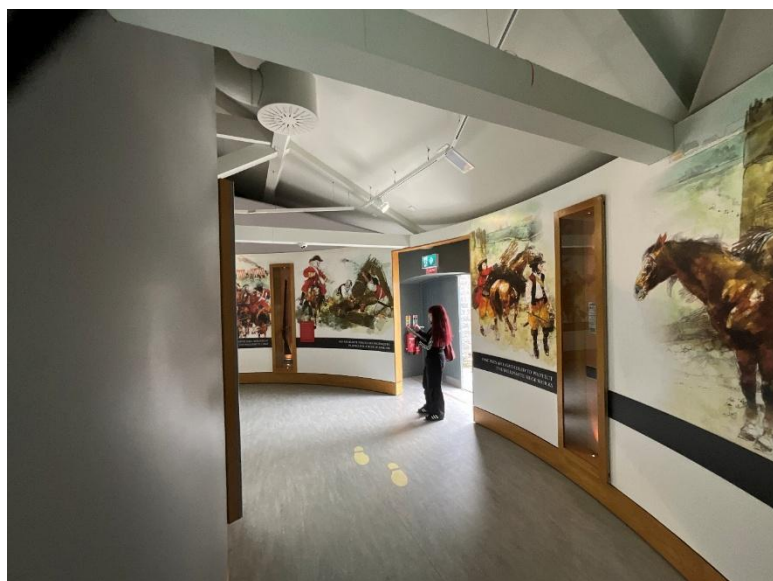
**Figure 18: Armoury Building**

The 1<sup>st</sup> floor build in the Armoury is currently unknown and to be investigated. At roof level, there are existing boxed out trusses.

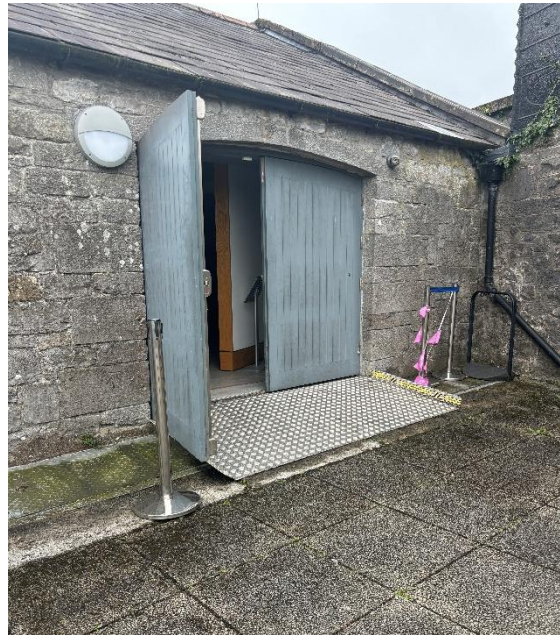
**Figure 19: Access to Terrace from Armoury**

Access to the terrace is through a fire escape door in the Armoury and via an external cobbled stone stair adjacent to the entrance to the castle grounds. There are existing galvanised access covers along the base of the wall to the Armoury. These were not opened up or investigated.

It is proposed to replace 2no existing doors with airlock doors. One at the ground floor entrance to the link building and another at the 1<sup>st</sup> floor exit from the Armoury to the Terrace. The airlock structures will be 2no. pairs of 2no. steel portal frames, portalised in both axes for stability. Internal and external pairs will be separated to help mitigate any thermal losses. The ground floor link airlock can be fixed to existing foundations constructed in 2012, with an extension to the width of the strip. The terrace airlock will be founded within the 1990s interventions.

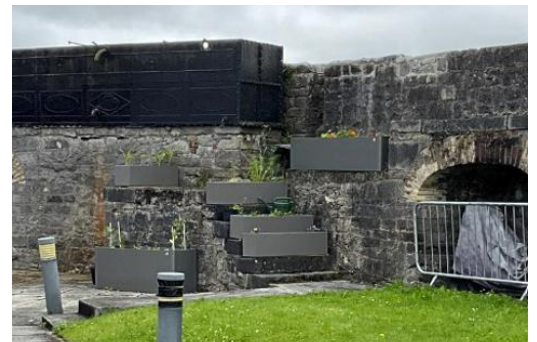
**Figure 21: Stone steps**

The terrace is a combination of paving stones and soft grass landscape and planting. There are existing stones steps which facilitate access to an existing water tank and to the wall tops.

It is proposed to reduce the level of the soft landscaping in the garden, thus requiring the need for an additional stone step to the external steps. A new guardrail is proposed to the steps and landing. New guardrails are proposed throughout the site. Guardrails can be resin fixed into existing stonework joints.
