SITE OBSERVATIONS

Site: Robinstown, County Westmeath
Client: Westmeath County Council
Ref: 23-310-03
Survey Date: Thursday 26th June 2025

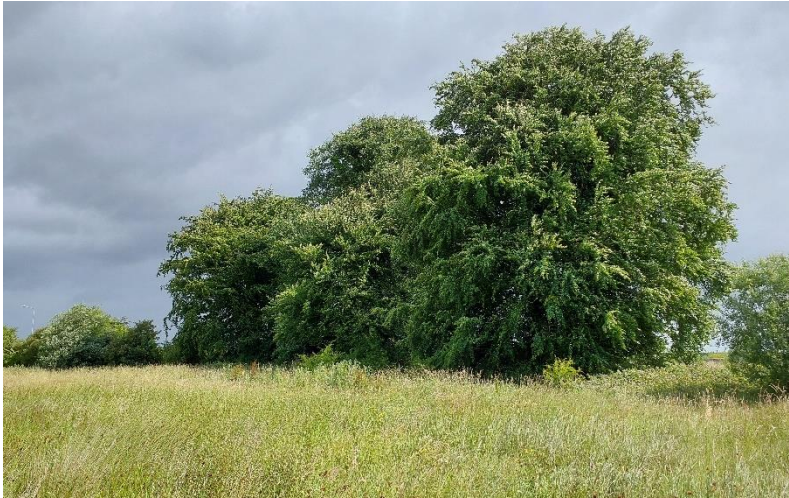
Five mature beech trees growing from an old field bank boundary in the most southern field provide high visual amenity in the local landscape. The remnants of a lapsed mixed species hedgerow which extends north towards the link road boundary forms an understorey, in part beneath these trees. The beech are fully mature and have considerable girths with the largest over 1.4 m diameter at breast height. Three of the beech were observed to have significant defects including large primary limb and stem failures, basal cavities, stem cavities, hollowing and decay fungi including *Kretschmaria deusta* and *Ganoderma australe*, and will require removal if the lands become accessible to the public. The other two beech are in fair condition but dense ivy that extends high into crowns is recommended for removal to allow a full visual inspection.

Figure 1. Mature beech in most southern field.

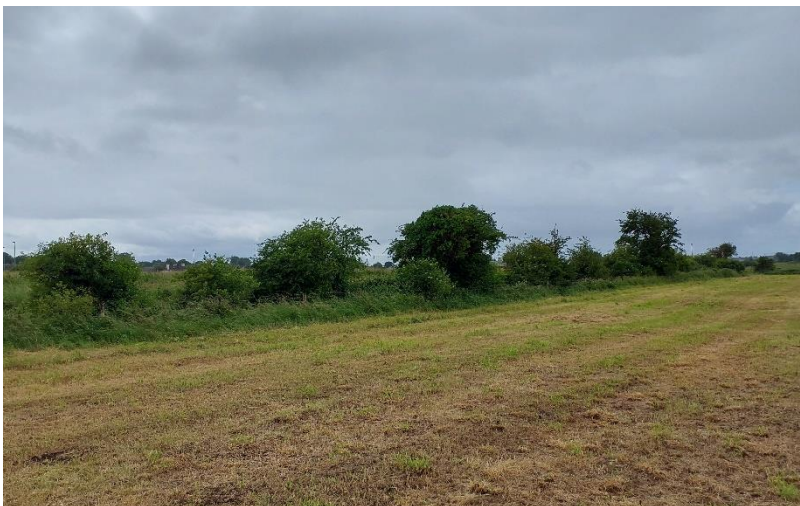
The two most northern fields are bound in part by the remnants of lapsed mixed species hedgerows and self-sown hawthorn with occasional elder and grey willow, behind post and barb wire stock proof fencing. The most intact hedgerow extends along the north western boundary of the site, with a number of fully mature hawthorn interspersed with good natural regeneration forming understorey succession.

Figure 2. Remnants of lapsed hedgerow (H12) and self-sown natural regeneration from rank grass along field boundary.

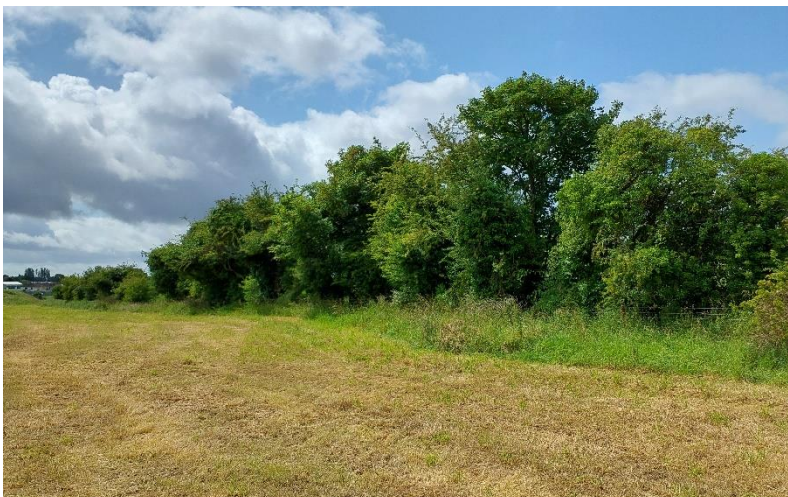
Figure 3. Lapsed mixed species hedgerow (H23) with mature hawthorn and good natural regeneration from understorey.

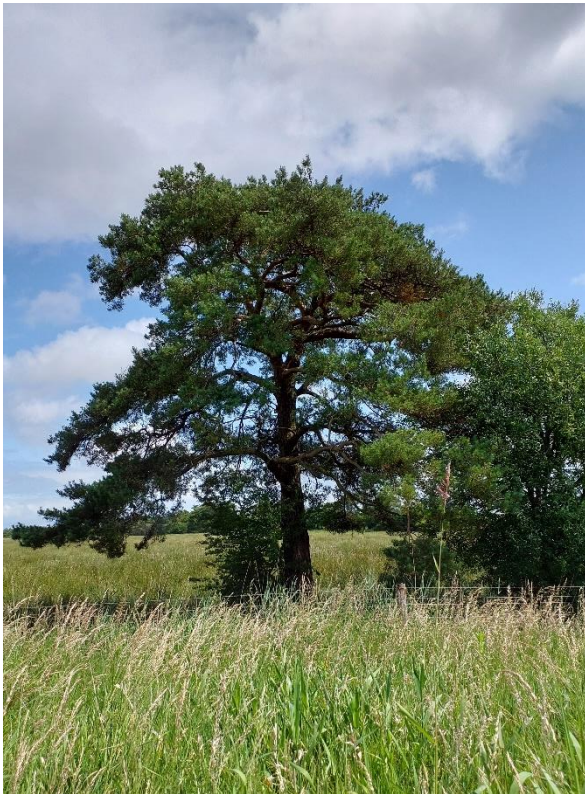
On lands immediately north east of the site are several early mature Scots pine interspersed with self-sown hawthorn, elder and grey willow. The Scots pine are in good condition and beyond influencing distance of the site, being separated from the site by a deep field drainage ditch.

Figure 4. Early mature Scots pine beyond field ditch on neighbouring land, beyond influencing distance of site.
