Re: An Arboricultural Assessment of the Site Area at Belvedere Orphanage, Tyrrelspass, Co Westmeath

The proposed development is to provide 6 no. social houses at Belvedere Orphanage, Tyrrelspass, Co. Westmeath. The proposal includes the refurbishment of the 'Matron's House' at Belvedere Orphanage, a protected structure. It is proposed to extend and alter the existing structure to form 2no. two-bedroom, two storey houses. It is also proposed to provide up to four no. single storey dwelling houses on the lands to the rear. I inspected the tree vegetation within the above site area at Tyrrelspass and the proposed development layout drawings forwarded to me as requested and I am pleased to submit the following documents:

A Condition Assessment of the Tree and Hedge Vegetation within the site area at Belvedere Orphanage, Tyrrelspass, Co Westmeath

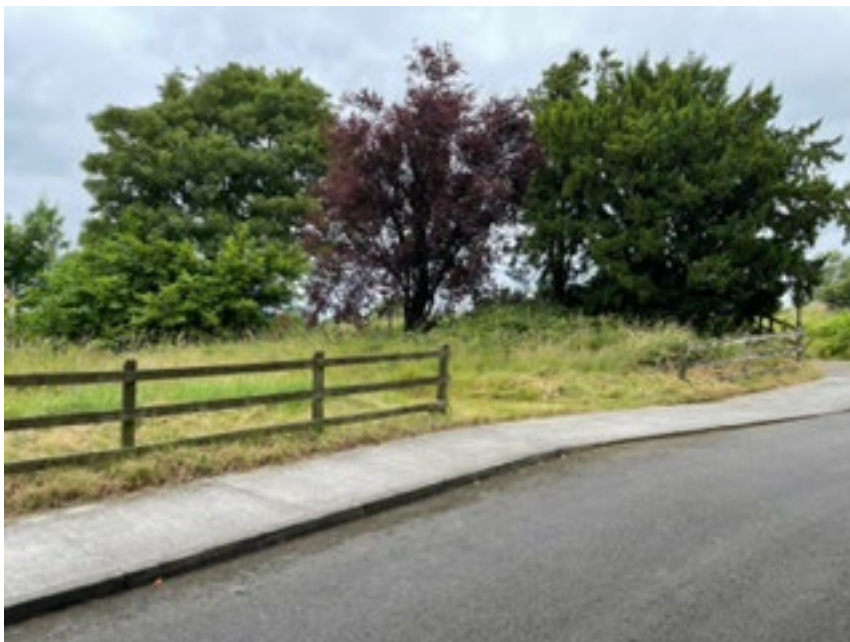
Label numbers 263, 265 and 266 – Yew, plum and sycamore trees in good condition. The cypress tree 264 should be removed to facilitate the yew specimen

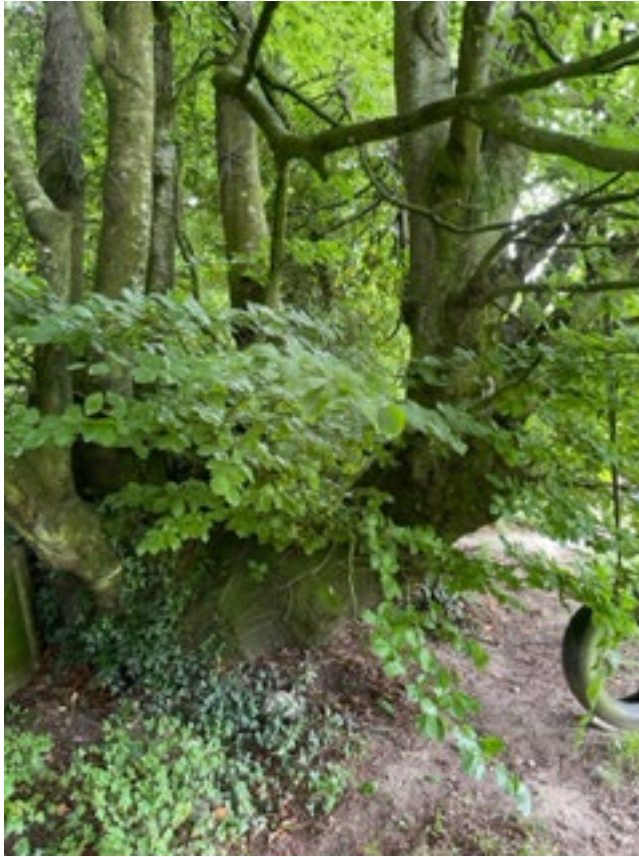
Label number 267 – Large Multistemed beech tree overhanging private property

267	<i>Fagus sylvatica</i>	Beech	M	62 36 31	15	N – 5 S – 6 E – 6 W - 5	Fair	Good vigour and fair form. Multistemed. Overhanging adjoining dwelling house property. Some lateral limbs removed in the past. Crossing limbs present	C <15 years	Thin and clean the crown. Monitor stability and potential root damage! Consider removal for health and safety reasons Priority A

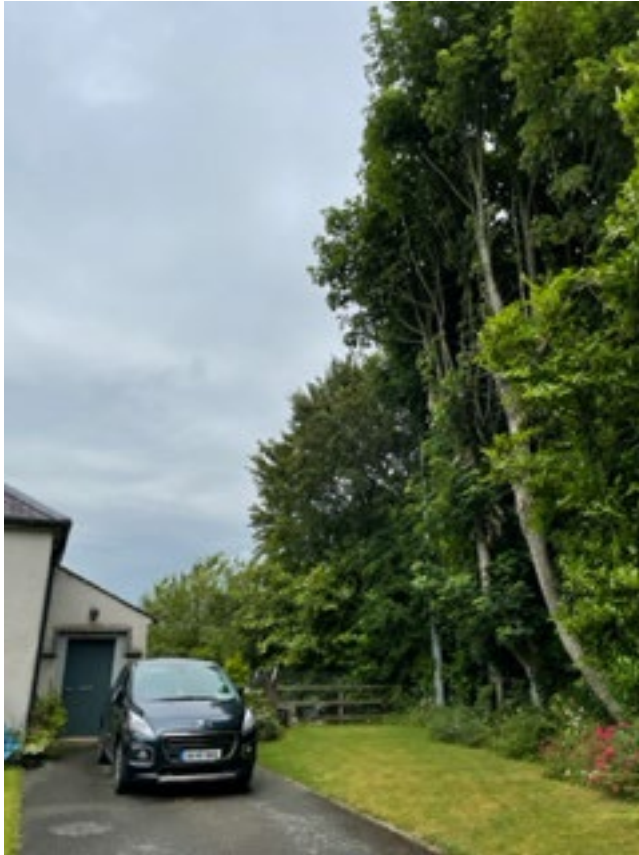
Label numbers 268, 269, 270 and 271 – Line of mature sycamore trees heavily pruned in the past and with potential safety issues

Tree No	Species Botanical Name	Common Name	Age Y SM EM M OM V	DBH (cms)	Height (m) ----- Height of clear stem	Crown Span (m)	Physiological Condition -Good -Fair -Poor -Dead	Comments Structural Observations	Retention Category A-High B-Moderat C-Low D-Fell -Lifespan	Preliminary Management Recommendations Priority A, B, C or U
268	<i>Acer pseudoplatanus</i>	Sycamore	M	38 21 16	15	N – 4 S – 2 E – 1 W - 4	Fair	Good vigour and fair form. Overhanging adjoining dwelling house property. Major crown reductions in the past. New growth with weak attachments. Ivy on one stem.	C <15 years	Reduce new growth back to original cuts. Clean and reshape the crown. Consider removal Priority A
269	<i>Acer pseudoplatanus</i>	Sycamore	M	40 30 31 20	16	N – 5 S – 3 E – 3 W - 3	Fair	Good vigour and fair form. Overhanging adjoining dwelling house property. Major crown reductions in the past. New growth with weak attachments.	C <15 years	Reduce new growth back to original cuts. Clean and reshape the crown. Consider removal Priority A

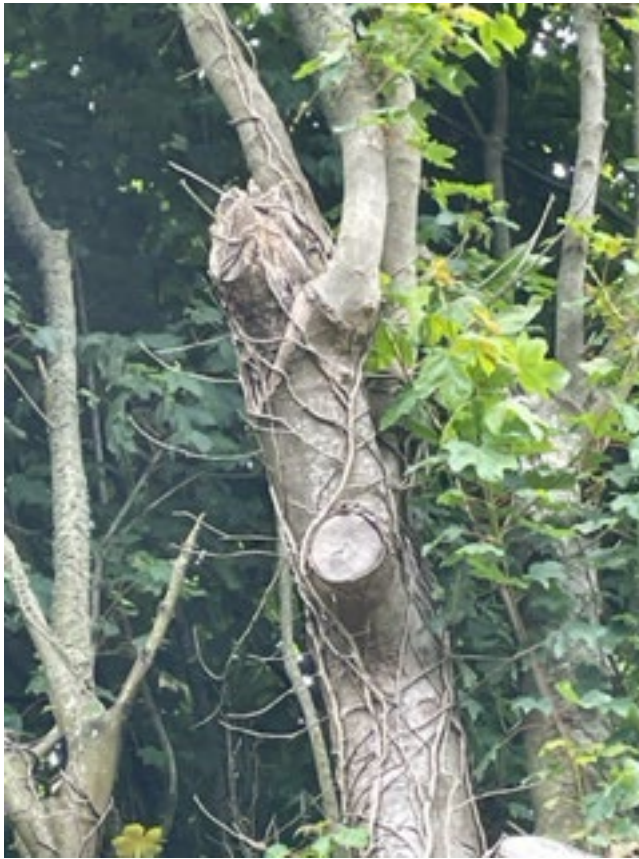
Typical limb removal and new growth with weak attachment's

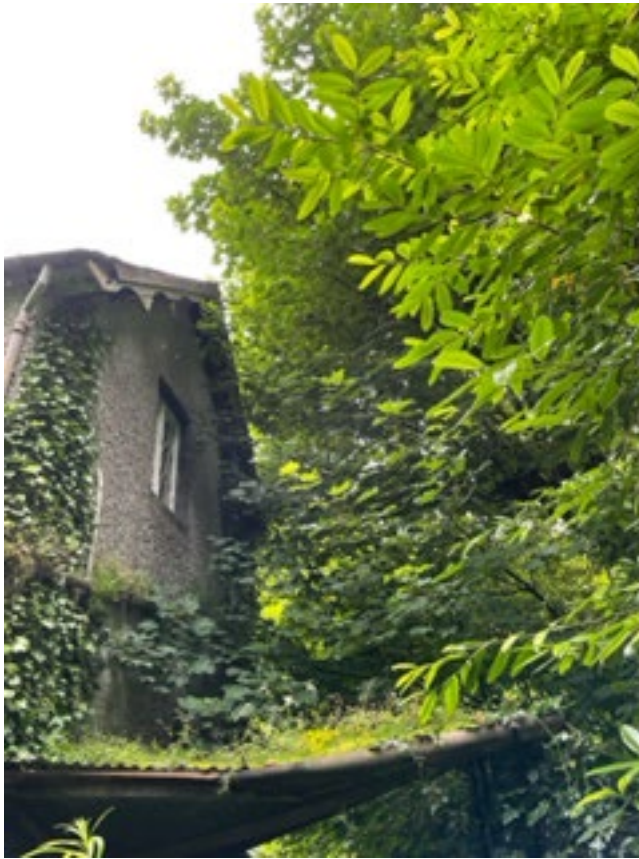
Trees near existing buildings – note some old laurel hedgerow

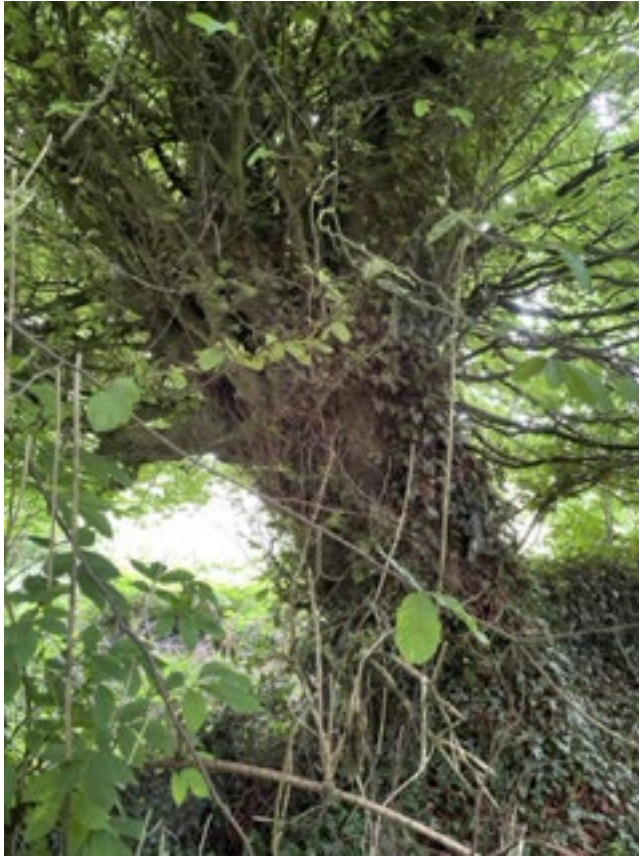
Label numbers 272, 273, 274 and 275 – Beech trees severely topped in the past and coppice growth present. Stability issues due to raised ground grade as well as limb failure potential!

Tree No	Species Botanical Name	Common Name	Age Y SM EM M OM V	DBH (cms)	Height (m) ----- Height of clear stem	Crown Span (m)	Physiological Condition -Good -Fair -Poor -Dead	Comments Structural Observations	Retention Category A-High B-Moderat C-Low D-Fell -Lifespan	Preliminary Management Recommendations Priority A, B, C or U
271	<i>Acer pseudoplatanus</i>	Sycamore	M	38	16	N – 2 S – 2 E – 4 W - 1	Fair	Good vigour and fair form. Overhanging adjoining dwelling house property. Major crown reductions in the past. New growth with weak attachments.	C <15 years	Reduce new growth back to original cuts. Clean and reshape the crown. Consider removal Priority A
272	<i>Fagus sylvatica</i>	Beech	M	45	10	N – 2 S – 4 E – 2 W - 5	Poor	Fair vigour and poor form. Topped back to c5m in the past. Coppice growth with weak attachments. Close to buildings. Growing on c1m raised grade in ground at base of tree with limited stability	C <10 years	Consider removal due to poor condition and stability issues!

273	<i>Fagus sylvatica</i>	Beech	M	35	12	N – 2 S – 2 E – 3 W - 6	Fair	Fair vigour and poor form. Topped back to c5m in the past. Coppice growth with weak attachments. Close to buildings. Growing on c1m raised grade in ground at base of tree with limited stability	C <10 years	Consider removal due to poor condition and stability issues!

Tree No	Species Botanical Name	Common Name	Age Y SM EM M OM V	DBH (cms)	Height (m) ----- Height of clear stem	Crown Span (m)	Physiological Condition -Good -Fair -Poor -Dead	Comments Structural Observations	Retention Category A-High B-Moderat C-Low D-Fell -Lifespan	Preliminary Management Recommendations Priority A, B, C or U
274	<i>Fagus sylvatica</i>	Beech	M	60	13	N – 3 S – 3 E – 5 W - 6	Poor	Fair vigour and poor form. Topped back to c5m in the past. Coppice growth with weak attachments. Close to buildings. Growing on c1m raised grade in ground at base of tree with limited stability	C <10 years	Consider removal due to poor condition and stability issues!
275	<i>Fagus sylvatica</i>	Beech	M	80	13	N – 6 S – 5 E – 6 W - 7	Fair	Fair vigour and poor form. Topped back to c5m in the past. Coppice growth with weak attachments. Close to buildings. Growing on c1m raised grade in ground at base of tree with limited stability	C <10 years	Consider removal due to poor condition and stability issues!

Trees to be removed due to their condition and in the interest of safety to public and property, as per attached schedule, include label numbers 267, 268, 269, 270, 271, 272, 273, 274 and 275

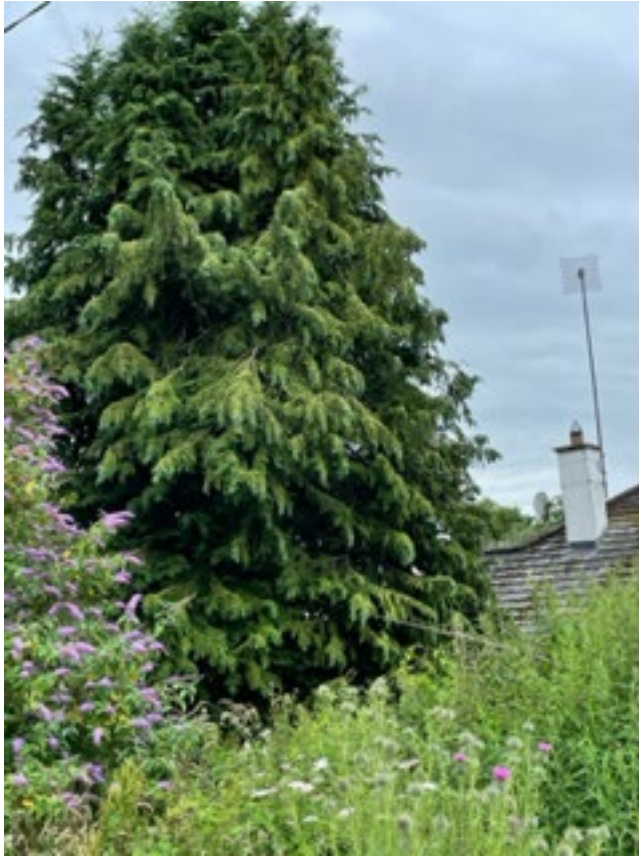
Label number 276 – Cypress tree
