ASBESTOS SURVEY REPORT

Client: Westmeath County Council

Location: Belvedere Orphanage, Tyrrellspass,
Co. Westmeath N91 W2K4

Date of Survey: 06/12/2023

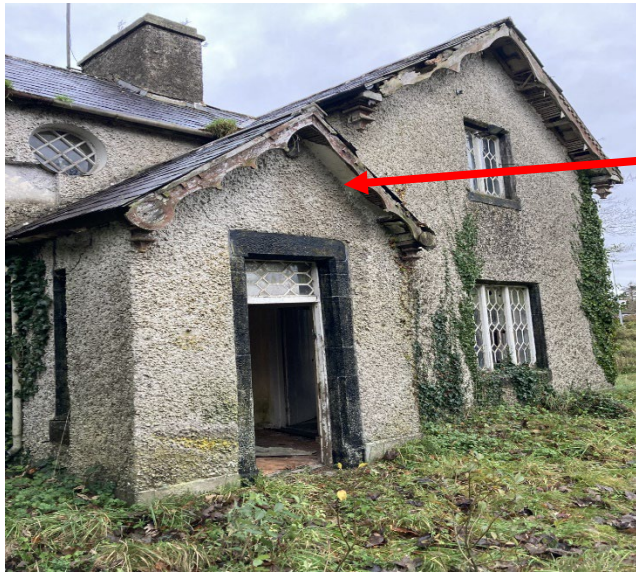
PHOTOGRAPH'S:	COMMENTS:
<p data-bbox="204 353 268 383">No 1.</p>

<p data-bbox="1086 383 1225 412">Front porch.</p> <p data-bbox="1086 450 1369 539">A sample was taken here of the manufactured roof slate (black).</p> <p data-bbox="1086 577 1209 607">Sample S1.</p> <p data-bbox="1086 645 1369 734">The lab results show that Asbestos was Not detected in the sample.</p>
<p data-bbox="204 1050 268 1079">No 2.</p>

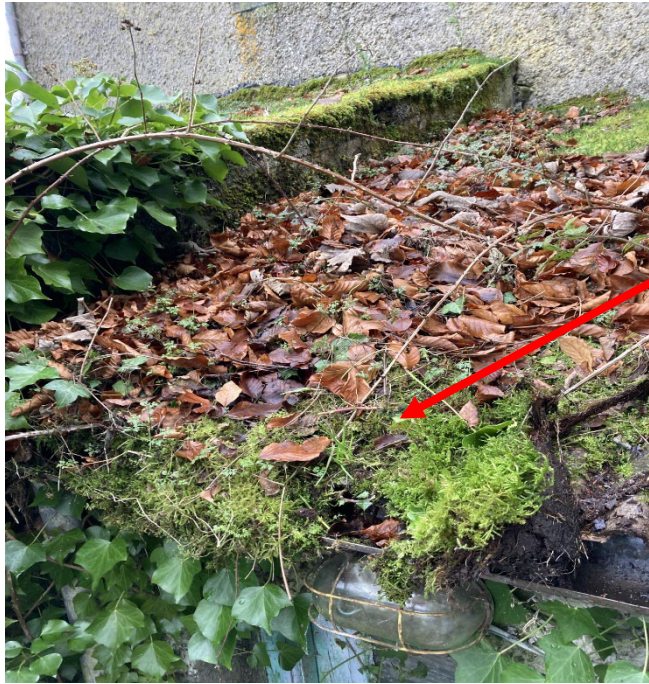
Asbestos Containing Materials/ ACMs were detected to be present in two of the samples taken in the premises. These were the corrugated roof sheeting at the rear on the porch and the water tank in the attic.

<p data-bbox="1086 1115 1257 1182">Roof on back porch/hallway.</p> <p data-bbox="1086 1220 1369 1377">A sample was taken here of the corrugated cement roof sheeting underneath the leaves and ivy in the photo shown here.</p> <p data-bbox="1086 1415 1209 1444">Sample S2.</p> <p data-bbox="1086 1482 1369 1706">The lab results show that Asbestos was detected in the sample. The roof area is circa 2.9m x 1.8m, as per drawings received reference 105_01_002.</p>

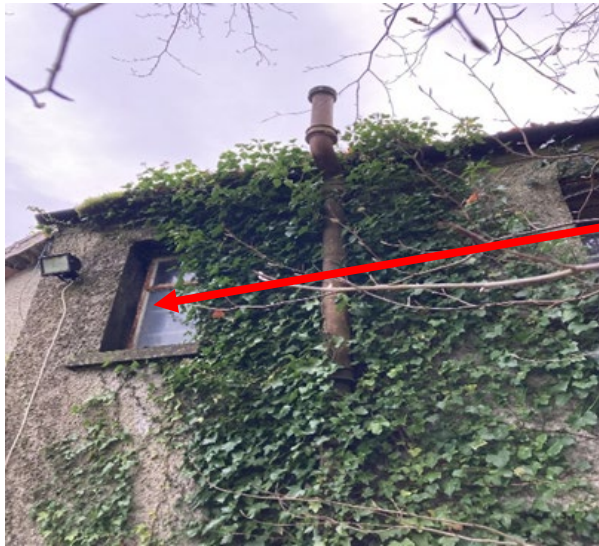
No 3.

Window on the first floor back extension.

A sample was taken from the window putty/paint.

Sample S3.

The lab results show that Asbestos was Not detected in the sample.

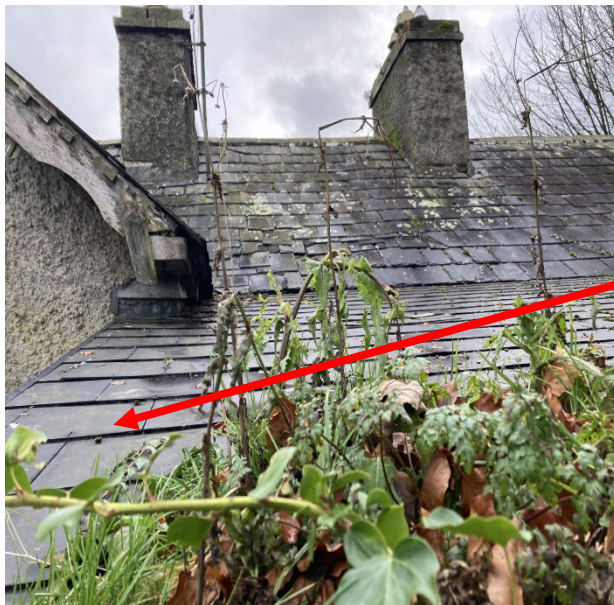
No 4.

Back roof lean too building.

A sample was taken here of the manufactured roof slate.

Sample S4.

The lab results show that Asbestos was Not detected in the sample.

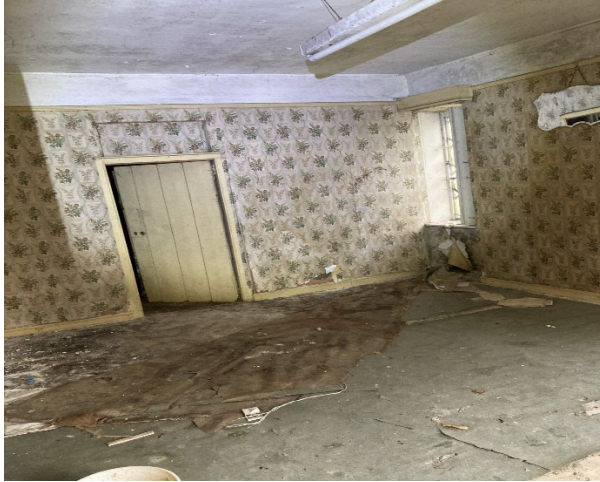
No 5.

Ground floor living room.

A sample was taken here of the floor lino.

Sample S5.

The lab results show that Asbestos was Not detected in the sample.

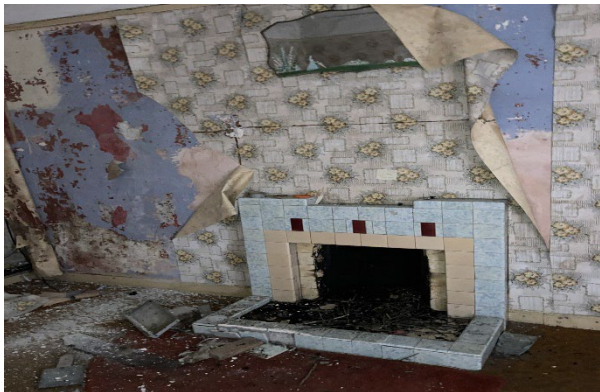
No. 6.

Ground floor living and sitting rooms.

A sample of the wallpaper (patterned) was taken here from two rooms.

Sample S6.

The lab results show that Asbestos was Not detected in the sample.

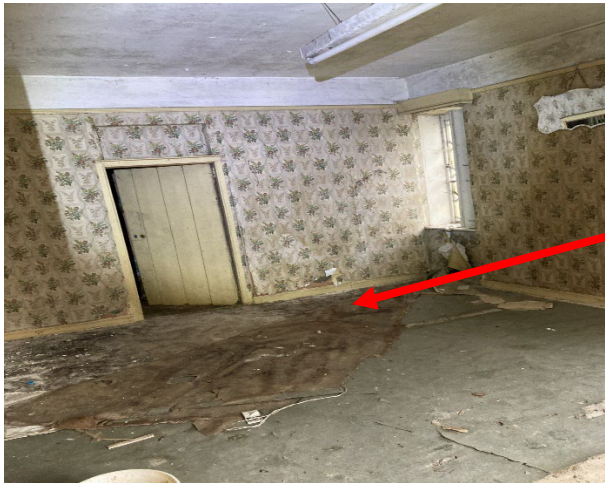
<p>No. 7.</p>

<p>Living room.</p> <p>A sample of the wall plaster board between the living room and storeroom was taken here.</p> <p>Sample S7.</p> <p>The lab results show that Asbestos was Not detected in the sample.</p>
<p>No. 8.</p>

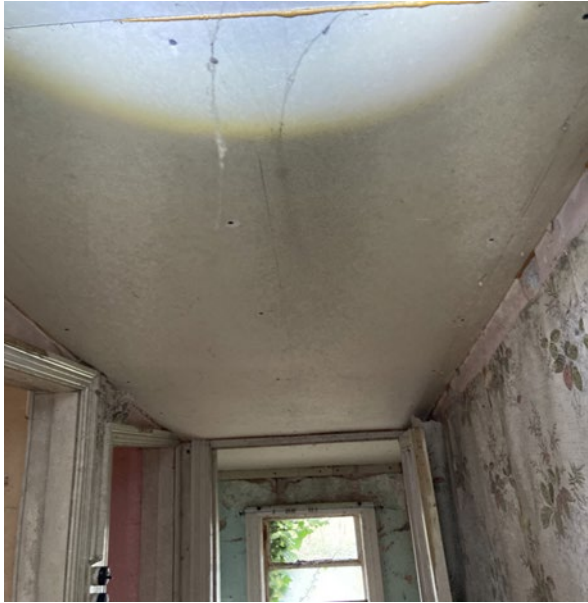
<p>First floor hallway outside bedroom 3 and the bathroom/toilet.</p> <p>A sample of the ceiling board was taken here.</p> <p>Sample S8.</p> <p>The lab results show that Asbestos was Not detected in the sample.</p>

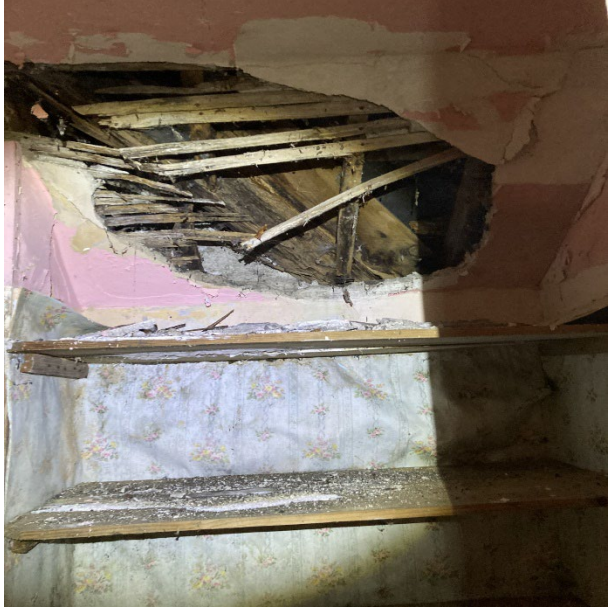
<p>No. 9.</p>

<p>First floor bedroom 3.</p> <p>A sample of the ceiling board was taken here.</p> <p>Sample S9.</p> <p>The lab results show that Asbestos was Not detected in the sample.</p>
<p>No. 10.</p>

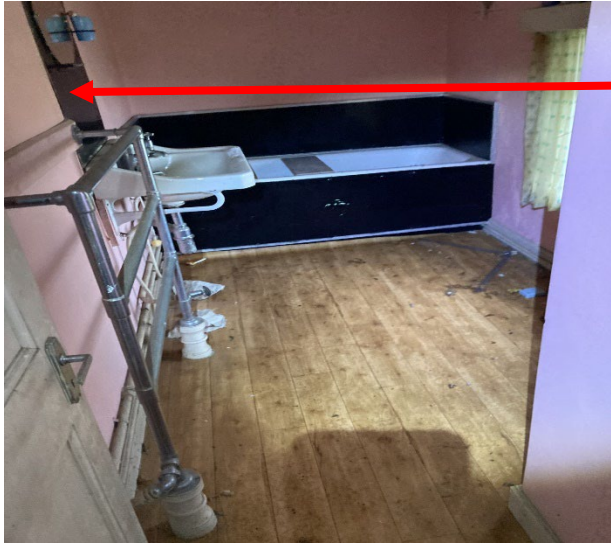
<p>First floor bathroom.</p> <p>A sample of the wall panel was taken here. The panel was behind the mirror on the wall and surrounding the bath.</p> <p>Sample S10</p> <p>The lab results show that Asbestos was Not detected in the sample</p>

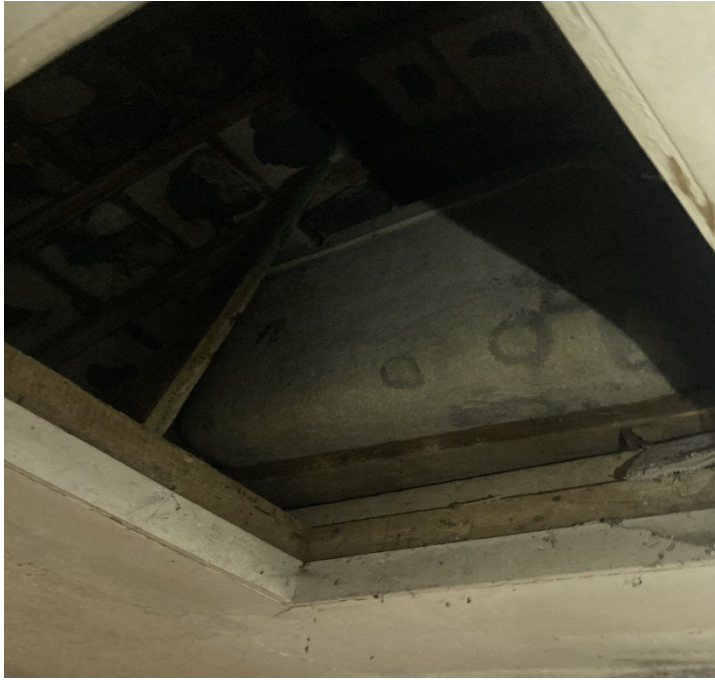
No. 11.

Attic water tank.

A sample was taken here
of the cement water tank
in the attic.

Sample S11.

The lab results show that
Asbestos was
detected in the sample.

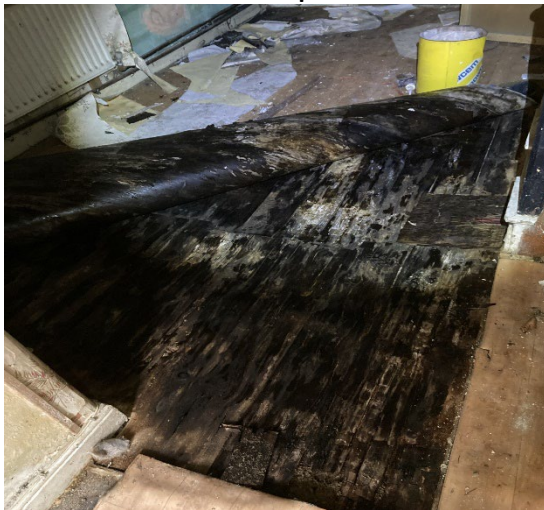
Lino on top of rotten timber in the ground floor hallway. Lino over concrete floor tiles inside the front door.

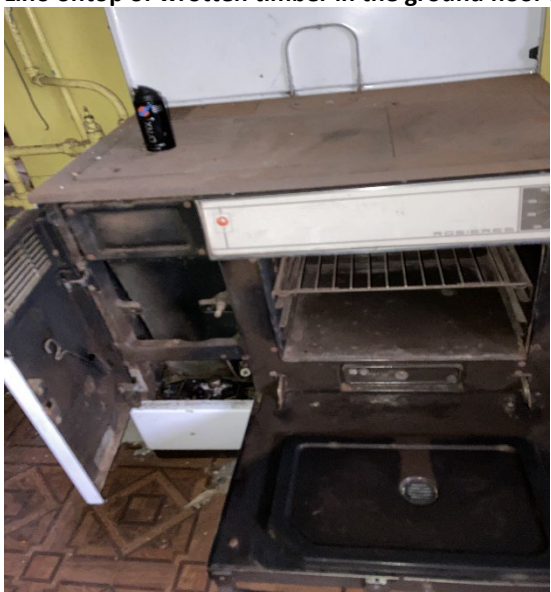
Kitchen cooker. No rope seal present.

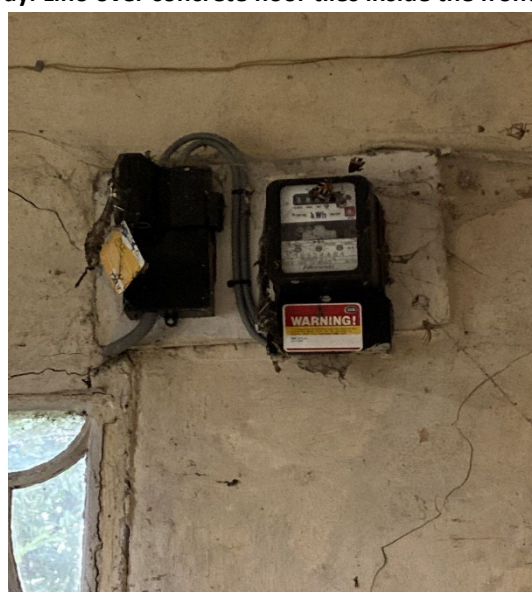
Electrical board. Mounted on timber board.
