Project: **PROPOSED HOUSING DEVELOPMENT AT
BELVEDERE ORPHANGE, TYRELLSPASS,
CO.WESTMEATH.**

Document Title: **STRUCTURAL SURVEY OF
EXISTING MATRON'S HOUSE**

Project No.: **22124**

Revision: **Rev 01 – 07.02.2024**

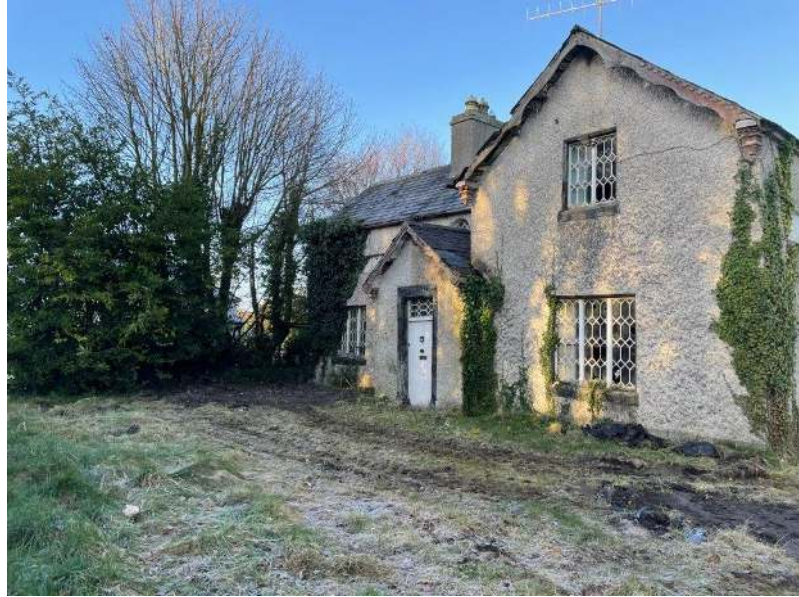
Photo 1 – Front Elevation

Generally the main body external walls of the main structure are in good condition. (See Photo 1 – Appendix B).

Notwithstanding this, the existing lintels do not appear to be in good condition and should be replaced to ensure an adequate future design life of the proposed works.

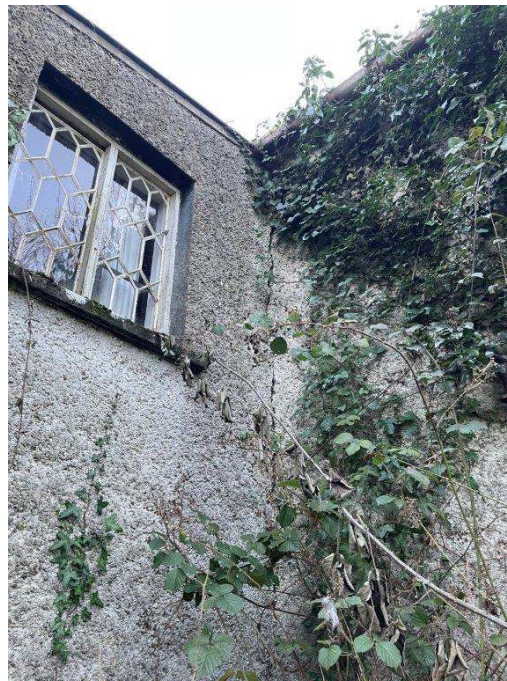
However there is a large vertical crack at the junction of the two storey return where the wall of bedroom 4 meets the wall of Bedroom 1. This is another indicator that the Bed 4/Kitchen return was a later addition of the house. (See Photo 2 – Appendix B)

Photo 2 – Vertical Crack at Junction of Two Storey Return at Rear of Building

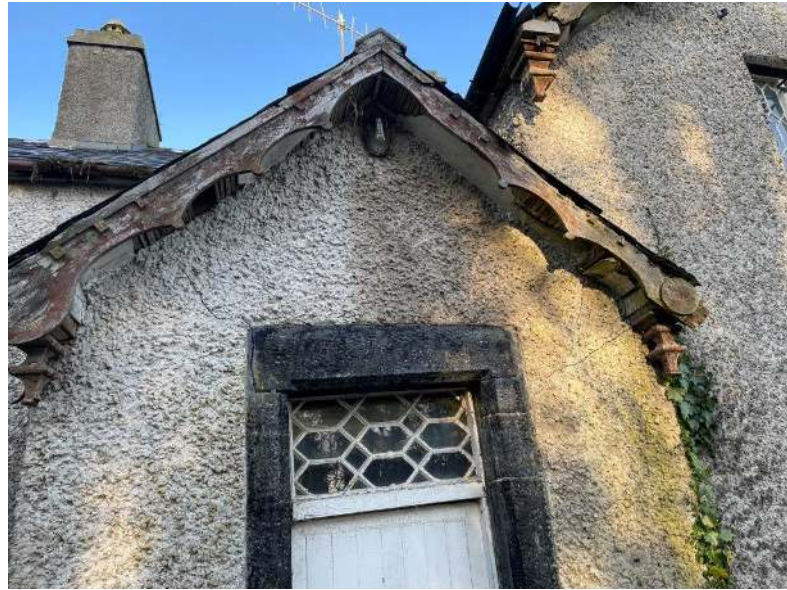
The external walls to the front porch area are in poor condition and there are large cracks to both the side and front of these walls. The front of the porch appears to lean away from the house. This and the orientation of the cracking appear to indicated the substructure of the front porch walls has subsided. (See Photos 3&4 – Appendix B)

The cracking visible on the external face of the external walls at the front porch is also visible on the internal face of these walls.

Photo 3 – Cracking to
Porch Front Elevation

- Existing external walls are generally in good condition, with the exception of the front porch.
- Front porch walls will require underpinning and significant crack repair works.
- Existing lintels should be replaced.
- Existing roof slates should be replaced as part of any major renovation to ensure an adequate design life of the slates.
- The existing first floor structure appears in mostly good condition and should be re-useable, subject to further opening up works.
- The existing roof structure at the valleys should be replaced.
- Existing roof rafters may need strengthening or replacement.
- Further opening up works should be carried out to determine if rafter ends need to be replaced.

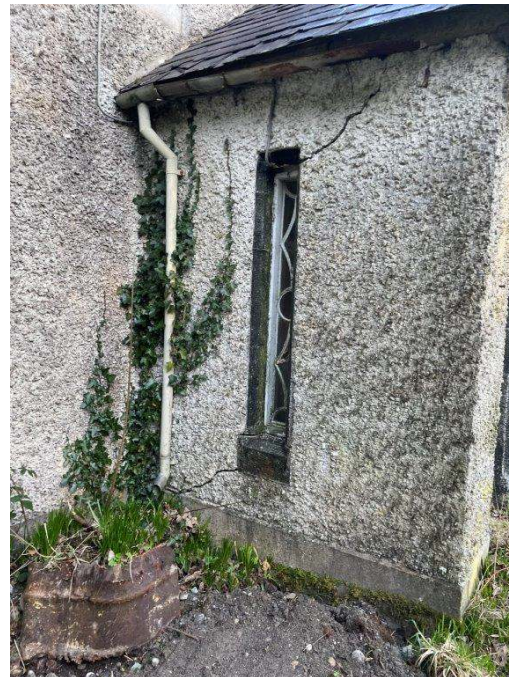
Photo 4 – Cracking to
Porch Side Elevation

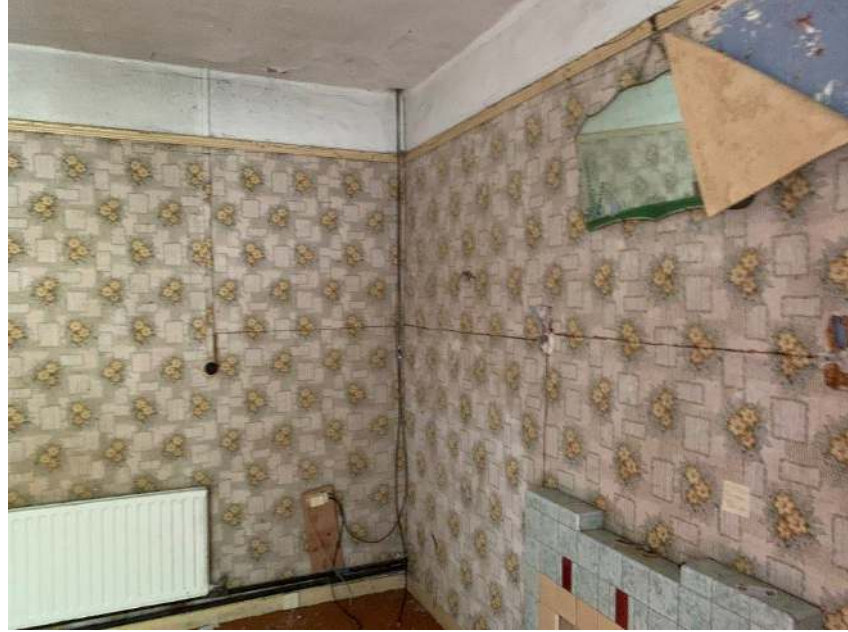
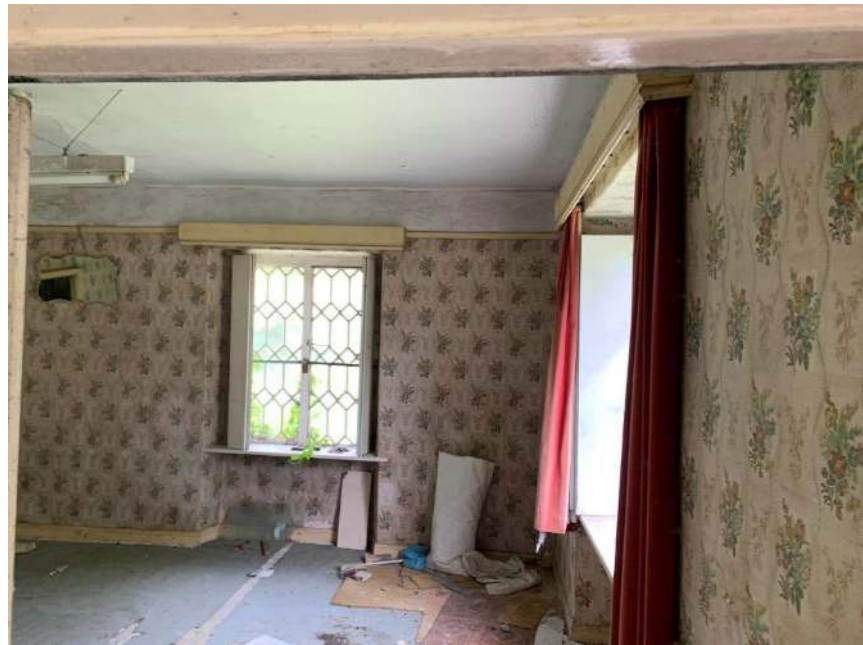
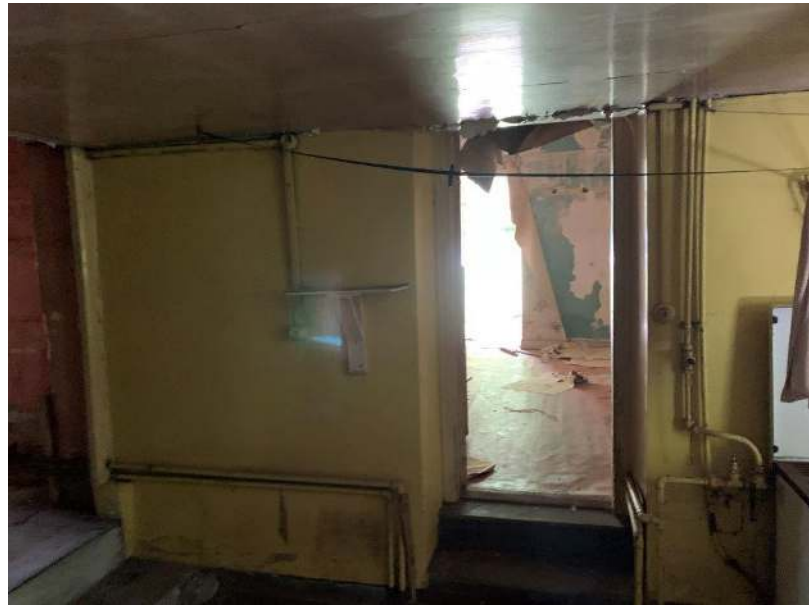
Most of the rendered walls were either covered in layers of wallpaper or drylined, but where visible they generally appeared to be of sound construction, and no obvious cracking was observed. (See Photos 5-7 – Appendix B)

Photo 5 – Ground Floor Walls

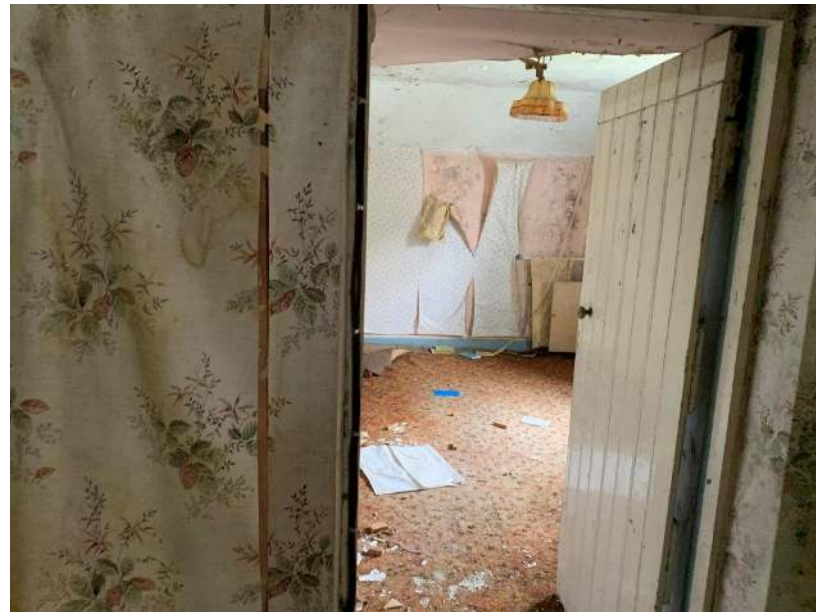
Most of the rendered walls were either covered in layers of wallpaper or drylined, but where visible they generally appeared to be of sound construction, and no obvious cracking was observed. (See Photo 8 – Appendix B)

Photo 8 – First Floor Walls

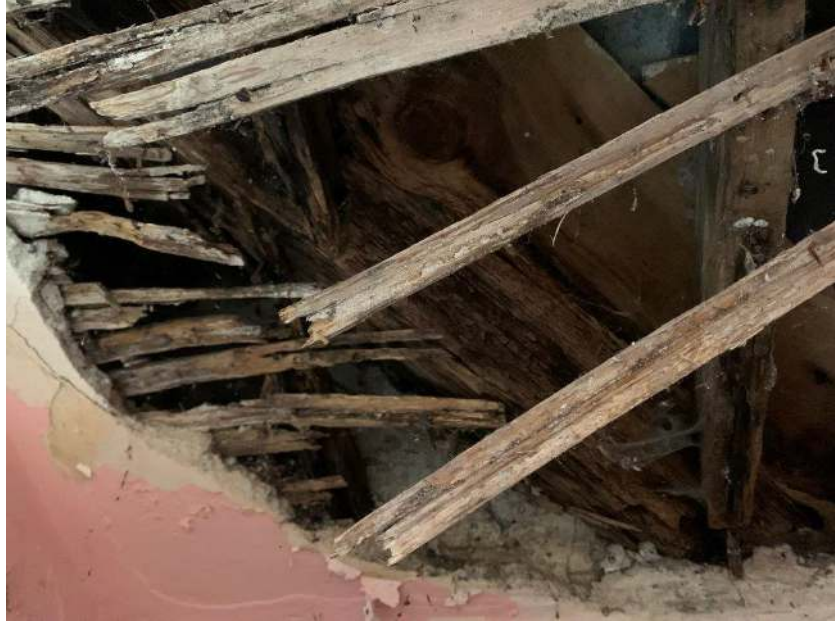
There is visible major water damage to the valley rafters. The rotting of the valley rafters will mean they need to be replaced and existing rafters supported by the valley rafters will also largely need to be replaced. (See Photo 9 – Appendix B).

Photo 9 – Valley Rafter
Rot
