BELVEDERE ORPHANAGE, TYRRELLSPASS, CO.
WESTMEATH.

STRUCTURAL ASSESSMENT OF "MATRON'S HOUSE"
REV 01

HOUSING CAPITAL SECTION
WESTMEATH COUNTY COUNCIL
MARCH 2026

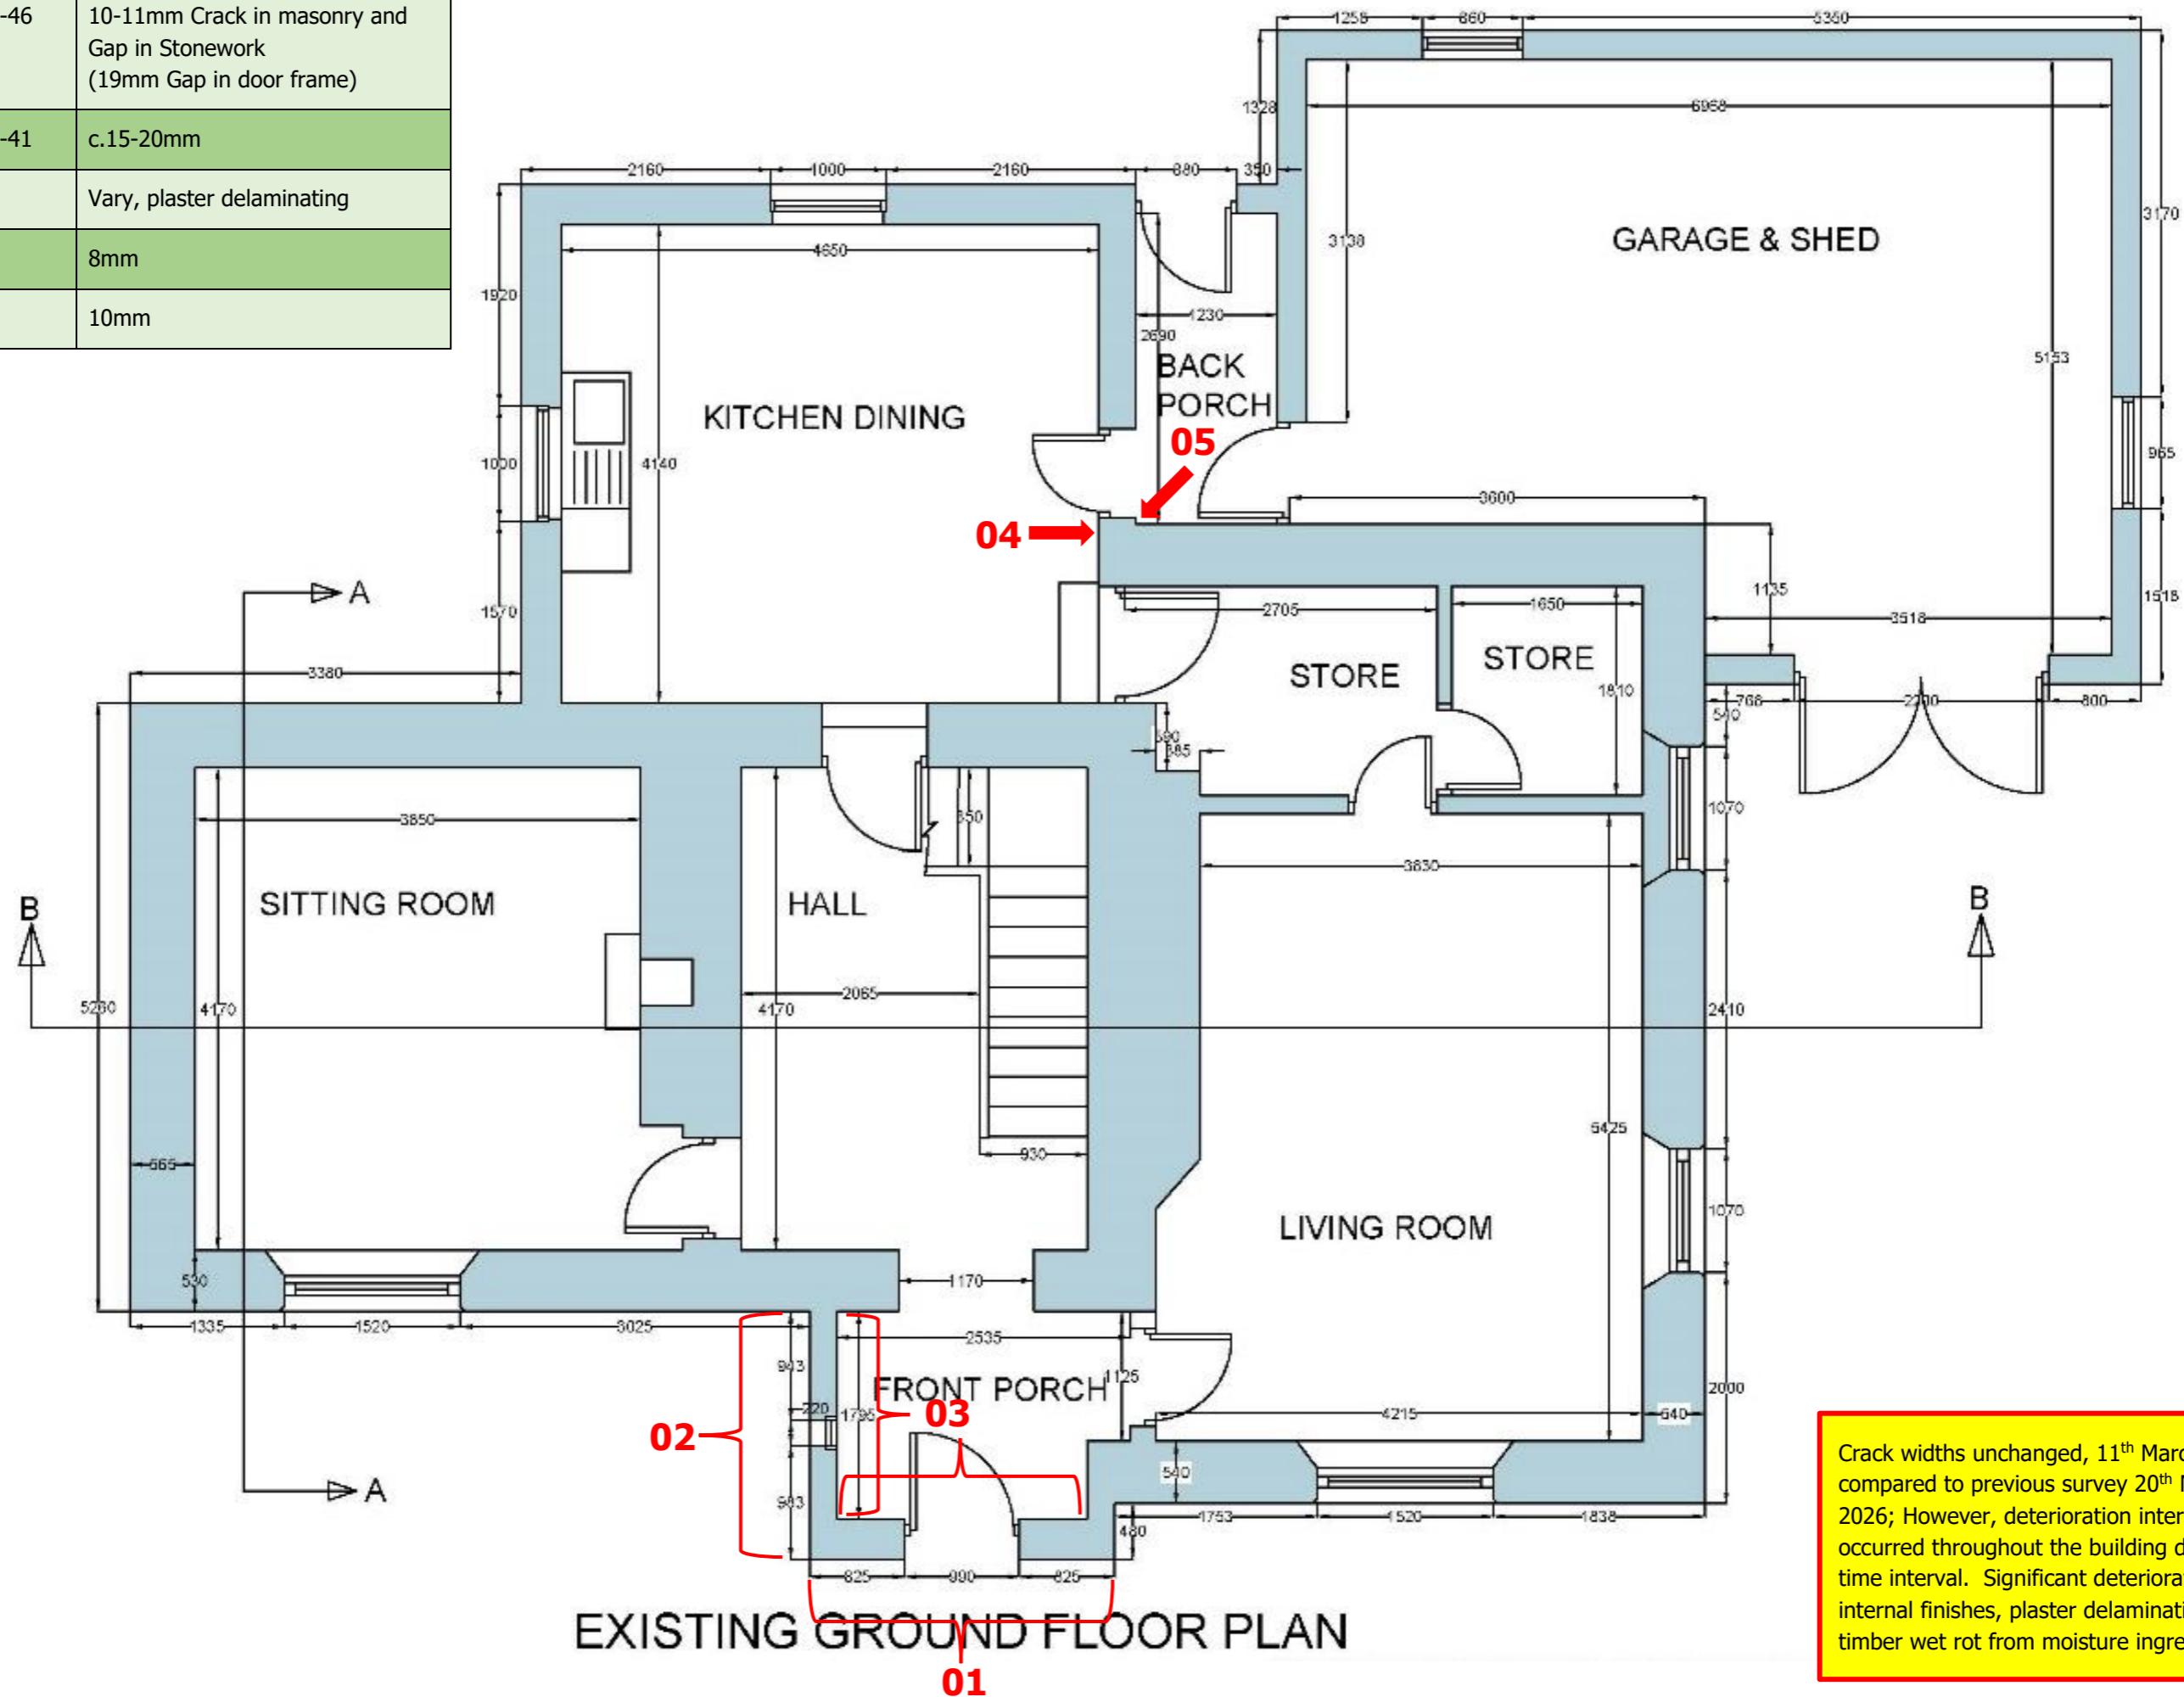
EXISTING GROUND FLOOR PLAN

Ref:	Pages:	Crack Width
1	30,33,41-46	10-11mm Crack in masonry and Gap in Stonework (19mm Gap in door frame)
2	31,32,36-41	c.15-20mm
3	47-50	Vary, plaster delaminating
4	53	8mm
5	54	10mm

Crack widths unchanged, 11th March 2026 compared to previous survey 20th November 2026; However, deterioration internally has occurred throughout the building during this time interval. Significant deterioration of internal finishes, plaster delamination and timber wet rot from moisture ingress.

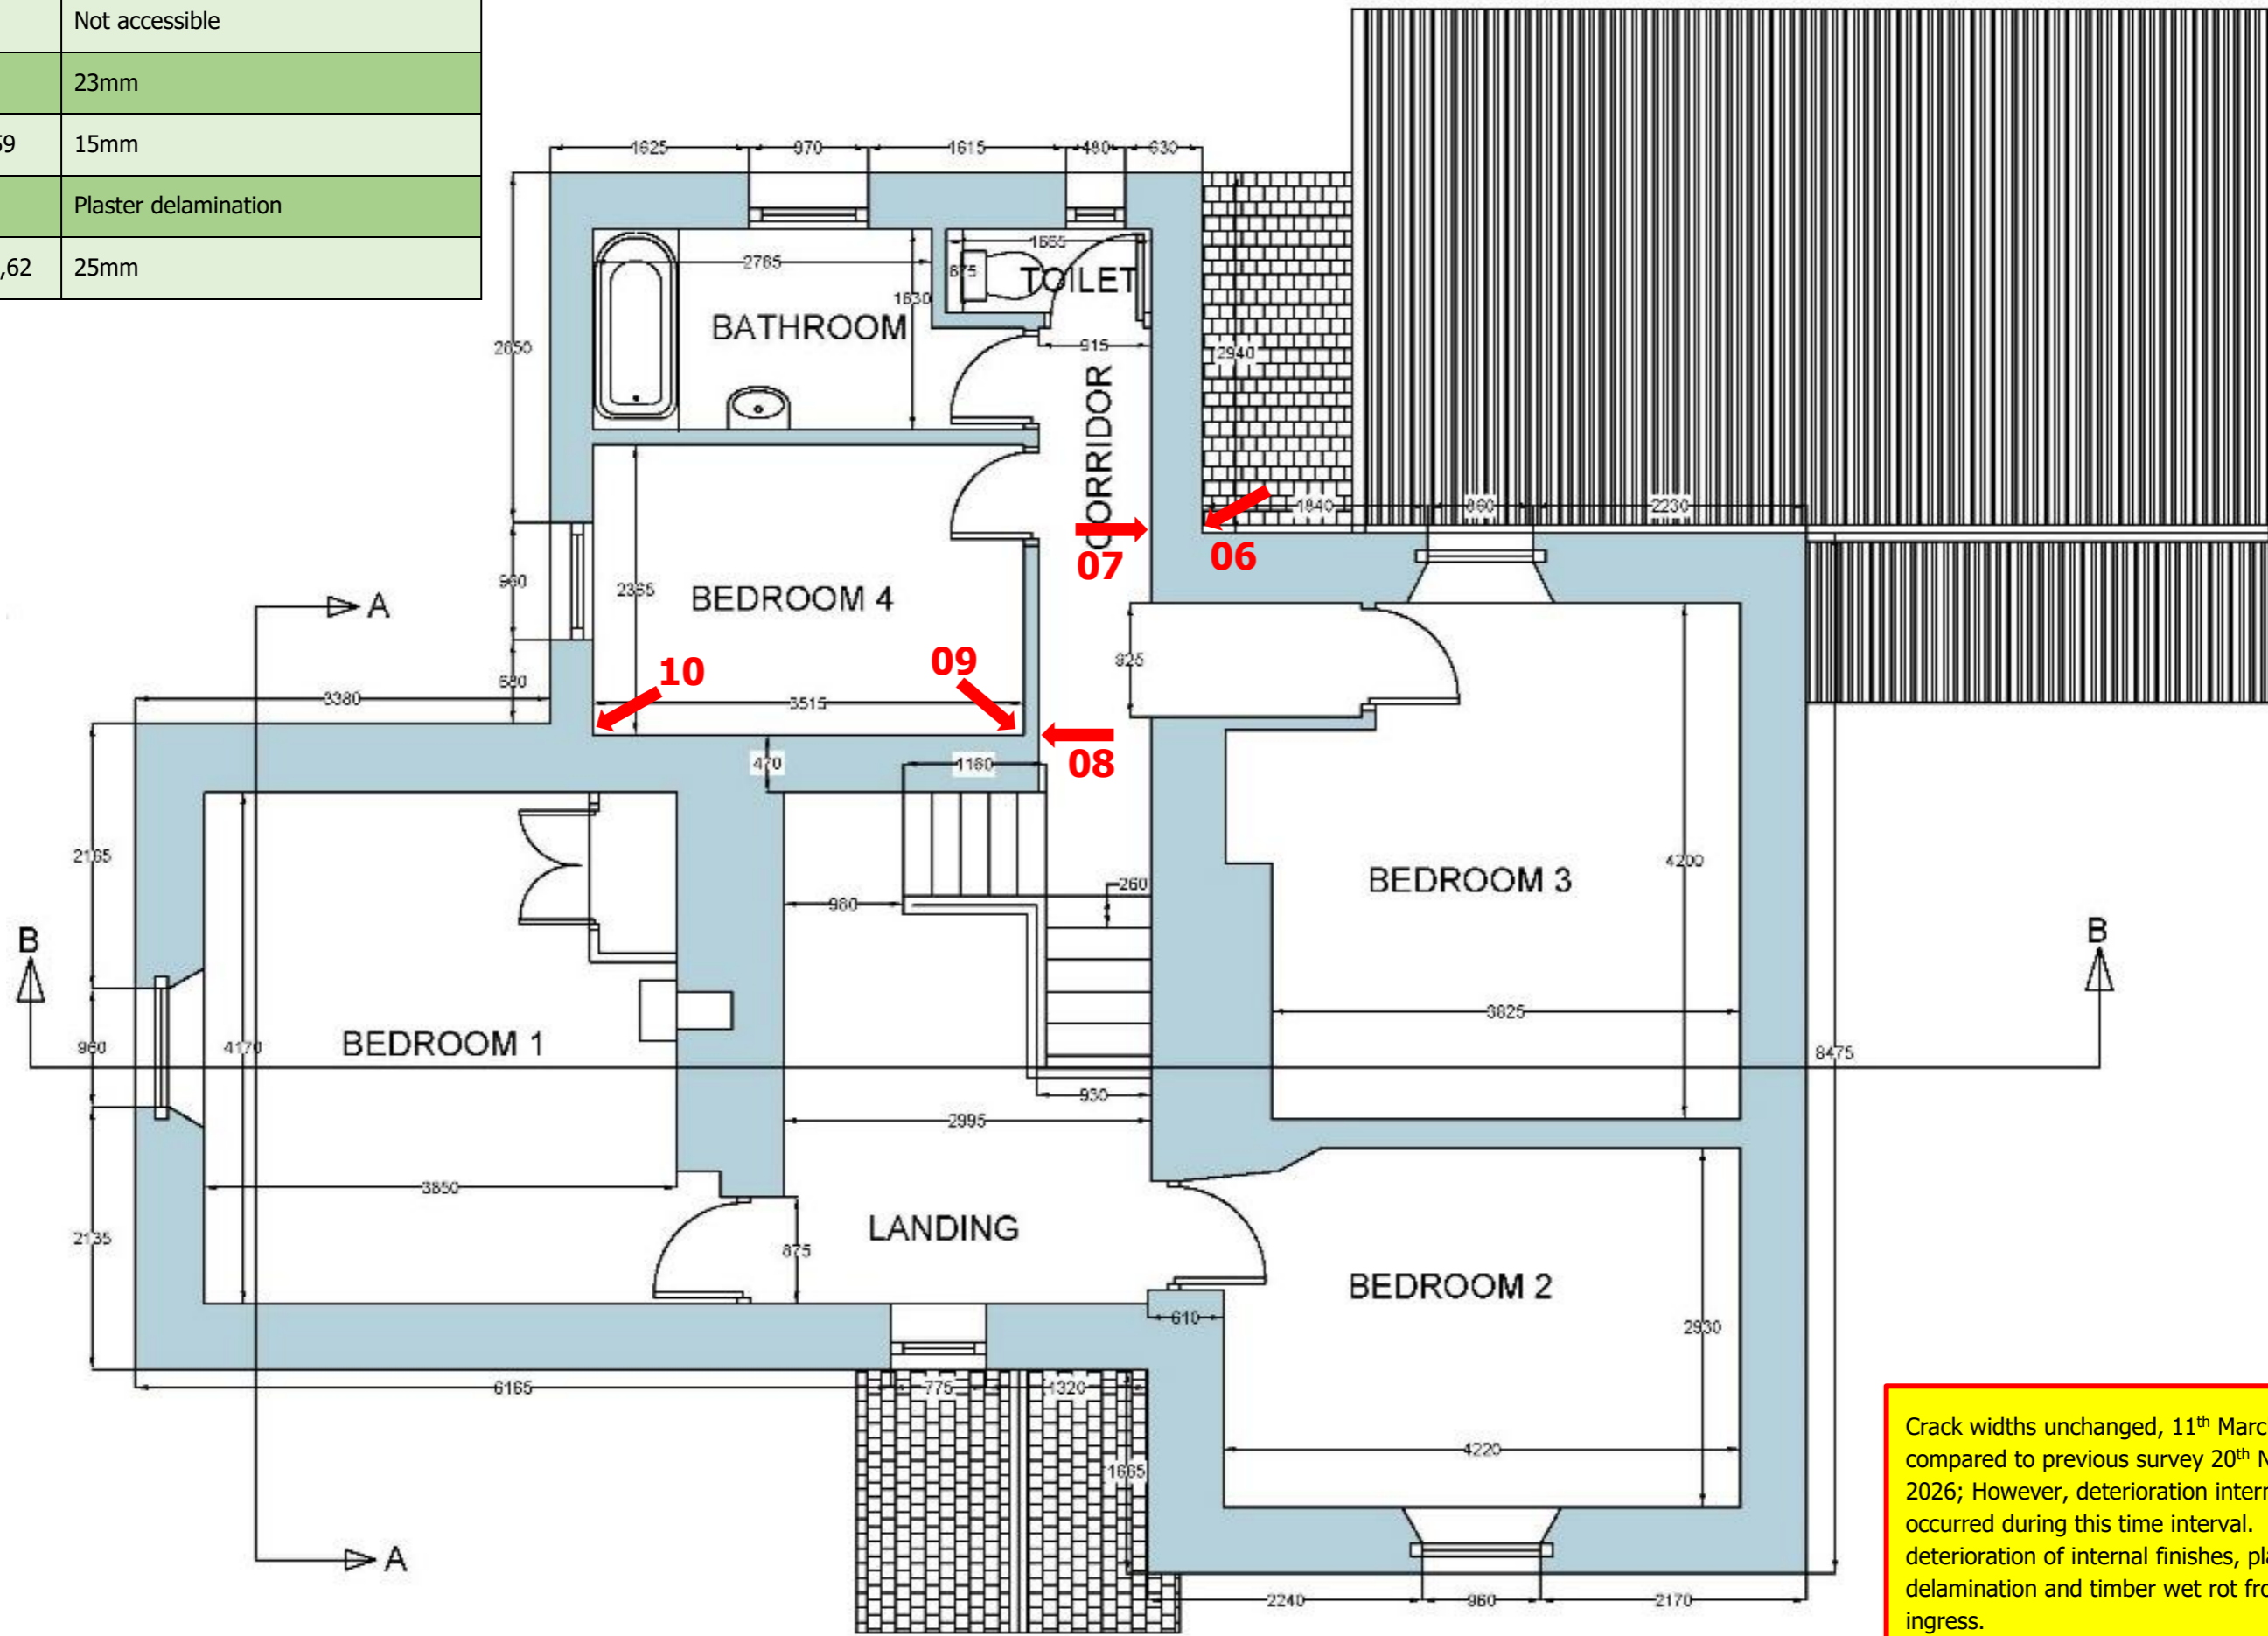
EXISTING FIRST FLOOR PLAN

Ref:	Page:	Crack Width
6	19	Not accessible
7	56	23mm
8	58,59	15mm
9	63	Plaster delamination
10	57,58,62	25mm

Crack widths unchanged, 11th March 2026 compared to previous survey 20th November 2026; However, deterioration internally has occurred during this time interval. Significant deterioration of internal finishes, plaster delamination and timber wet rot from moisture ingress.

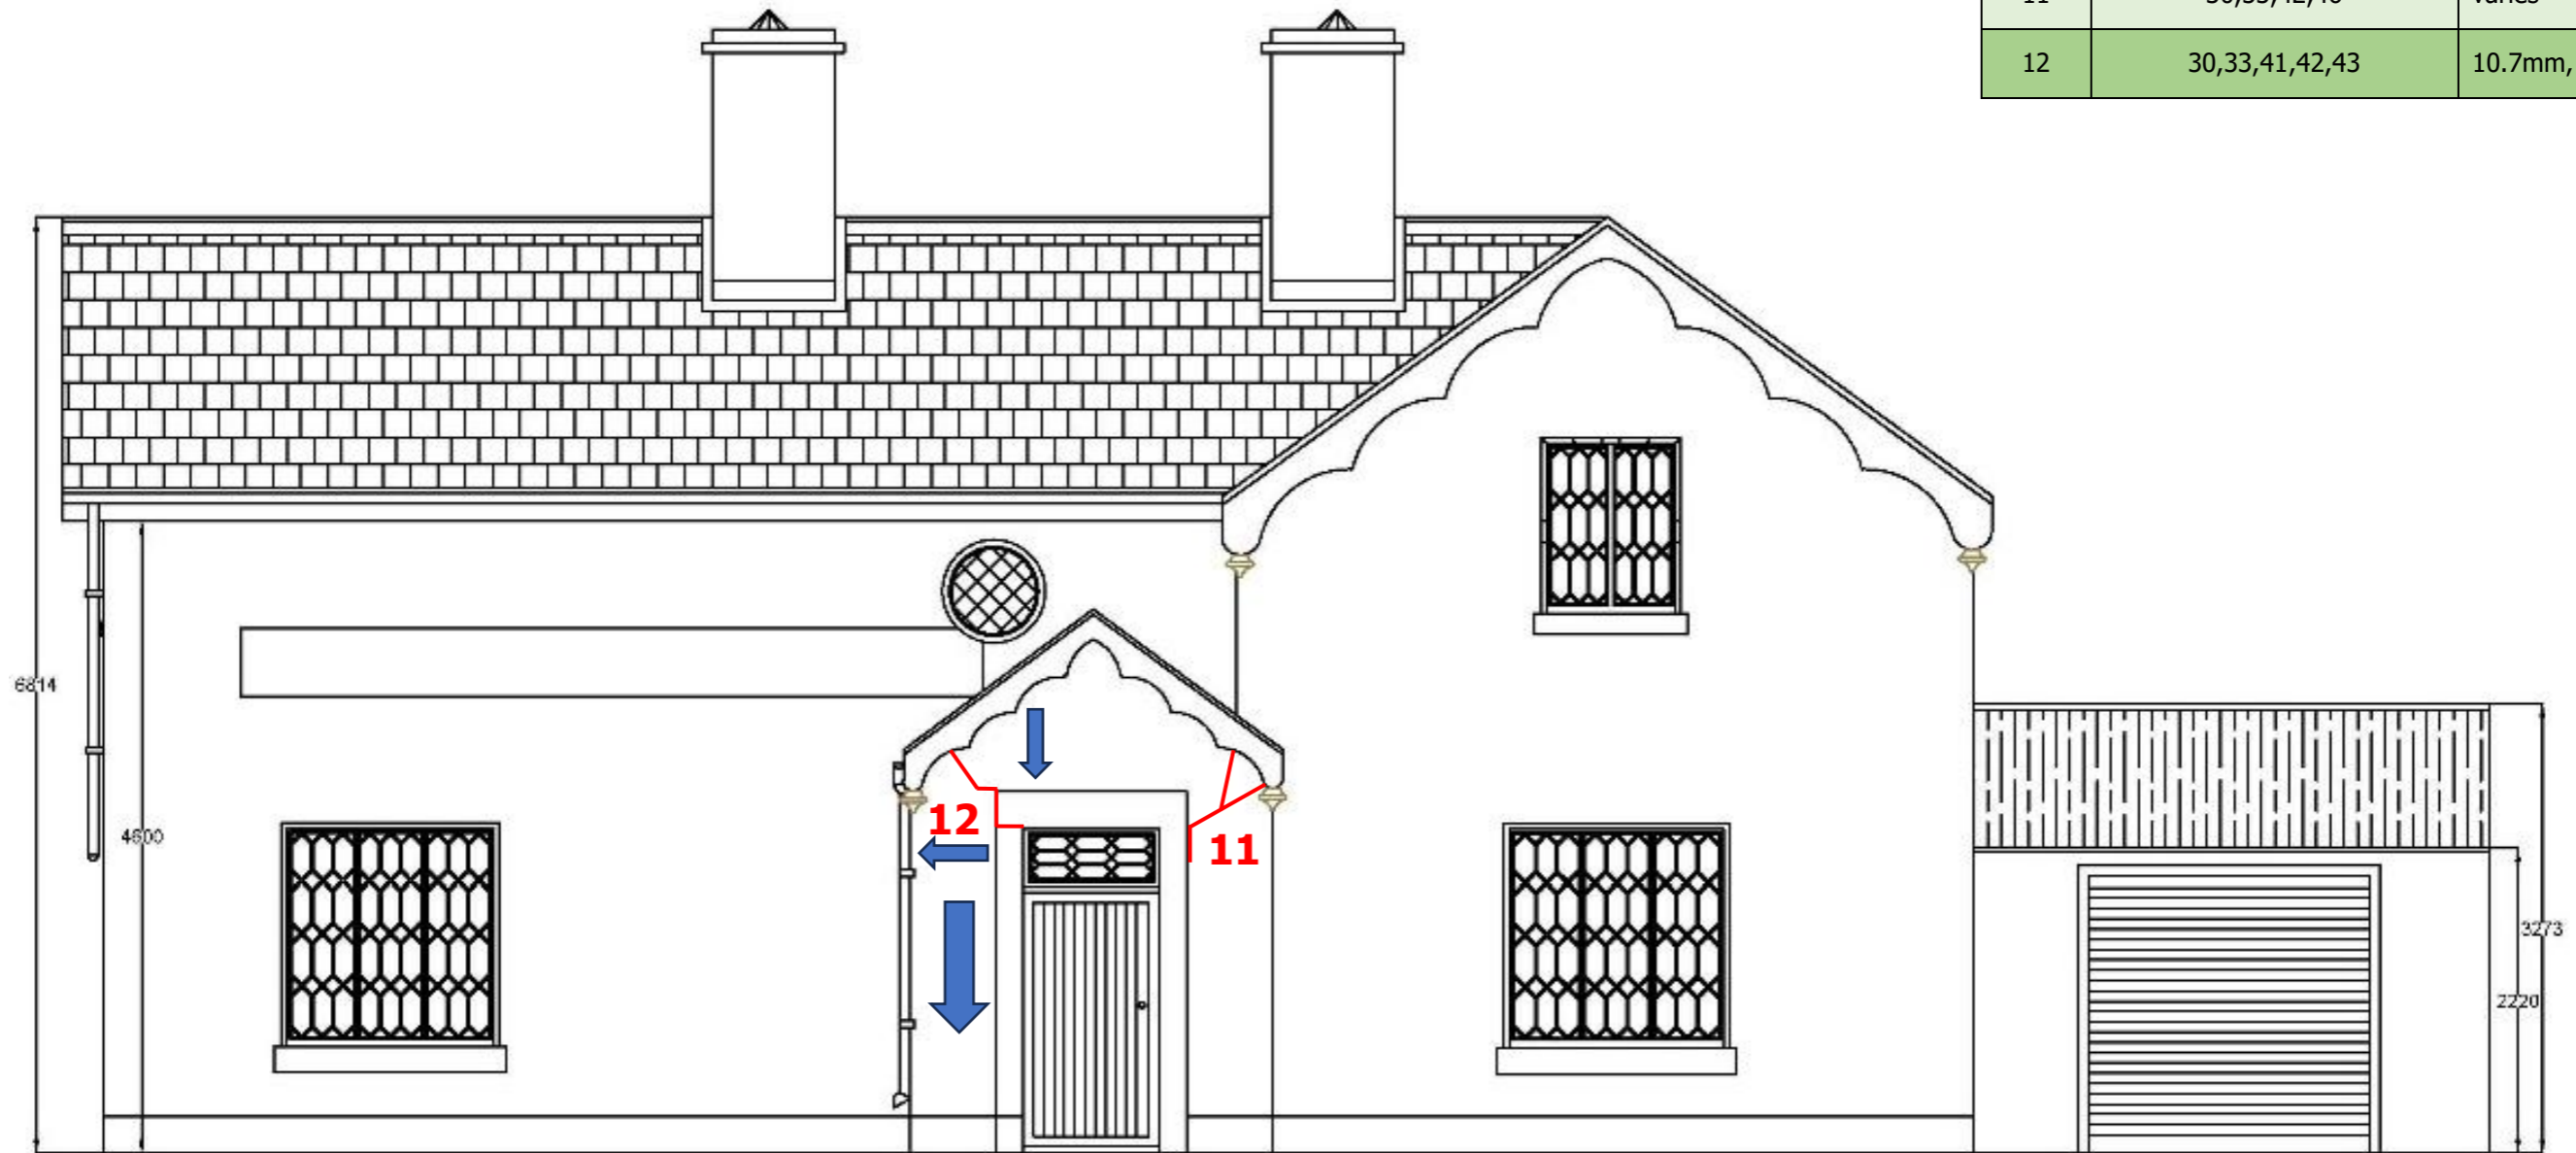
EXISTING FRONT ELEVATION

Ref:	Page:	Crack Width
11	30,33,42,46	varies
12	30,33,41,42,43	10.7mm, 10.9mm

Crack widths unchanged, 11th March 2026 compared to previous survey 20th November 2026; However, deterioration internally has occurred during this time interval. Significant deterioration of internal finishes, plaster delamination and timber wet rot from moisture ingress.

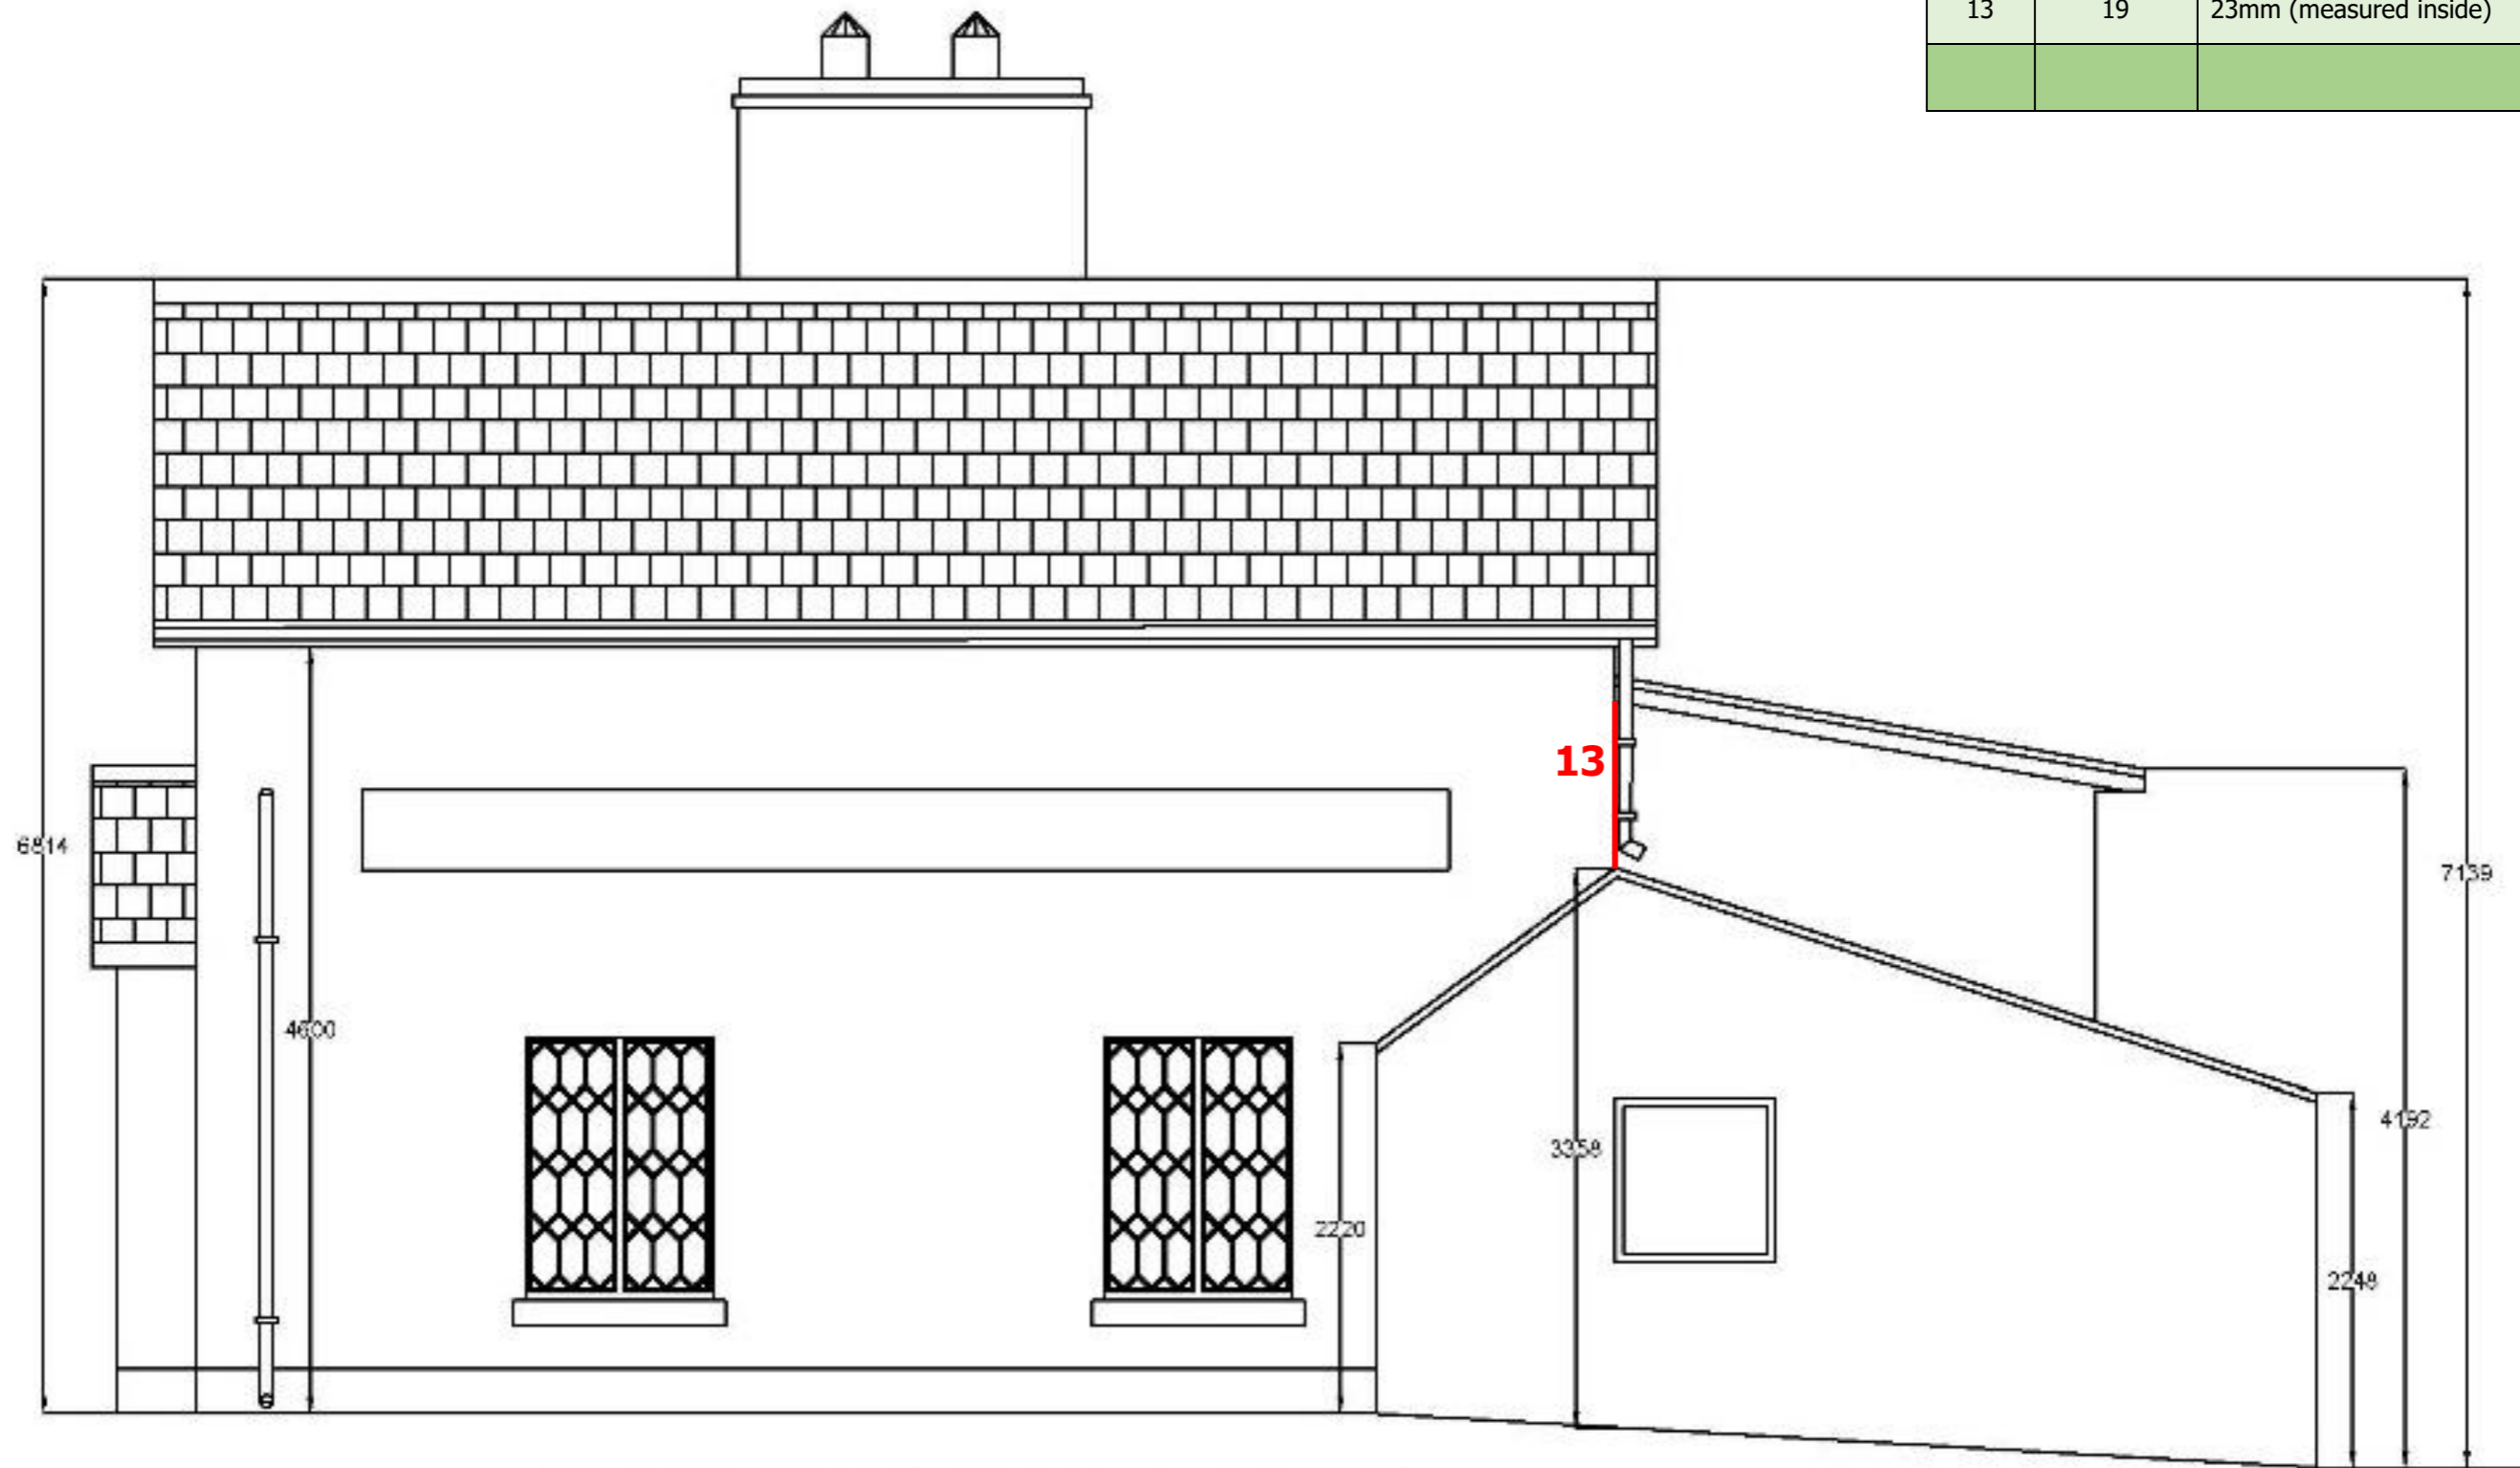
EXISTING SIDE ELEVATION

Ref:	Page:	Crack Width
13	19	23mm (measured inside)

Crack widths unchanged, 11th March 2026 compared to previous survey 20th November 2026; However, deterioration internally has occurred during this time interval. Significant deterioration of internal finishes, plaster delamination and timber wet rot from moisture ingress.

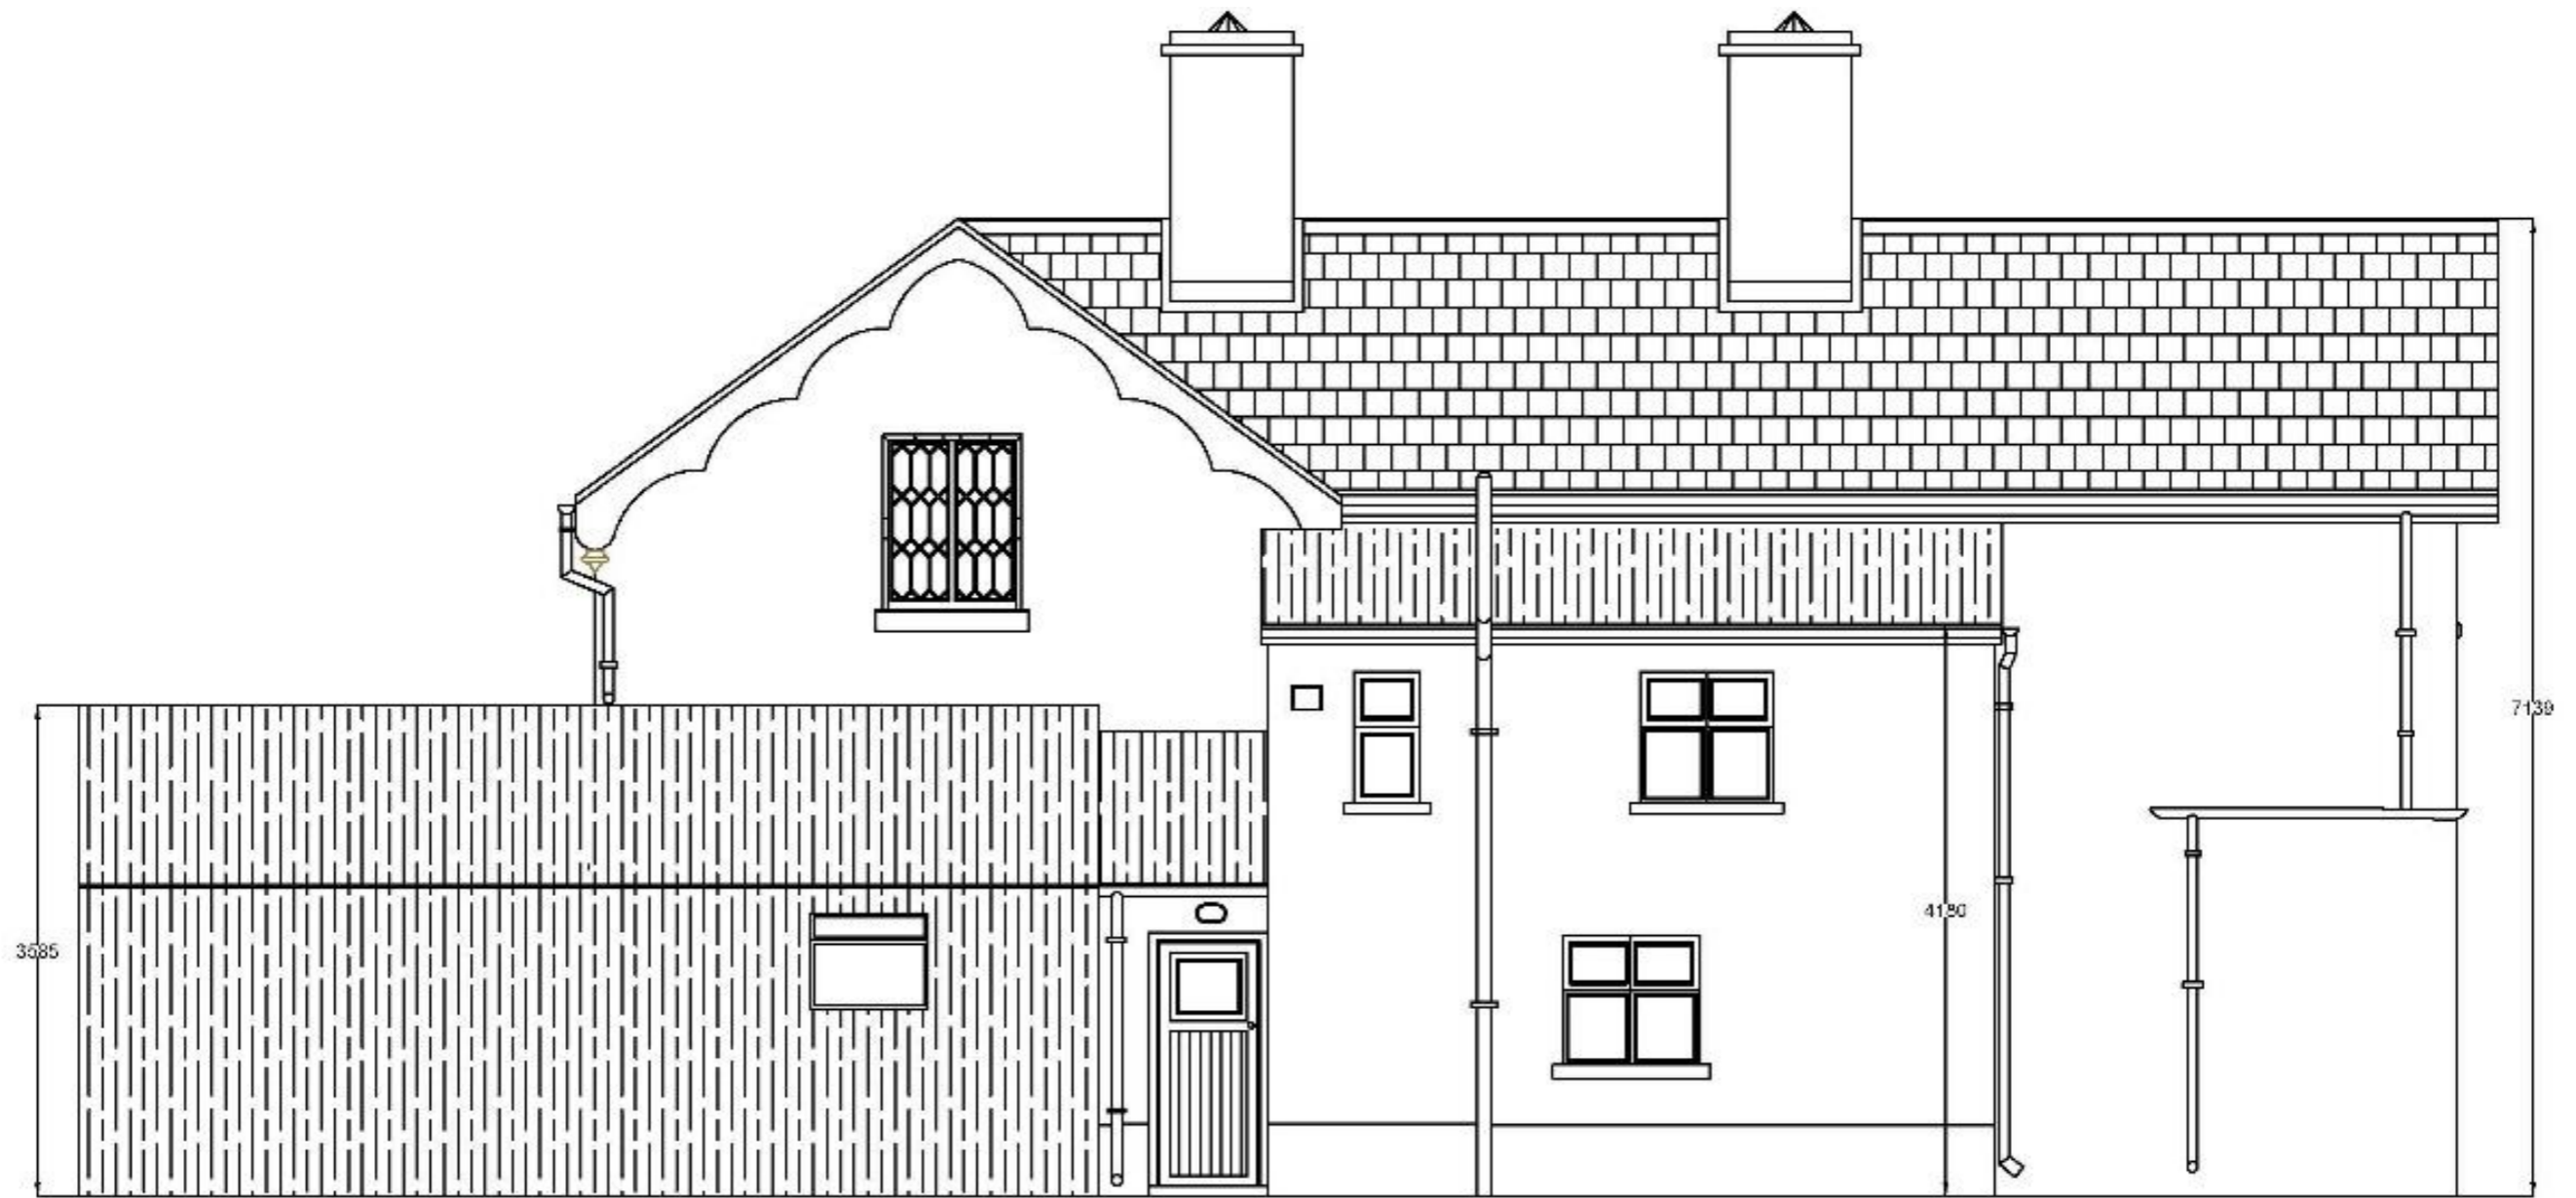
EXISTING BACK ELEVATION

Crack widths unchanged, 11th March 2026 compared to previous survey 20th November 2026; However, deterioration internally has occurred during this time interval. Significant deterioration of internal finishes, plaster delamination and timber wet rot from moisture ingress.

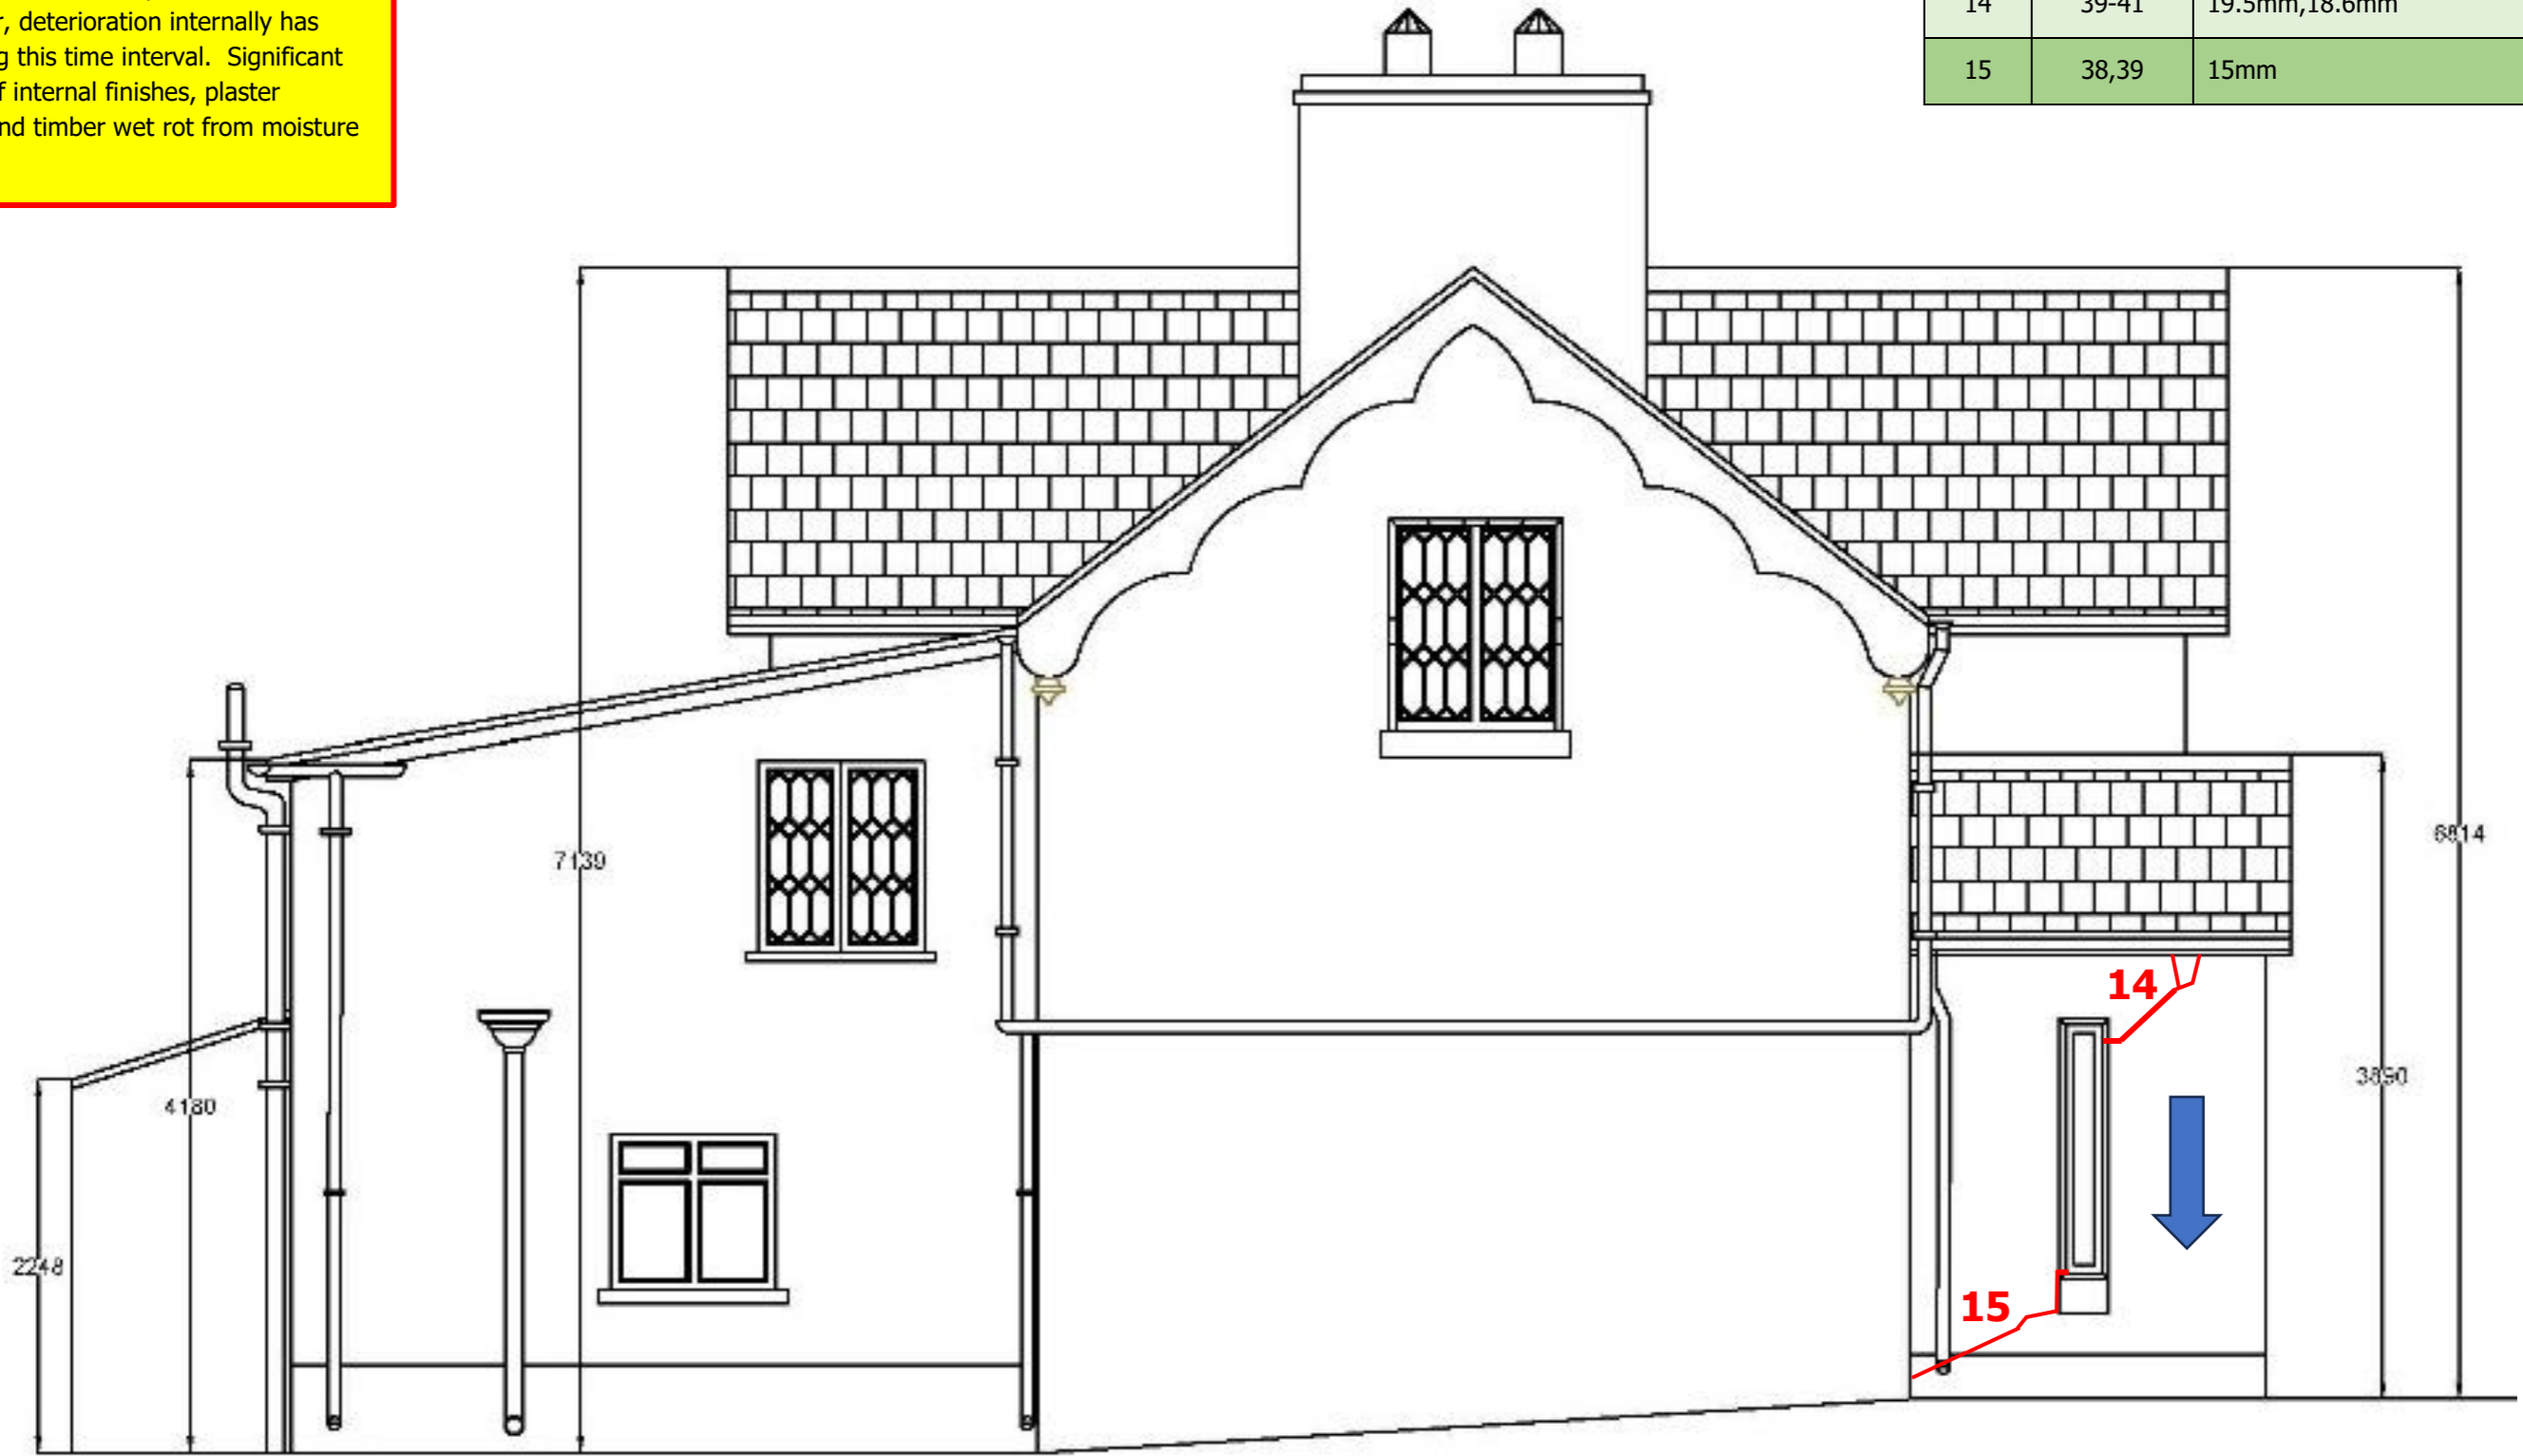
EXISTING SIDE ELEVATION

Crack widths unchanged, 11th March 2026 compared to previous survey 20th November 2026; However, deterioration internally has occurred during this time interval. Significant deterioration of internal finishes, plaster delamination and timber wet rot from moisture ingress.

Ref:	Page:	Crack Width
14	39-41	19.5mm,18.6mm
15	38,39	15mm
