BELVEDERE ORPHANAGE, TYRRELLSPASS, CO.  
WESTMEATH.

STRUCTURAL ASSESSMENT OF EXISTING STAIRS TO  
"MATRON'S HOUSE"

HOUSING CAPITAL SECTION  
WESTMEATH COUNTY COUNCIL  
**MARCH 2026**

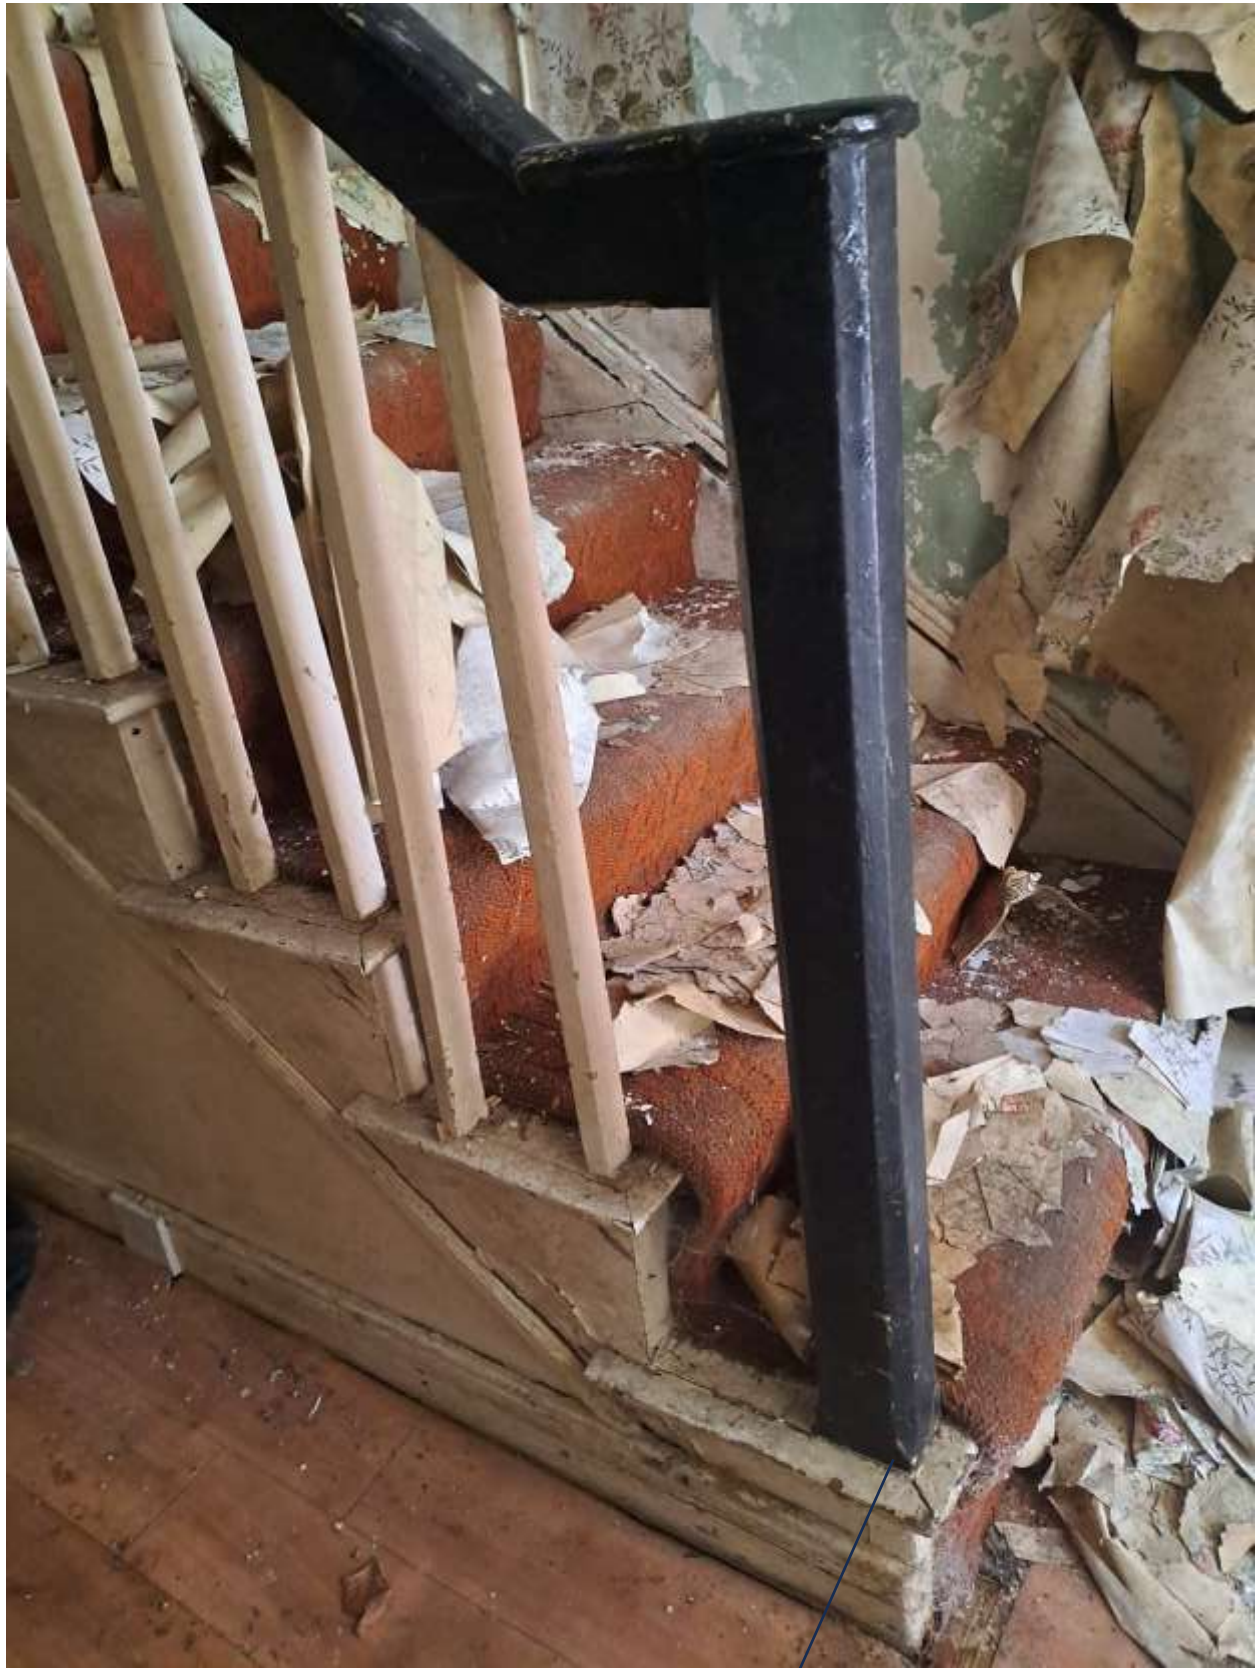
The existing painted timber handrails and spindles are in good condition. The main newel post at the 90deg crank in the stairs also appears in good condition. There is a significant defect, the first newel post at the foot of the stairs is loose with some damage/split locally to the first tread at the base of the newel post; thus the handrail to the first flight flexes laterally under horizontal barrier loading and will require remedial repairs to make it fit for purpose.

Remedial repair required to secure newel post base
