Project: **CASTLEPOLLARD REGENERATION**

Dwg Name: **VISUAL STRUCTURAL SURVEY OF WALL ALONG MULLINGAR RD**

Client/Architect: **WEST MEATH COUNTY COUNCIL**

Scale: (@ A1)	Date:	Drawn:	Checked:
SCALE	11.02.22	KMcC	EON
Drawing No:	20058-SK03	Rev:	P1

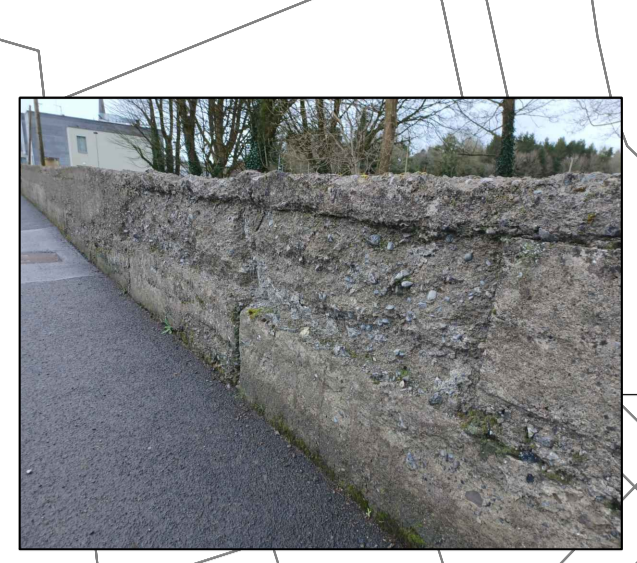
DUE TO REDUCED SECTION THICKNESS AND PRESENCE OF A VOID IN THE MASS CONCRETE WALL AT THE LOCATION IDENTIFIED AT 3AB, THE EFFECTIVE STRENGTH OF THE WALL HAS BEEN REDUCED. SHORT TERM REMEDIAL ACTION IS REQUIRED TO RESTORE WALL STRENGTH IN THIS AREA. THIS INVOLVES SUITABLE REMOVAL/REPLACEMENT OF THE WALL AND STRENGTHENING WITH REINFORCED CONCRETE. ALTERNATIVELY, PRELIMINARY PLANNING PROPOSALS INCLUDE FOR A REDUCTION OF THE WALL HEIGHT AND INCLUSION OF A NEW CONCRETE CAST IN SITU COPING WITH HAIRPIN FENCE ON TOP (SUBJECT TO DETAILED DESIGN FOLLOWING RECEIPT OF PROPOSALS FROM OTHERS).

3B - SEVERELY WEATHERED/SPALLED WALL RESULTING IN SEVERE LOSS OF SECTION AND VOID IN WALL.  
 VOID REQUIRES REMEDIAL WORKS IN SHORT TERM DUE TO REDUCED STRENGTH OF SECTION. SEE 'GENERAL SUMMARY'

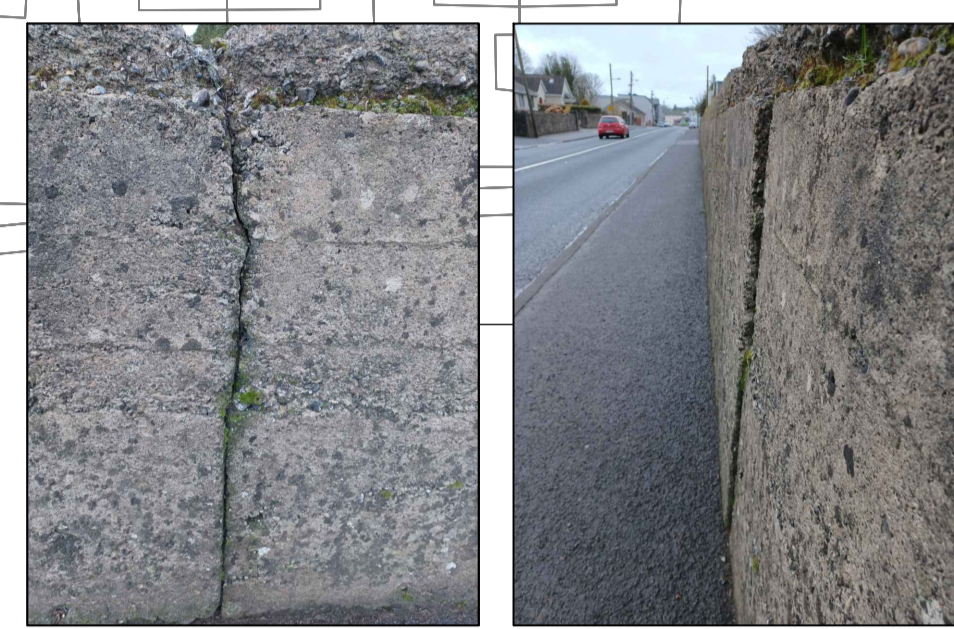
THE MASS CONCRETE WALL IS OUT OF PLUMB/MISALIGNED AND LEANS TOWARD THE LOWER SIDE AT VERTICAL JOINTS, INDICATING DIFFERENTIAL LATERAL MOVEMENT, OWING TO A LACK OF DOWELS ACROSS VERTICAL JOINTS.

4B - FULL HEIGHT VERTICAL CRACK INDICATING LATERAL MOVEMENT OF WALL ALONG CONSTRUCTION JOINT

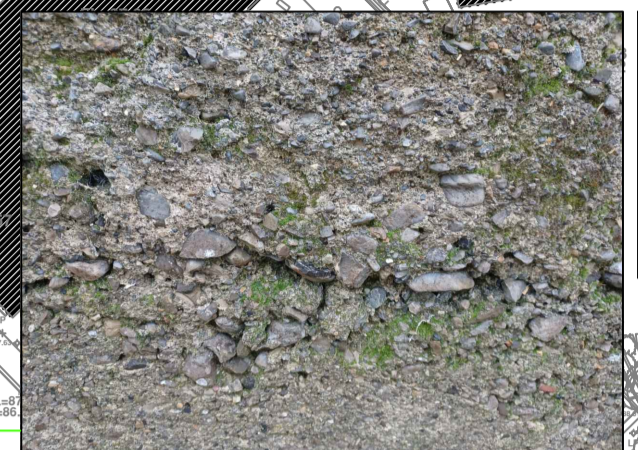
THE WALL IS EXTENSIVELY WEATHERED/SPALLED THROUGHOUT WITH AGGREGATES EXPOSED. THE AGGREGATE IS POORLY GRADED AND EXCESSIVELY LARGE, CONSISTING OF BEACH GRAVEL/ROUNDED STONE & CRUSHED ROCK.

1 - SECTIONS OF WEATHERED/SPALLED CONCRETE THROUGHOUT.  
 AGGREGATES ARE POORLY GRADED AND EXCESSIVELY LARGE FROM VARIOUS SOURCES. (MIXTURE OF BEACH GRAVEL/ROUNDED STONE & CRUSHED ROCK).

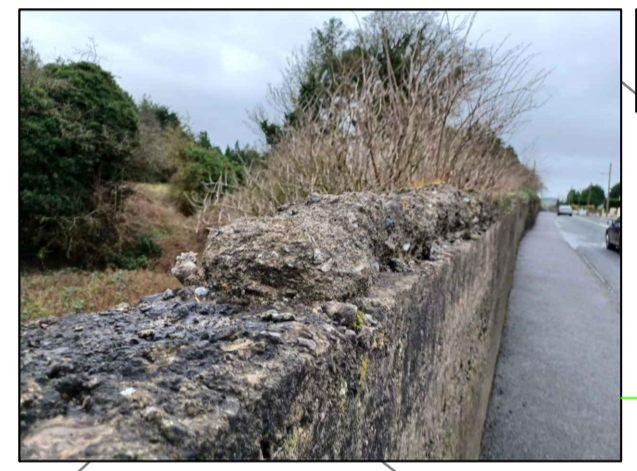
THERE ARE MULTIPLE INSTANCES OF WEATHERED/SPALLED/MISSING COPING.

6 - MULTIPLE AREAS OF MISSING/ EXCESSIVELY WEATHERED/SPALLED COPING ALONG MASS CONCRETE WALL

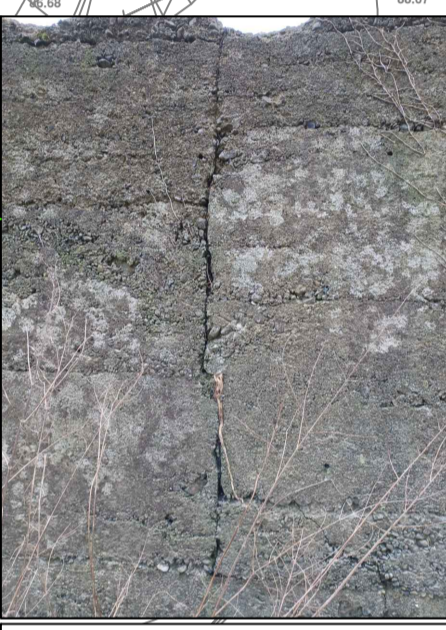
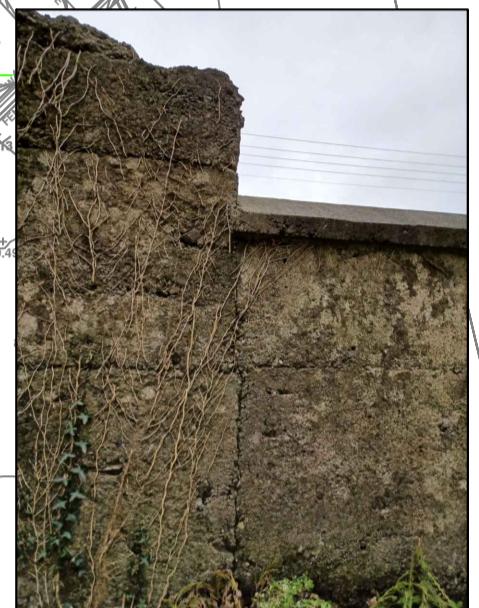
THERE IS EXTENSIVE VERTICAL AND HORIZONTAL CRACKING ALONG CONSTRUCTION JOINTS IN THE MASS CONCRETE WALL.

2 - VERTICAL AND HORIZONTAL CRACKING AT CONSTRUCTION JOINTS THROUGHOUT.  
 APPEARS TO BE POOR QUALITY OF CONCRETE (I.E. SITE MIX CONCRETE AND ABSENCE OF REINFORCEMENT)

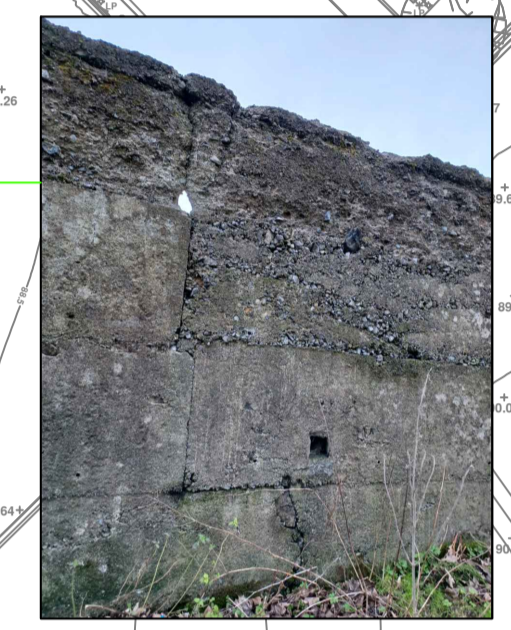
3A - SEVERELY WEATHERED/SPALLED SECTION OF WALL RESULTING IN SEVERE LOSS OF SECTION AND VOID IN WALL.  
 VOID REQUIRES REMEDIAL WORKS IN SHORT TERM DUE TO REDUCED STRENGTH OF SECTION. SEE 'GENERAL SUMMARY'

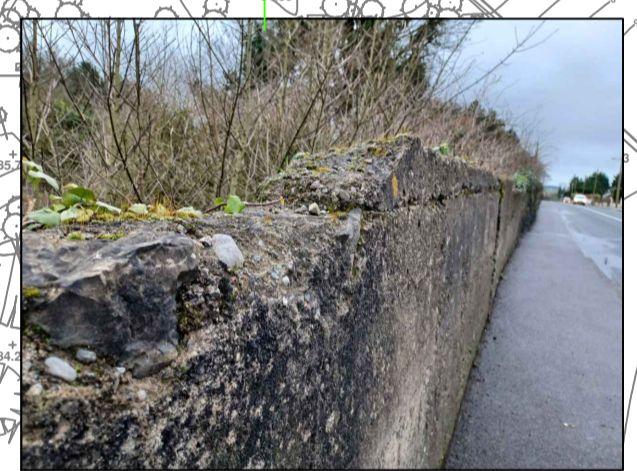
4A - HORIZONTAL AND VERTICAL CRACKS AT CONSTRUCTION JOINTS

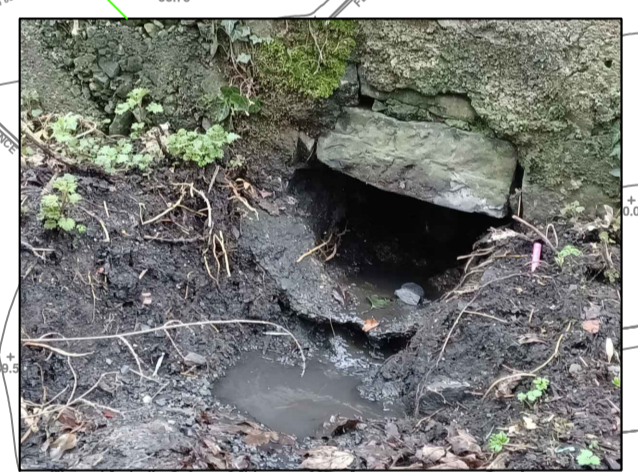
A NUMBER OF NON-STANDARD STORM DRAINAGE/WEEPHOLES THROUGH THE WALL HAVE RESULTED IN POOLING OF STORM WATER AT THE BOUNDARY WALL AT THE LOWER SIDE. THIS HAS RESULTED IN REGULAR SATURATION OF THE GROUND AND HAS LIKELY UNDERMINED THE WALL FOUNDATIONS TO SOME DEGREE. WEEPHOLES REQUIRE CONNECTION TO THE EXISTING FORMAL STORMWATER DRAINAGE SYSTEM TO PREVENT FURTHER UNDERMINING OF WALL DUE TO CONTINUOUS SATURATION AND WASHOUT OF FOUNDATIONS.

5 - NON-STANDARD STORM DRAINAGE/WEEPHOLES THROUGH THE WALL RESULT IN POOLING OF WATER AND SATURATION OF GROUND ON LOWER SIDE.  
 FOUNDATIONS LIKELY UNDERMINED TO SOME DEGREE. SEE 'GENERAL SUMMARY'

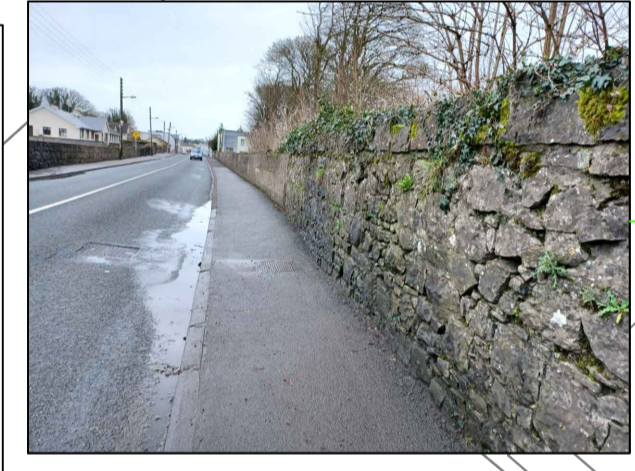
MISSING/INSUFFICIENT DRAINAGE ALONG THE MULLINGAR ROAD HAS RESULTED IN EXTENSIVE SPLASHING OF PONDED SURFACE WATER ON THE ROAD AND FOOTPATH ONTO BOUNDARY WALL BY PASSING CARS. THIS HAS CONTRIBUTED TO THE WEATHERED/SPALLED AREAS.

8A/B - BLOCKED/INSUFFICIENT DRAINAGE ALONG ROAD RESULTS IN LOCALISED SPLASHING OF PONDED SURFACE WATER ON THE ROAD AND FOOTPATH ONTO WALL FROM PASSING CARS.  
 THIS CONTRIBUTES TO THE WIDER WEATHERING OF THE MASS CONCRETE WALL AND THE WASHING OUT OF MORTAR ALONG THE PROTECTED RANDOM RUBBLE STONE WALL.  
 LONG TERM MAINTENANCE OF DRAINAGE ALONG ROAD REQUIRED.

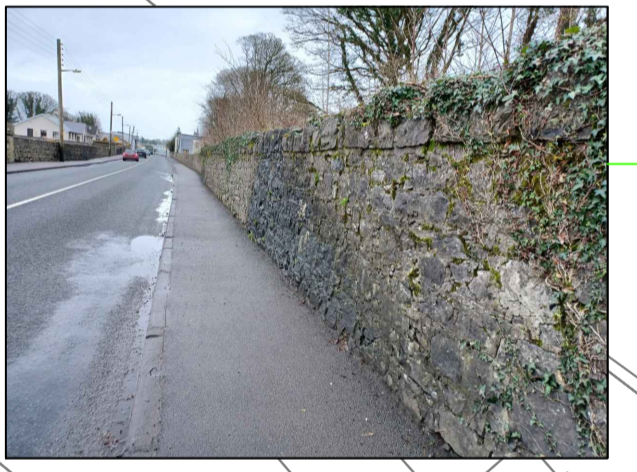
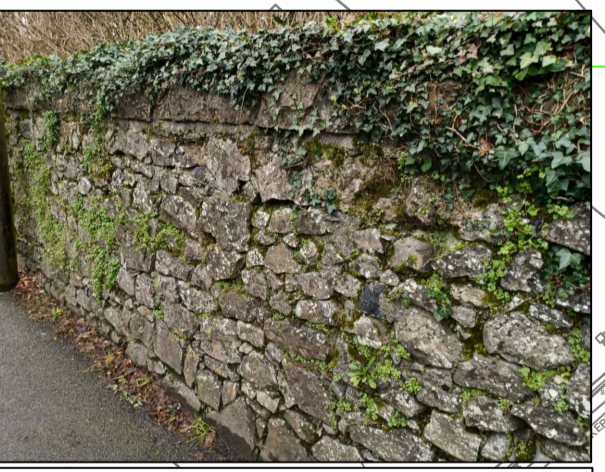
THE PROTECTED RANDOM RUBBLE STONE WALL HAS EXPERIENCED EXTENSIVE WASHING OUT OF OUT MORTAR THROUGHOUT, OWING IN PART TO THE AFOREMENTIONED POOR/INSUFFICIENT DRAINAGE ON THE MULLINGAR ROAD. VEGETATION/MOSS HAS GROWN IN PLACE OF THE MISSING MORTAR. ONGOING MAINTENANCE WOULD INVOLVE THE CLEARING OF VEGETATION/MOSS AND REPOINTING OF MORTAR JOINTS.

9 - VEGETATION/MOSS GROWTH ON PROTECTED RANDOM RUBBLE STONE WALL WHERE MORTAR WASHED OUT.

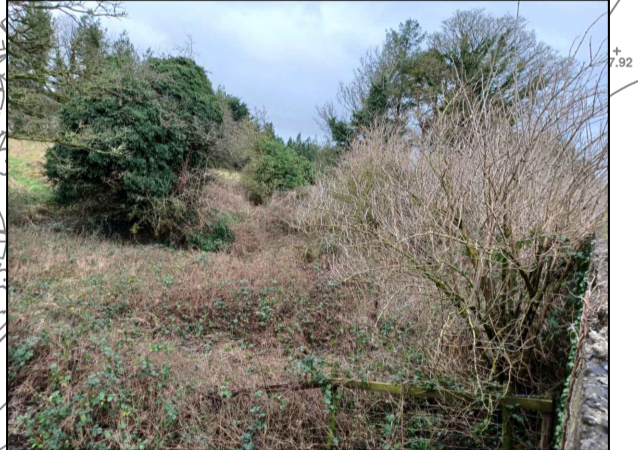
**PROTECTED RANDOM RUBBLE STONE WALL:**  
 THE VISUAL INSPECTION OF THE PROTECTED RANDOM RUBBLE STONE WALL WAS CARRIED OUT FROM THE ROAD SIDE ONLY, AS EXCESSIVE VEGETATION FROM THE LOWER SIDE PREVENTS ACCESS.

10 - NO ACCESS TO RANDOM RUBBLE STONE WALL AT LOWER SIDE DUE TO VEGETATION.
