Architectural Heritage Impact Assessment

Development of a new Kinnegad Economic Enterprise Hub,
Kinnegad, Co. Westmeath

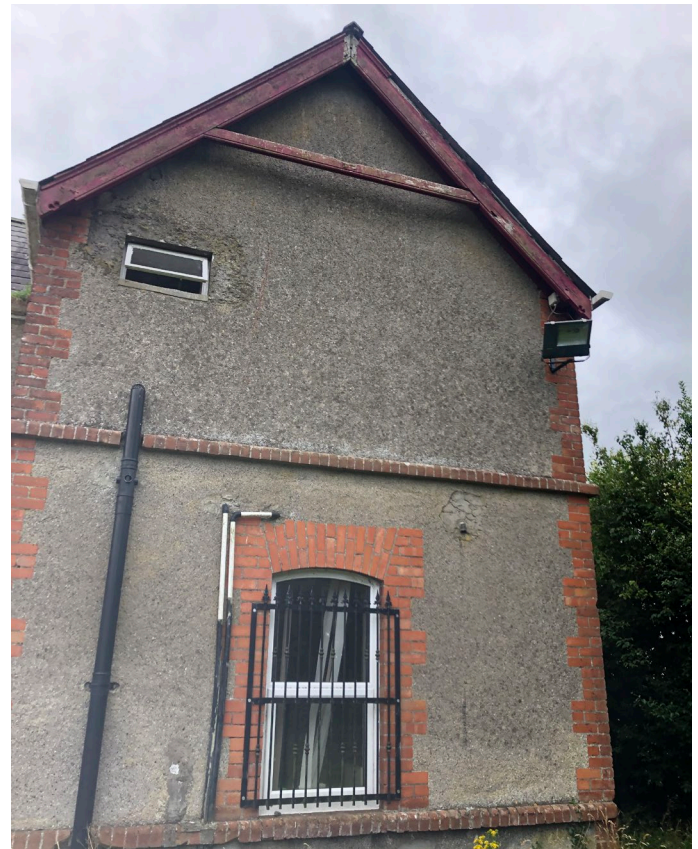
Fig 14: Elevation B. Ground floor window grille fixed to red brick. Existing fascia board has been damaged. *Note picture was taken in July 2020.

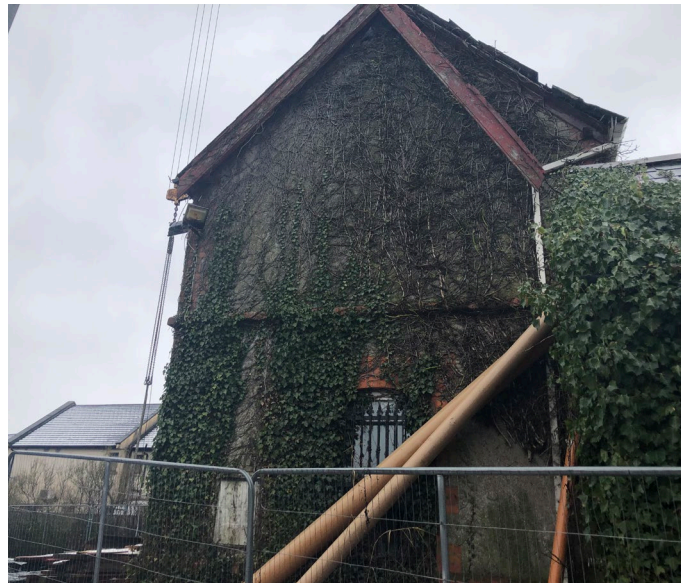
Fig 17: Elevation D. Evidence of climbing plants on side facade. Existing fascia board has been damaged.
*Note picture was taken in March 2024 during works to former school-house.

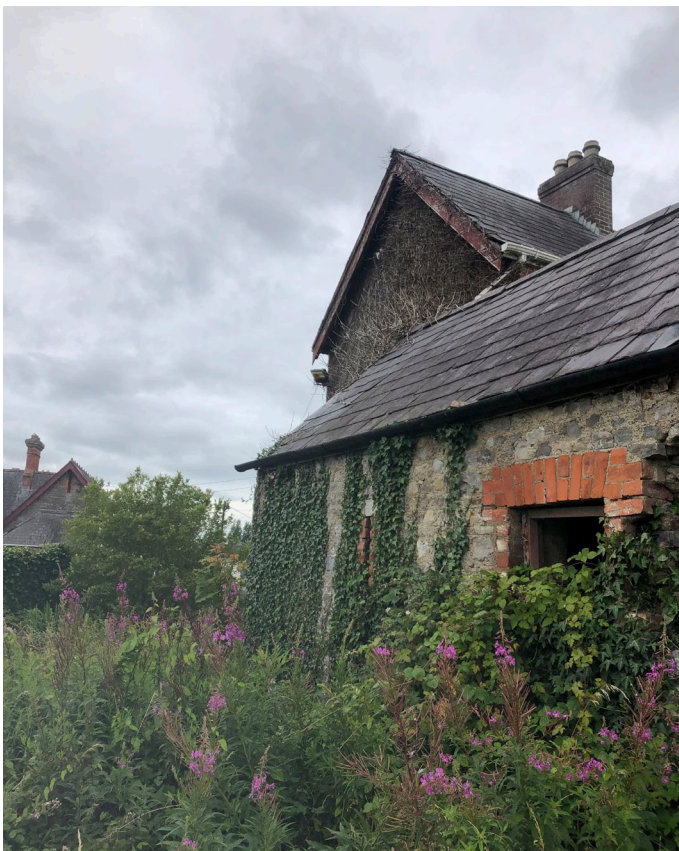
Fig 18: Elevation D.
*Note picture was taken in July 2020.

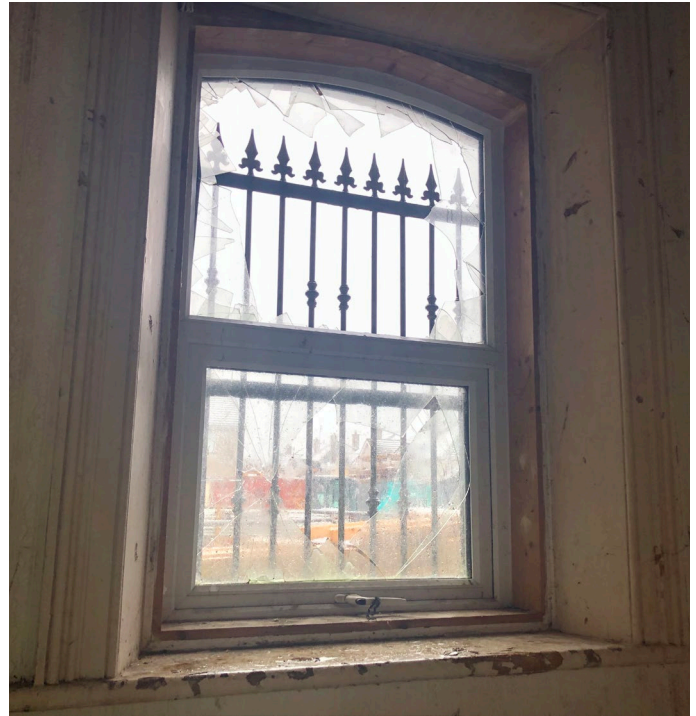
Fig 25: Internal Elevation 1.A. Window to staircase. Sash Window has been damaged.

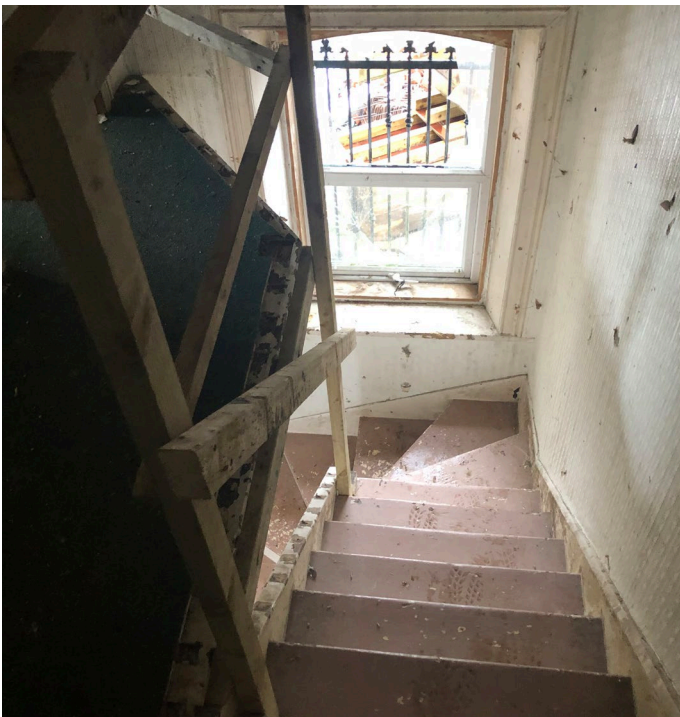
Fig 26: Internal Elevation 1.A. Staircase.

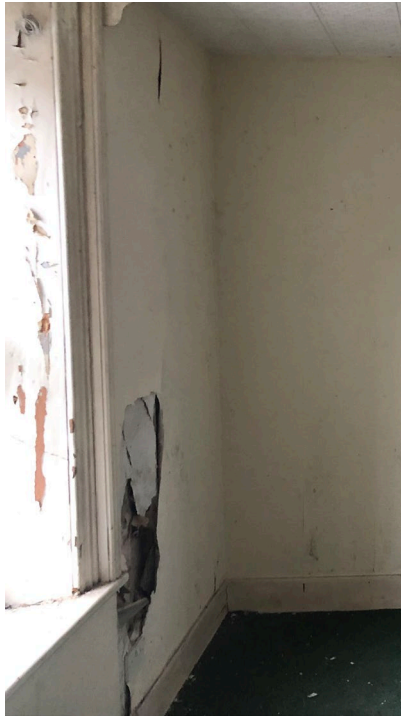
Fig 32: Internal Elevation 2.C. Wall has been damaged.

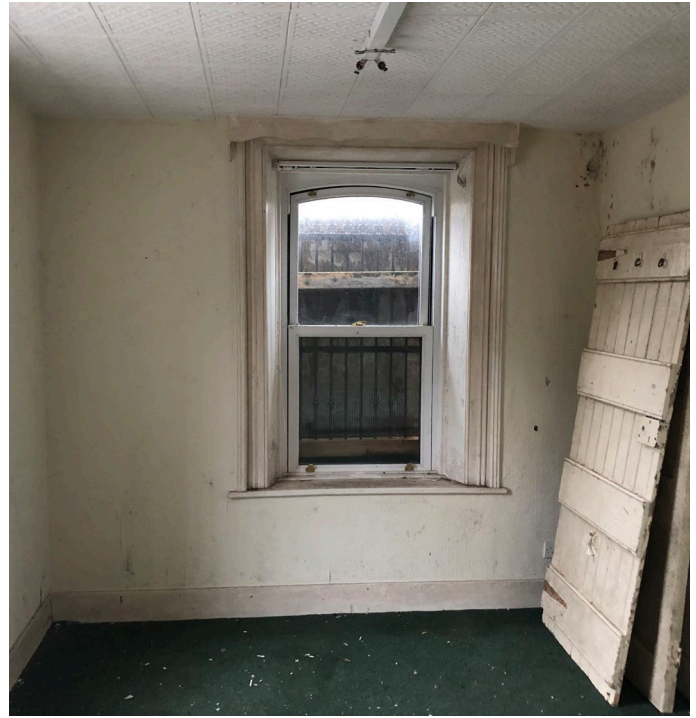
Fig 33: Internal Elevation 2.D.

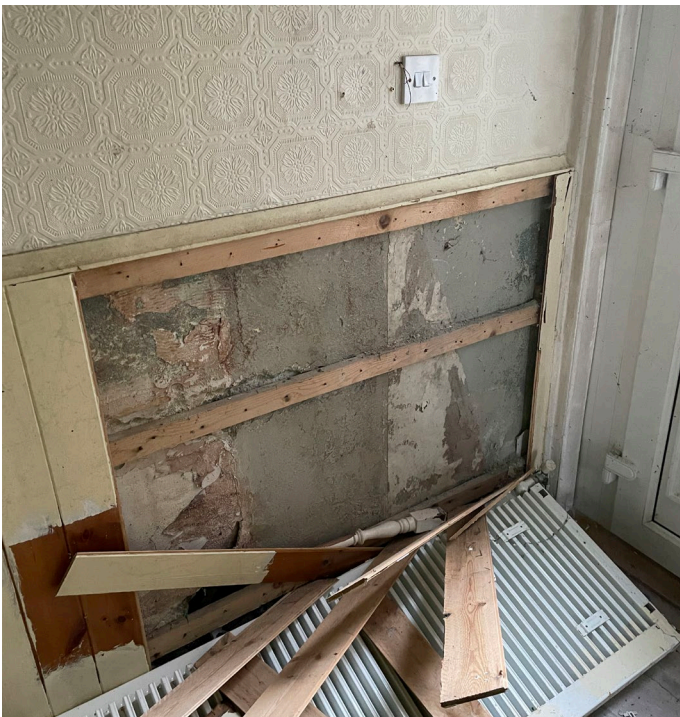
Fig 38: Internal Elevation 3.A. Timber dado panelling and existing radiator have been damaged.

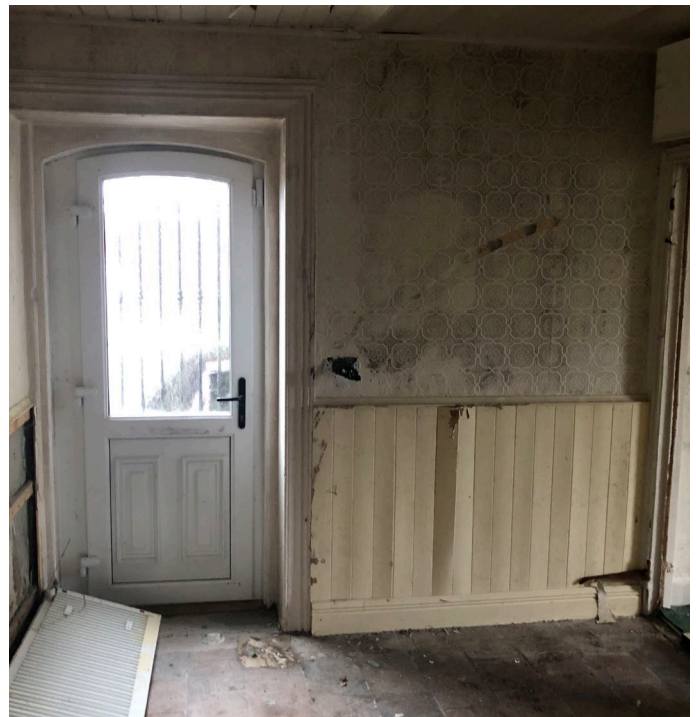
Fig 39: Internal Elevation 3.B. Timber wainscoting panelling has been damaged. Door to rear of the site.

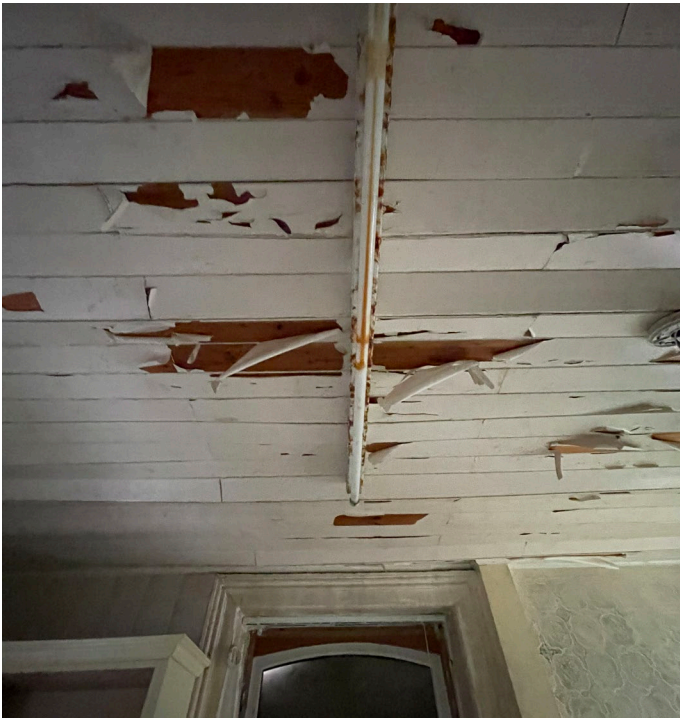
Fig 46: Internal Elevation: False ceiling has been damaged.

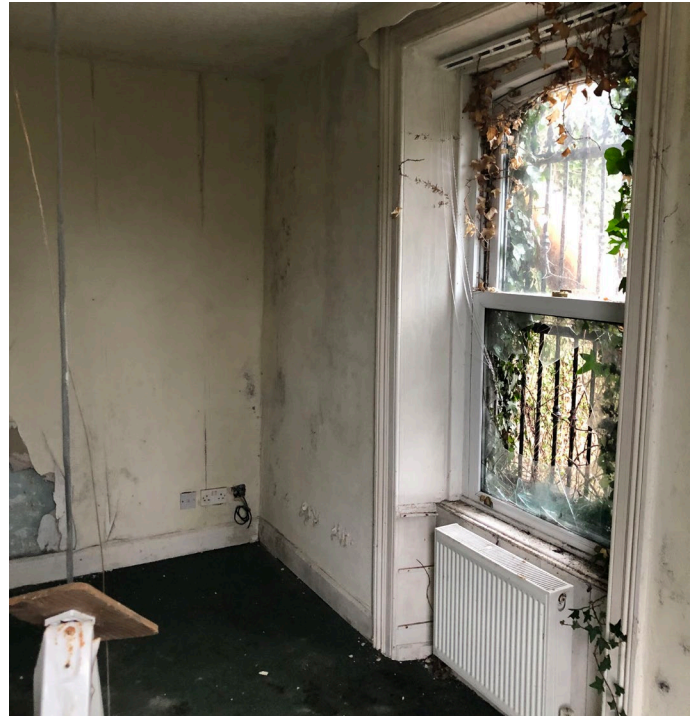
Fig 48: Internal Elevation 4.B. Sash Window has been damaged. Evidence of planting growing into the room.

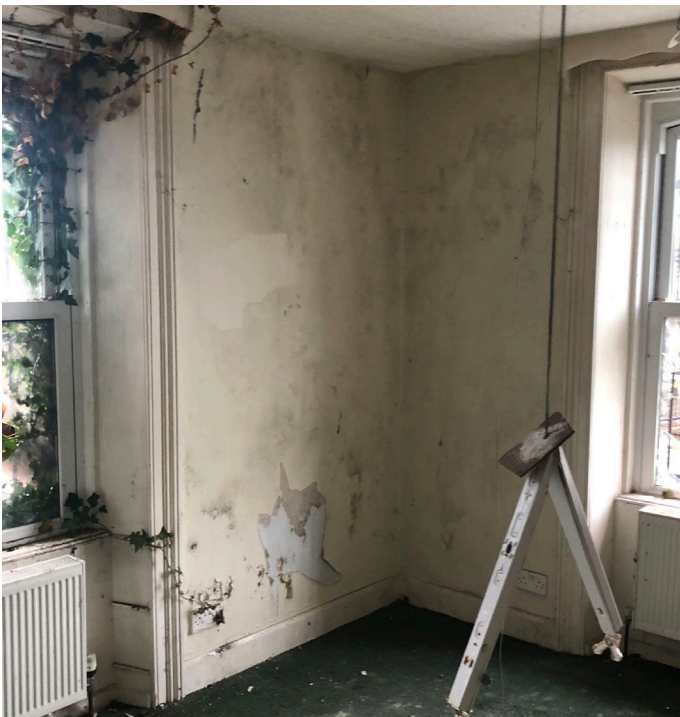
Fig 49: Internal Elevation 4.B.

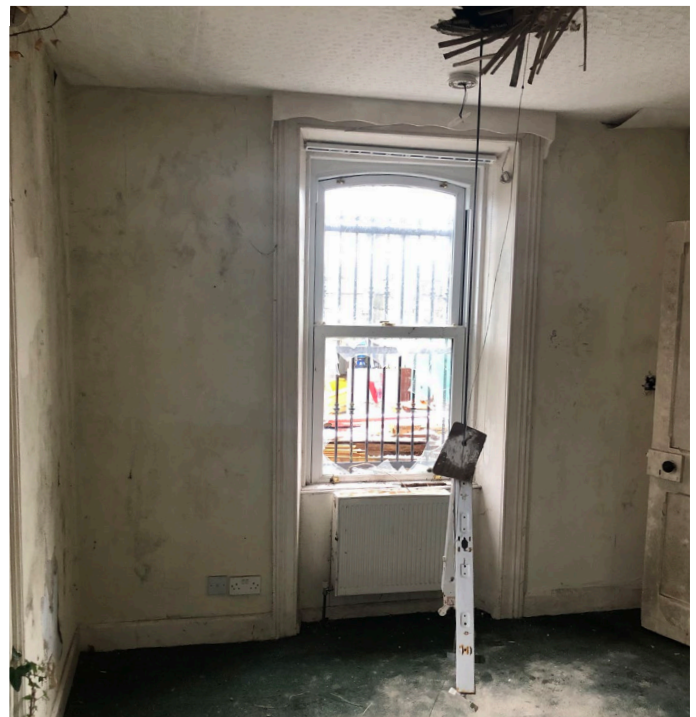
Fig 50: Internal Elevation 4.C. Sash Window has been damaged.

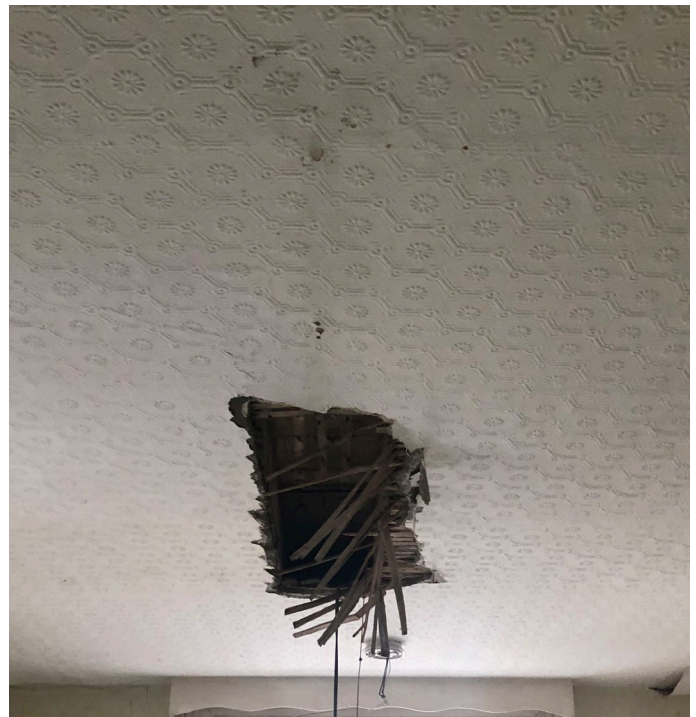
Fig 53: Internal Elevation: False ceiling has been damaged.

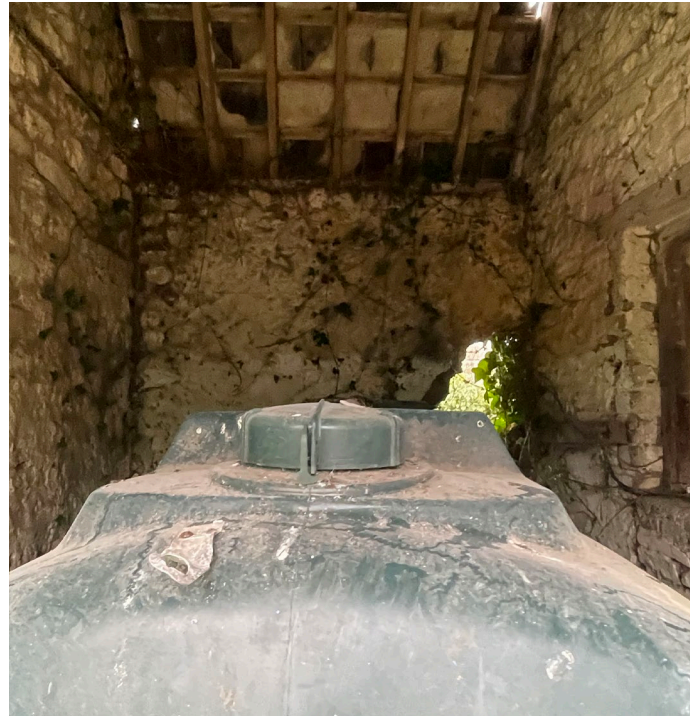
Fig 58: Internal Elevation 6.B. Stone wall has been damaged. Tank stored in room.

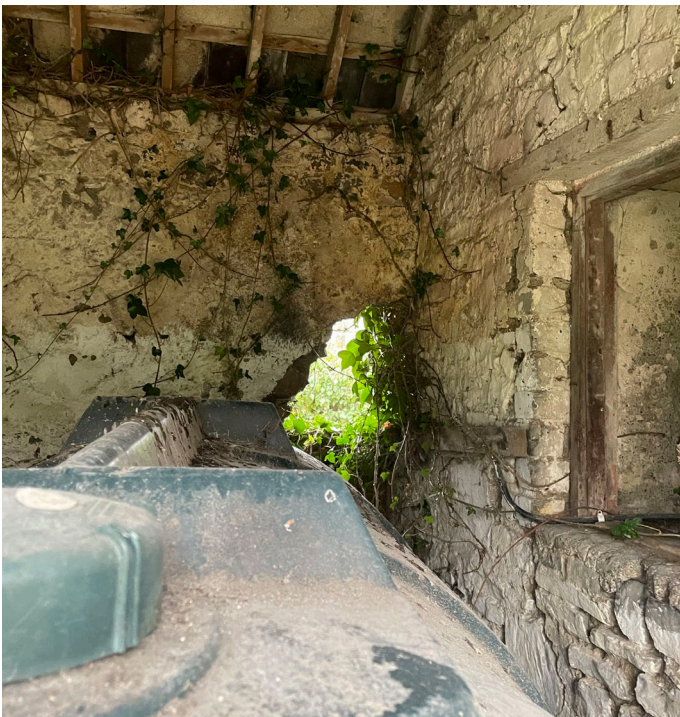
Fig 59: Internal Elevation 6.B. Detail of opening into stone wall.

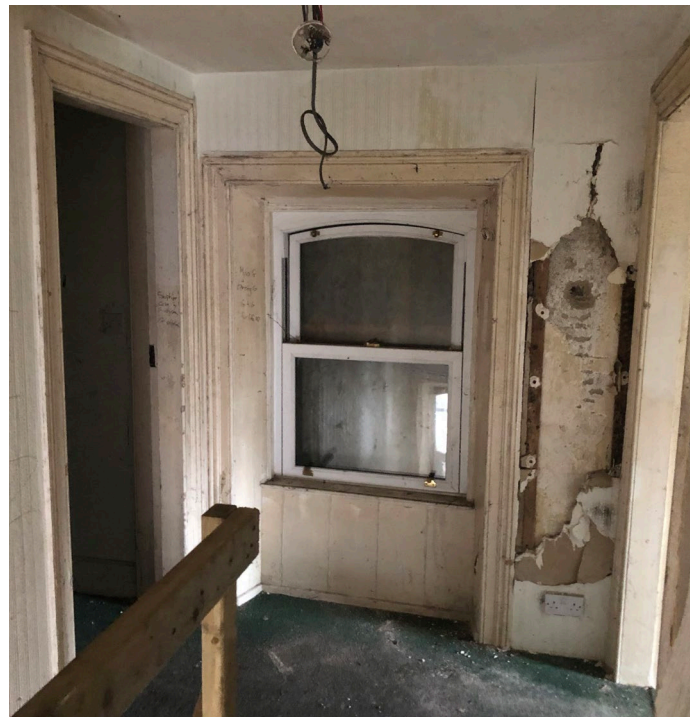
Fig 64: Internal Elevation 7.C. Existing window boarded up. Damaged plasterboard.

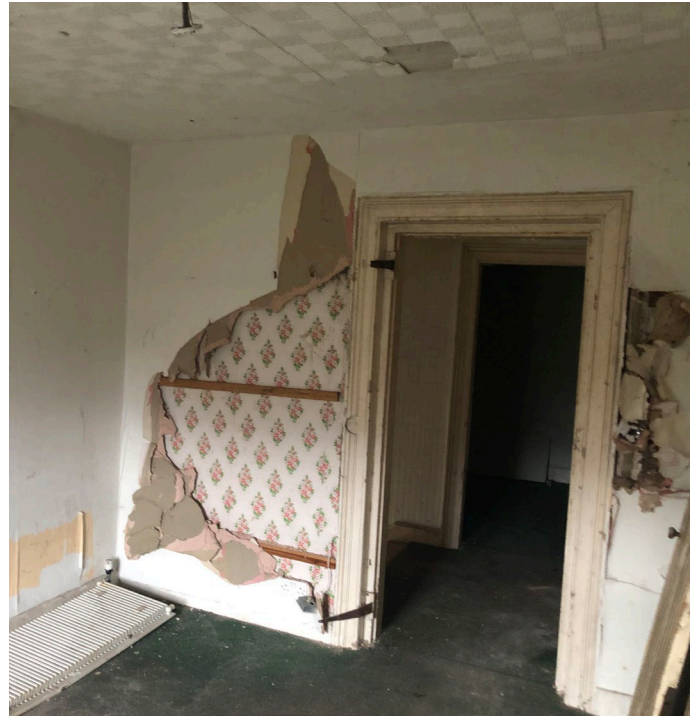
Fig 74: Internal Elevation 11.A. Doorway to room 7. Plasterboard has been damaged.

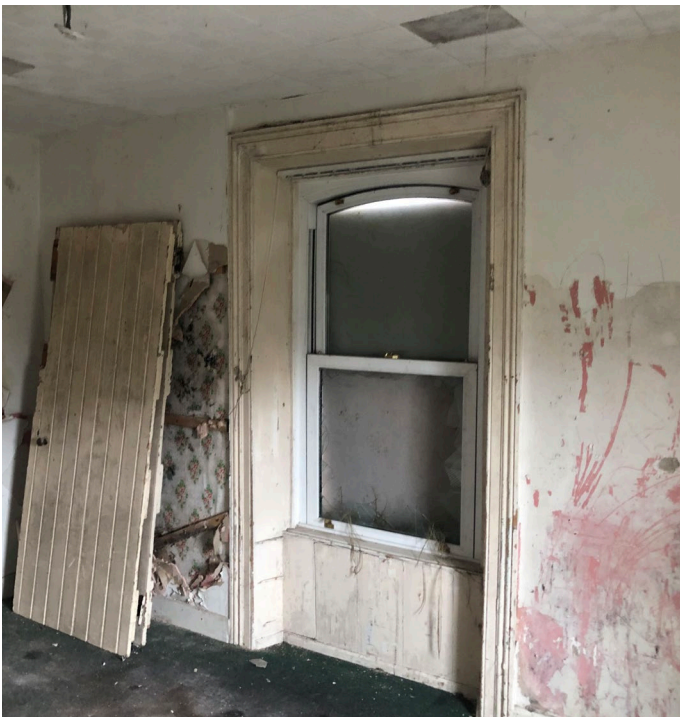
Fig 75: Internal Elevation 11.C. Remains of door. Sash Window and plasterboard have been damaged.

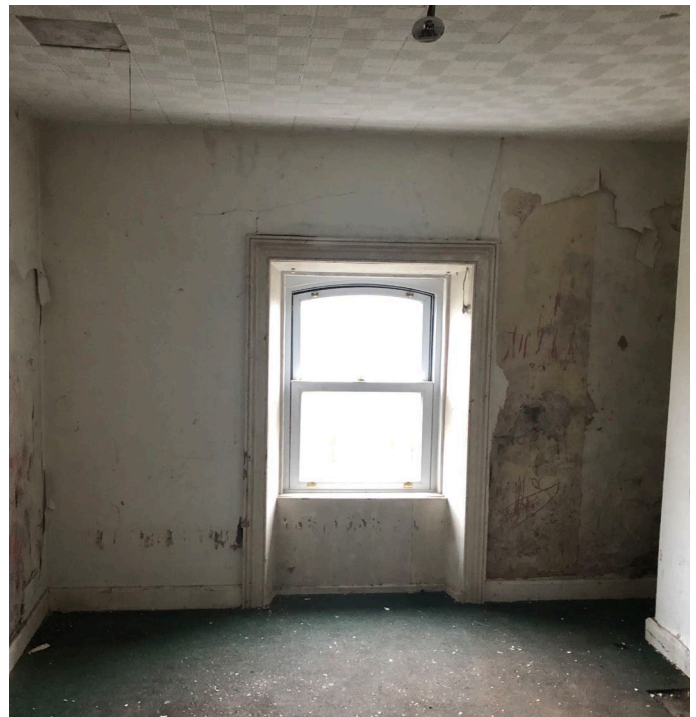
Fig 76: Internal Elevation 11.D. Plasterboard has been damaged.

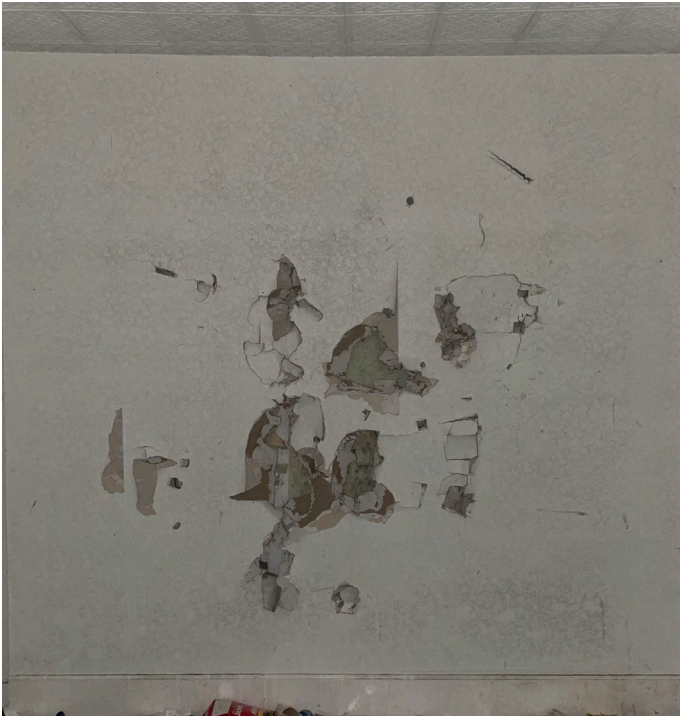
Fig 77: Internal Elevation 12.A. Plasterboard damaged.

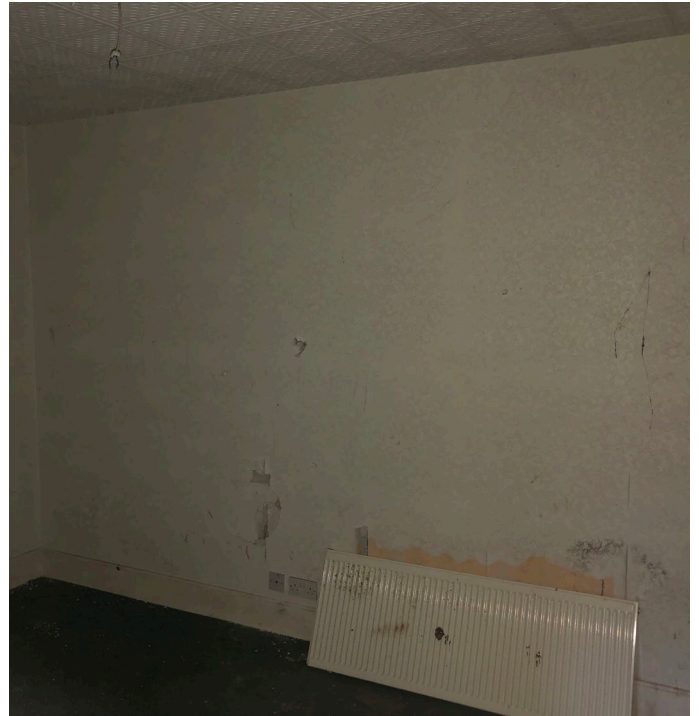
Fig 78: Internal Elevation 12.B.

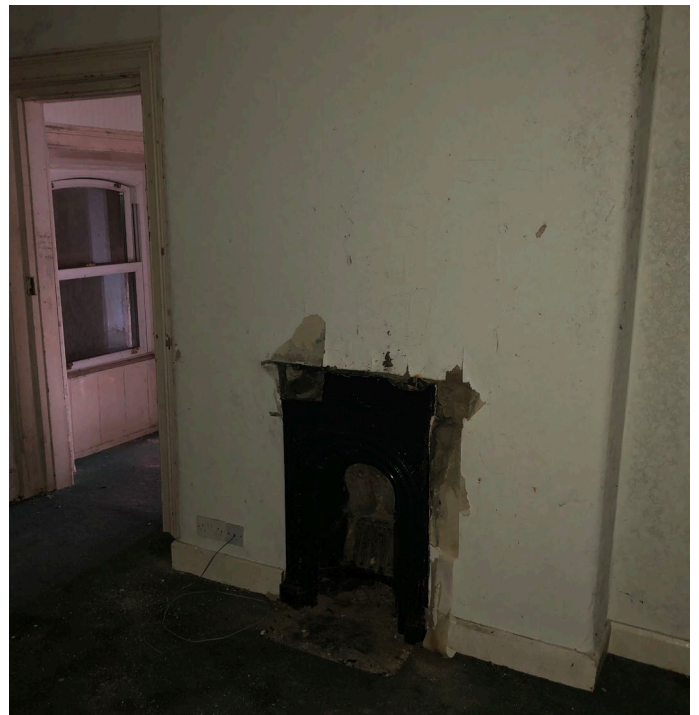
Fig 80: Internal Elevation 12.D. Existing fireplace. Plasterboard damaged.

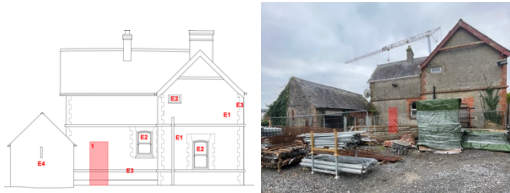
J1, J2, J6	The proposal is to create an opening size of c. 1200mm along the rear elevation. This opening will integrate the existing Masters House with the proposal mitigating the loss of existing fabric. Any works will be carried out in a minimum intervention fashion, ensuring the maximum retention of historic fabric.	Neutral because of mitigation.
Timber sash windows: Repairs to existing timber sash windows.	J1, J2, J3, J7	The proposal for the retention and repair of historic windows will ensure that openings and	Positive

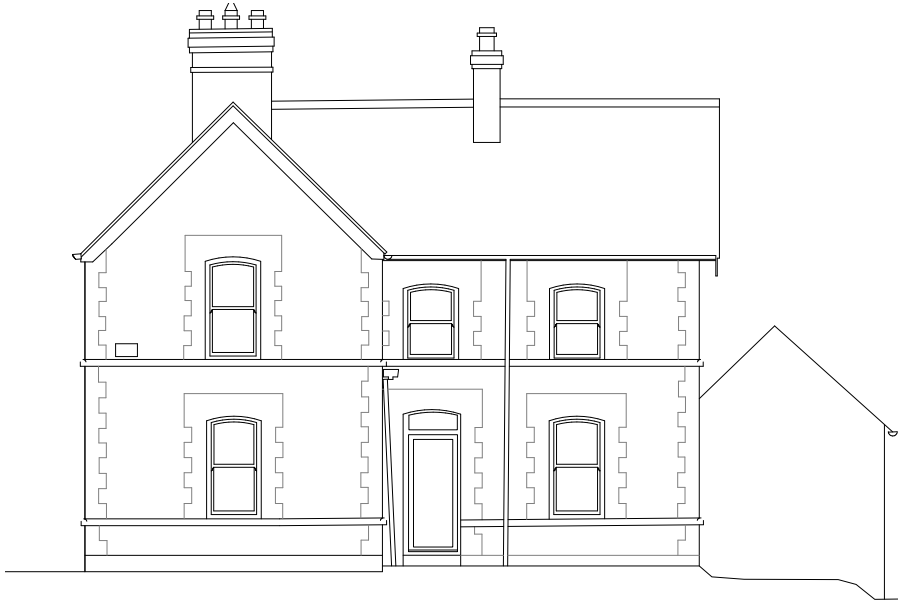
EXISTING FRONT ELEVATION

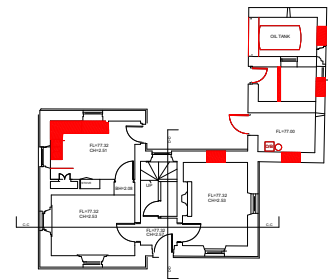
- E1 Existing limestone finish
- E2 Existing PVC type windows/doors to be replaced
- E3 Existing red brick
- E4 Existing stone finish
- Demolition

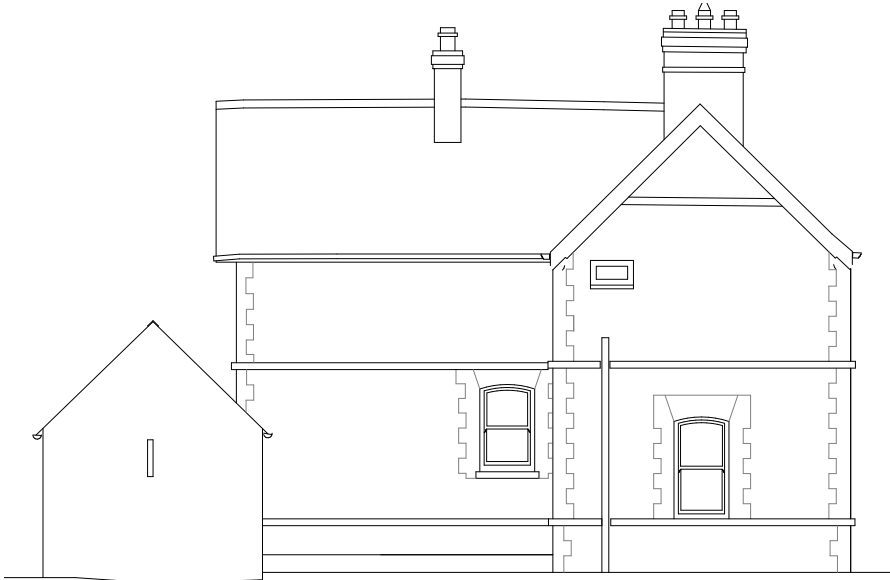
EXISTING REAR ELEVATION

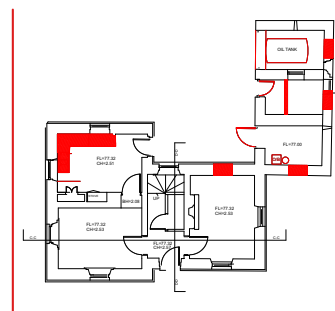
- E1 Existing limestone finish
- E2 Existing PVC type windows/doors to be replaced
- E3 Existing red brick
- E4 Existing stone finish
- Demolition

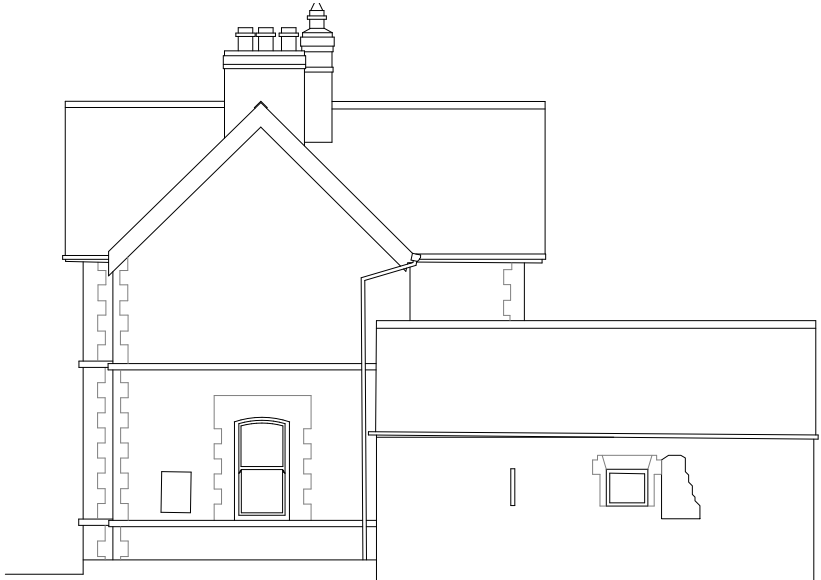
EXISTING SIDE ELEVATION

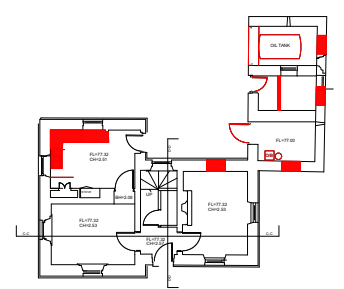
- E1 Existing limestone finish
- E2 Existing PVC type windows/doors to be replaced
- E3 Existing red brick
- E4 Existing stone finish
- Demolition

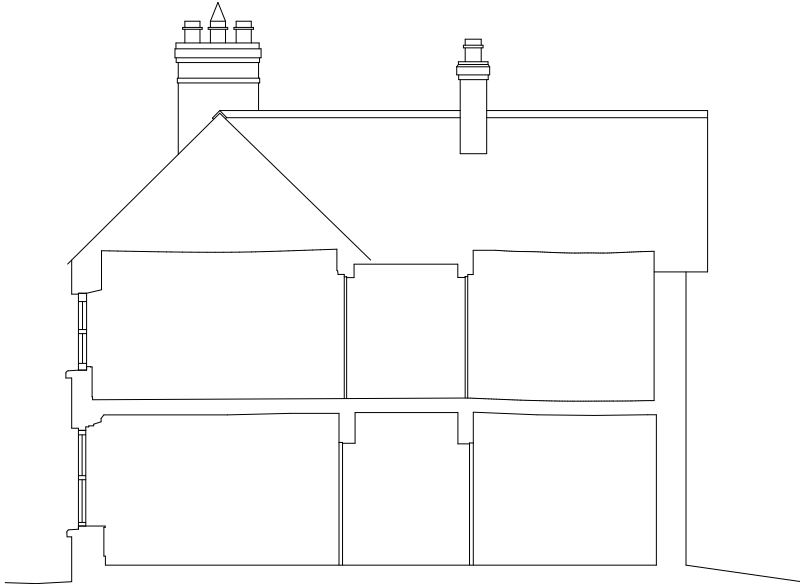
PP 1005A EXISTING SECTION CC

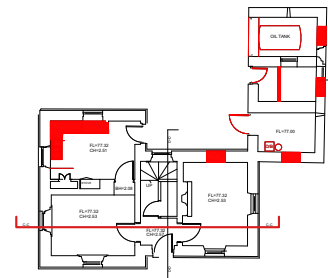
- E1 Existing limestone finish
- E2 Existing PVC type windows/doors to be replaced
- E3 Existing red brick
- E4 Existing stone finish
- Demolition

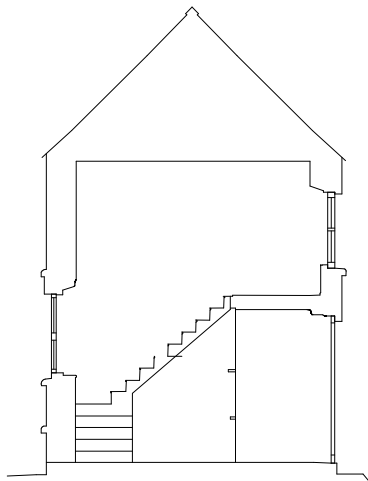
PP 1006A EXISTING SECTION DD

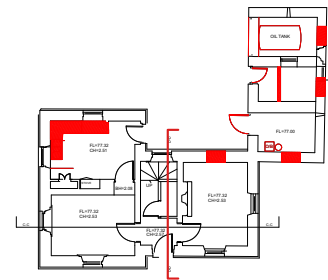
- E1 Existing limestone finish
- E2 Existing PVC type windows/doors to be replaced
- E3 Existing red brick
- E4 Existing stone finish
- Demolition
