# The Market House Castlepollard

Architectural Design Statement  
Planning Report

February 2022

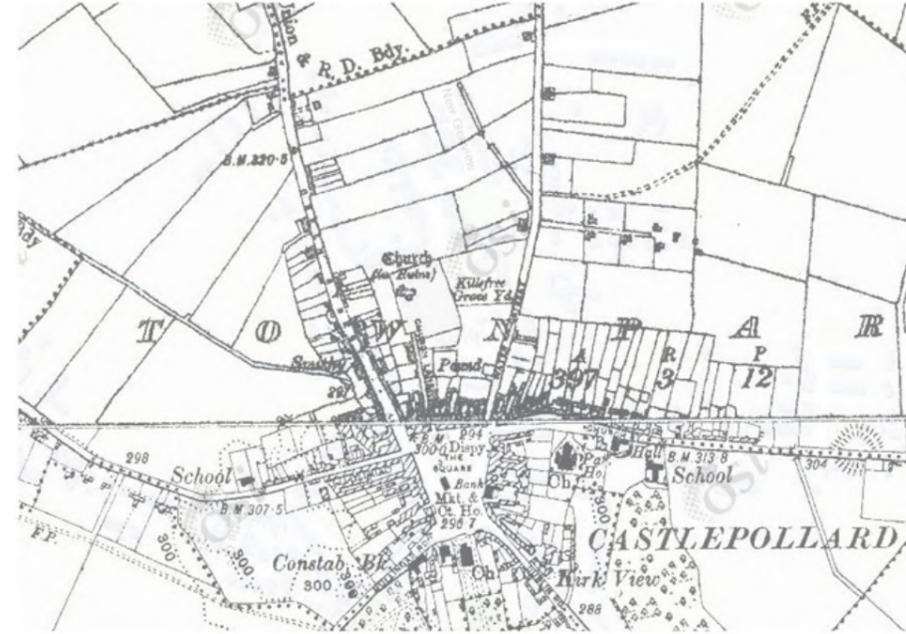
6-inch Cassini OS Map (1830)

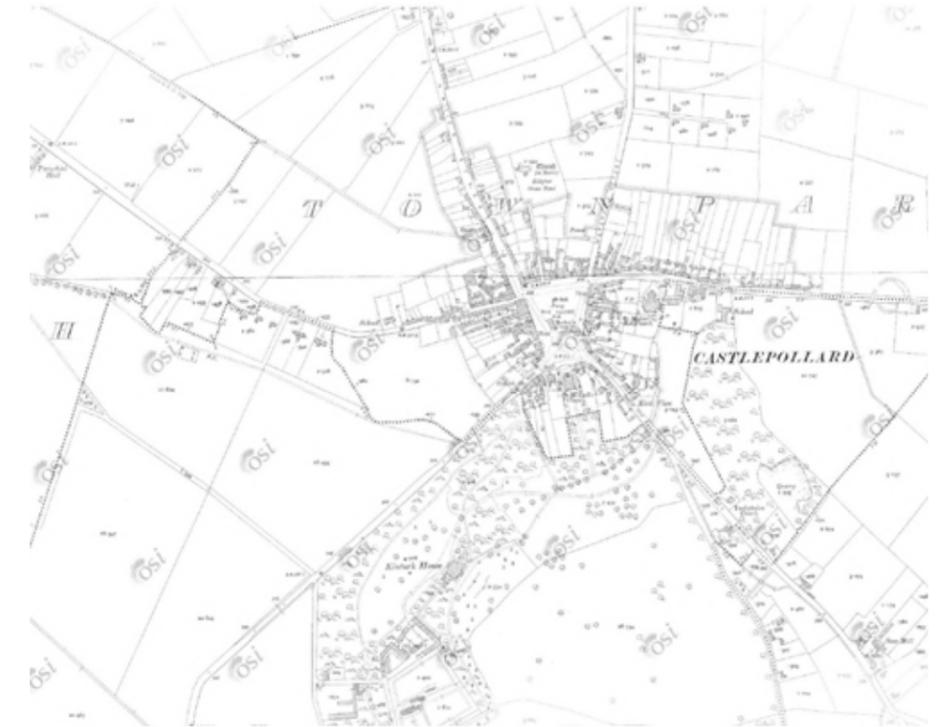
6-inch Cassini OS Map (1830)

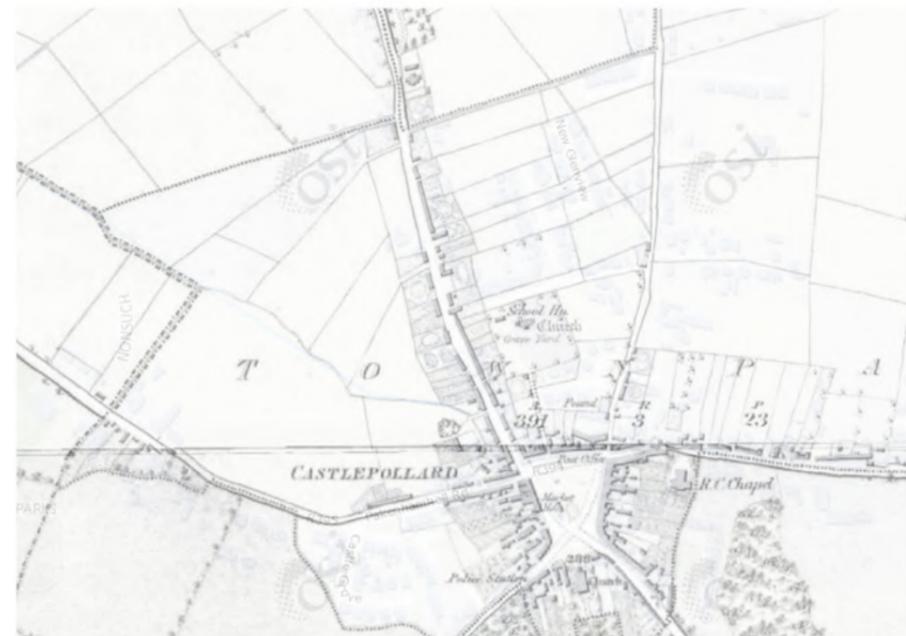
6-inch B&W OS Map (1837 - 1842)

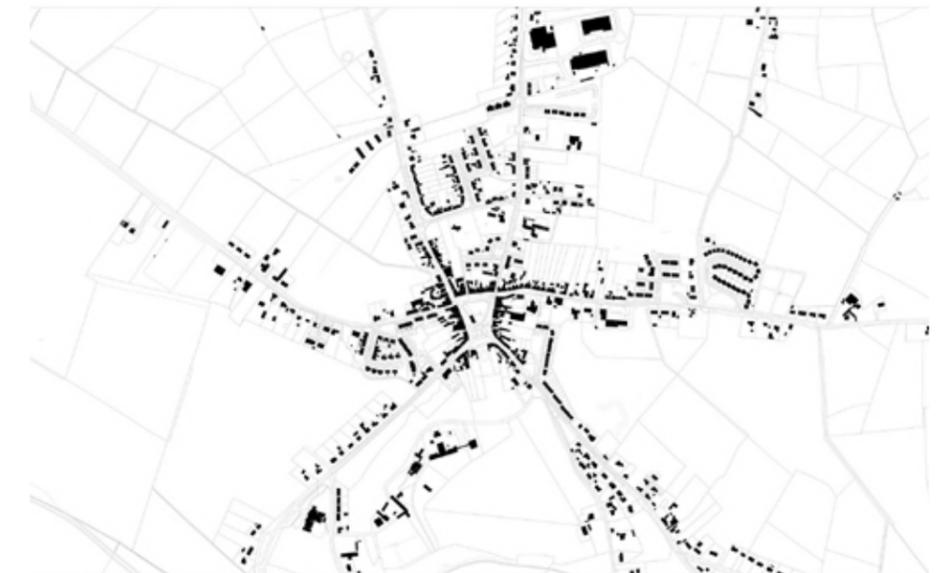
Current OS Map

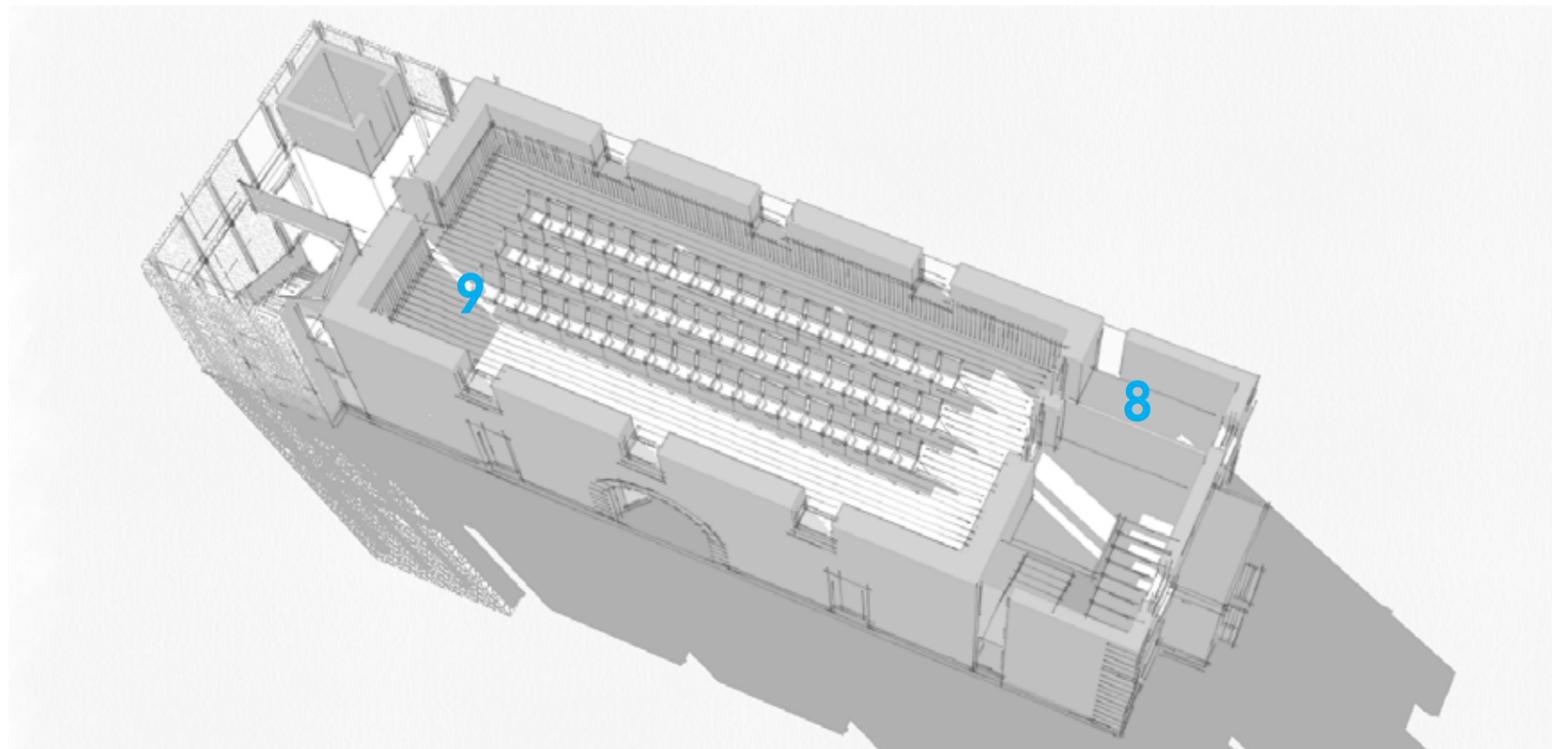
Proposed First Floor Plan 3D

- 1 Circulation
- 2 Storage
- 3 Services
- 4 WC's
- 5 Changing Places Toilet
- 6 Office
- 7 Entrance Foyer & Community Room
- 8 Kitchenette
- 9 Community Room

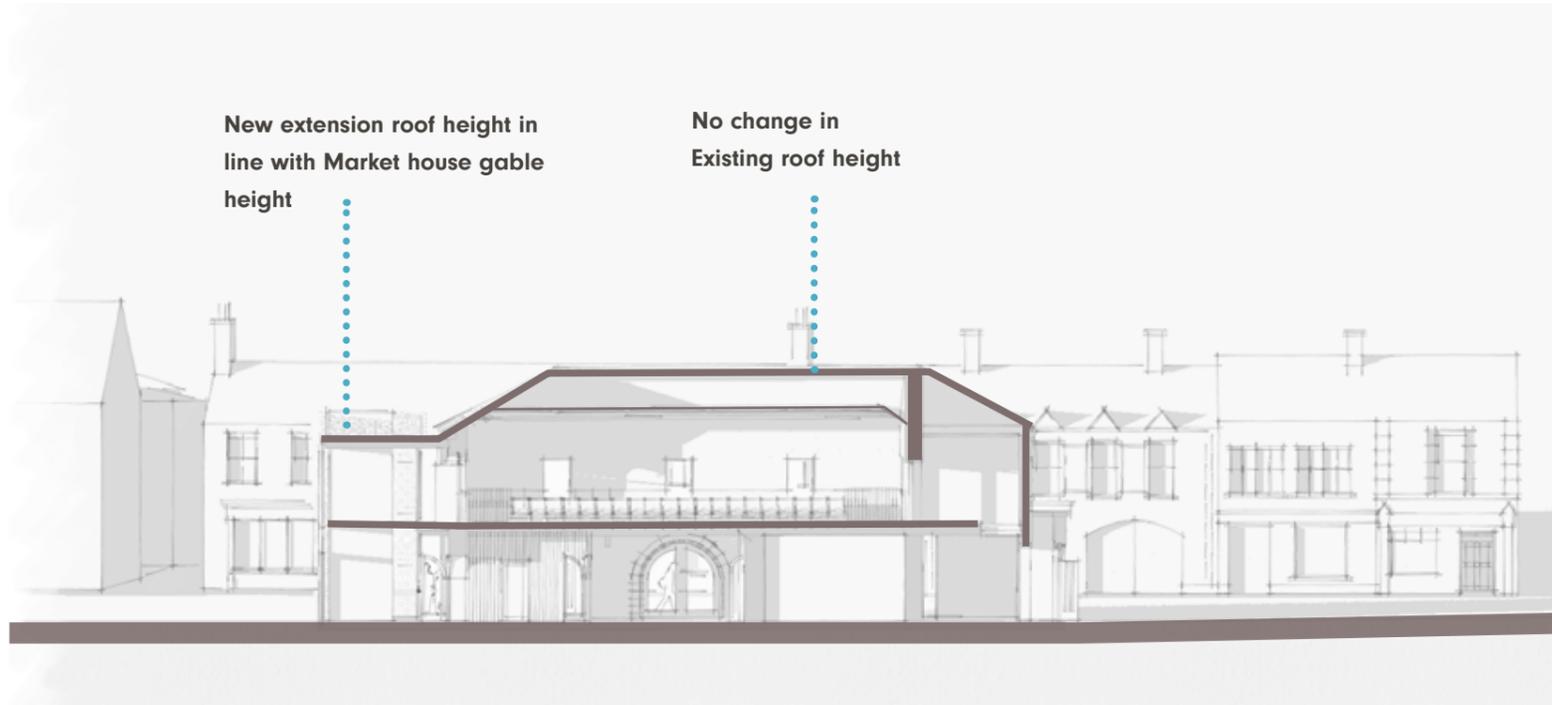
Section Through Market House

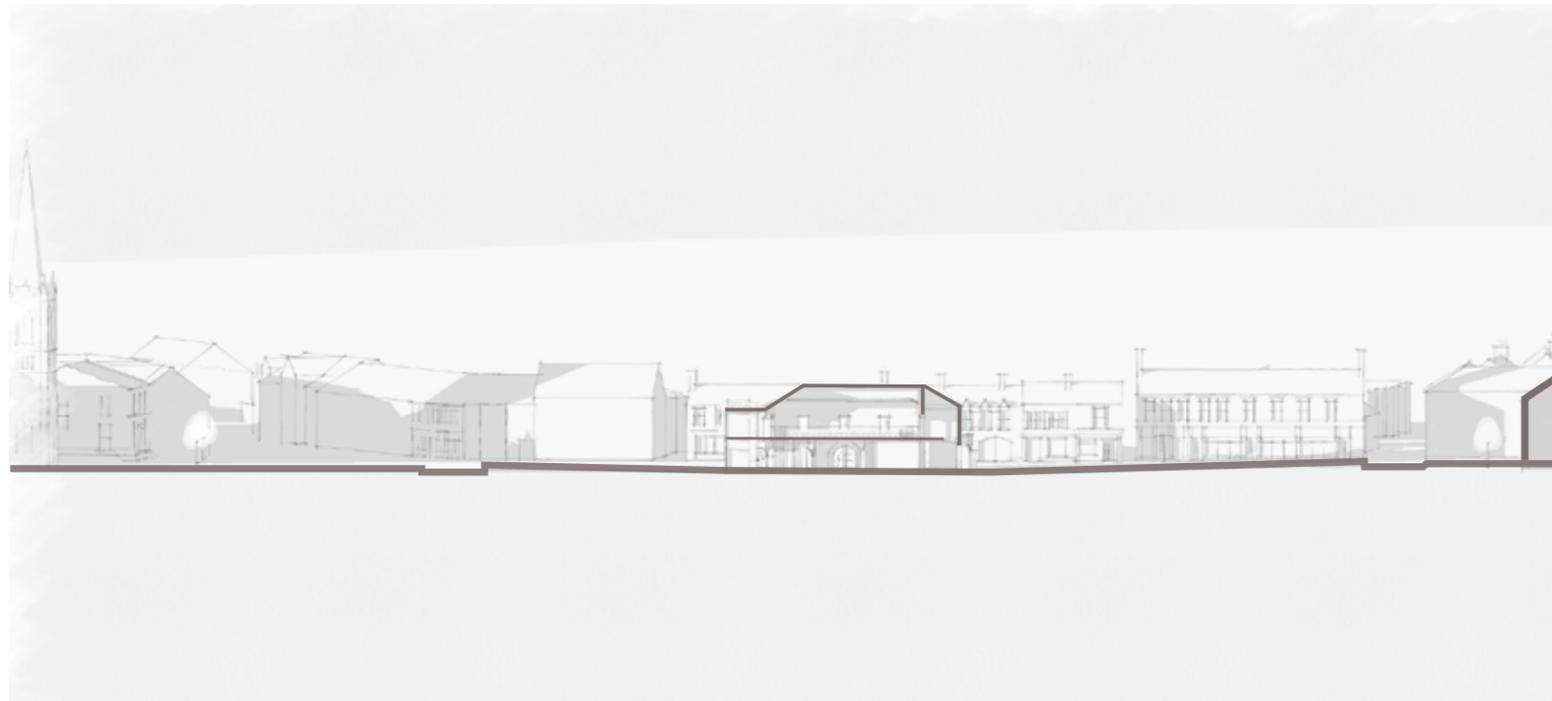
Context Section

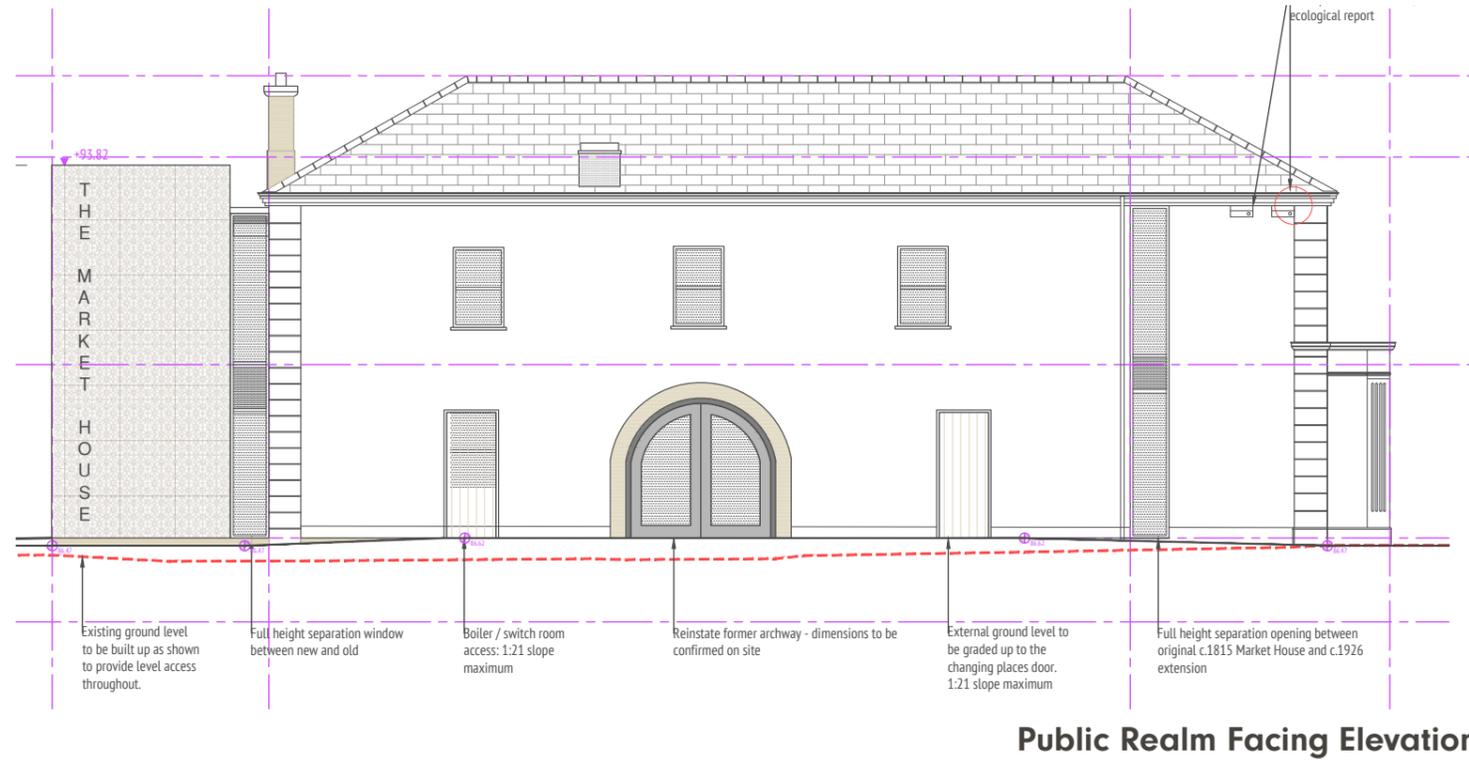
**Reinstating 1815 Original Architectural Intent**

**Expressing 1926 Extension**

Various design iterations have been prepared which examined how a new lightweight contemporary intervention could be articulated while still observing a respectful demeanor towards the pre-existing traditional building.

The resulting form seeks to balance a sense of 'architectural honesty' with respect to how the new extension will be expressed, while also reinstating the traditional archways and openings from the 1815 Market House intention and expressing the 1926 extension.

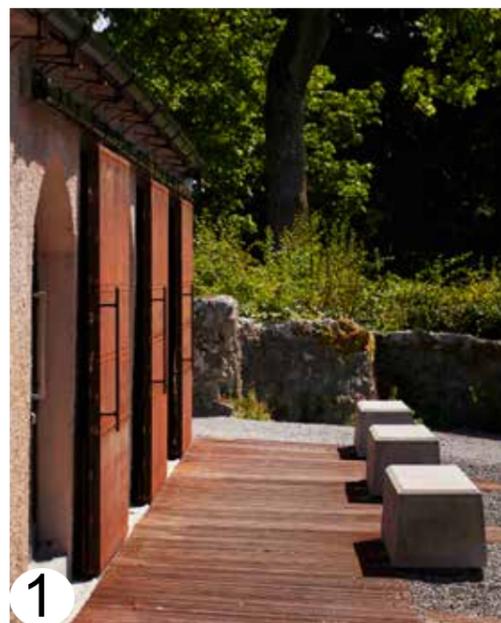
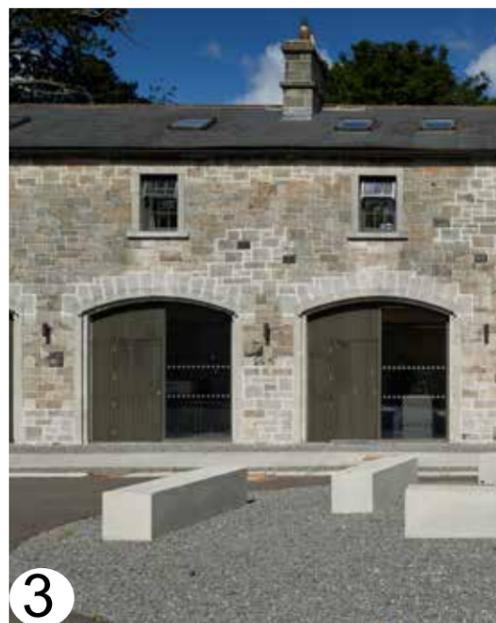
1. Architectural Heritage and design permeability
2. Expressing a differentiation between the old and the new
3. Reinstating original archways

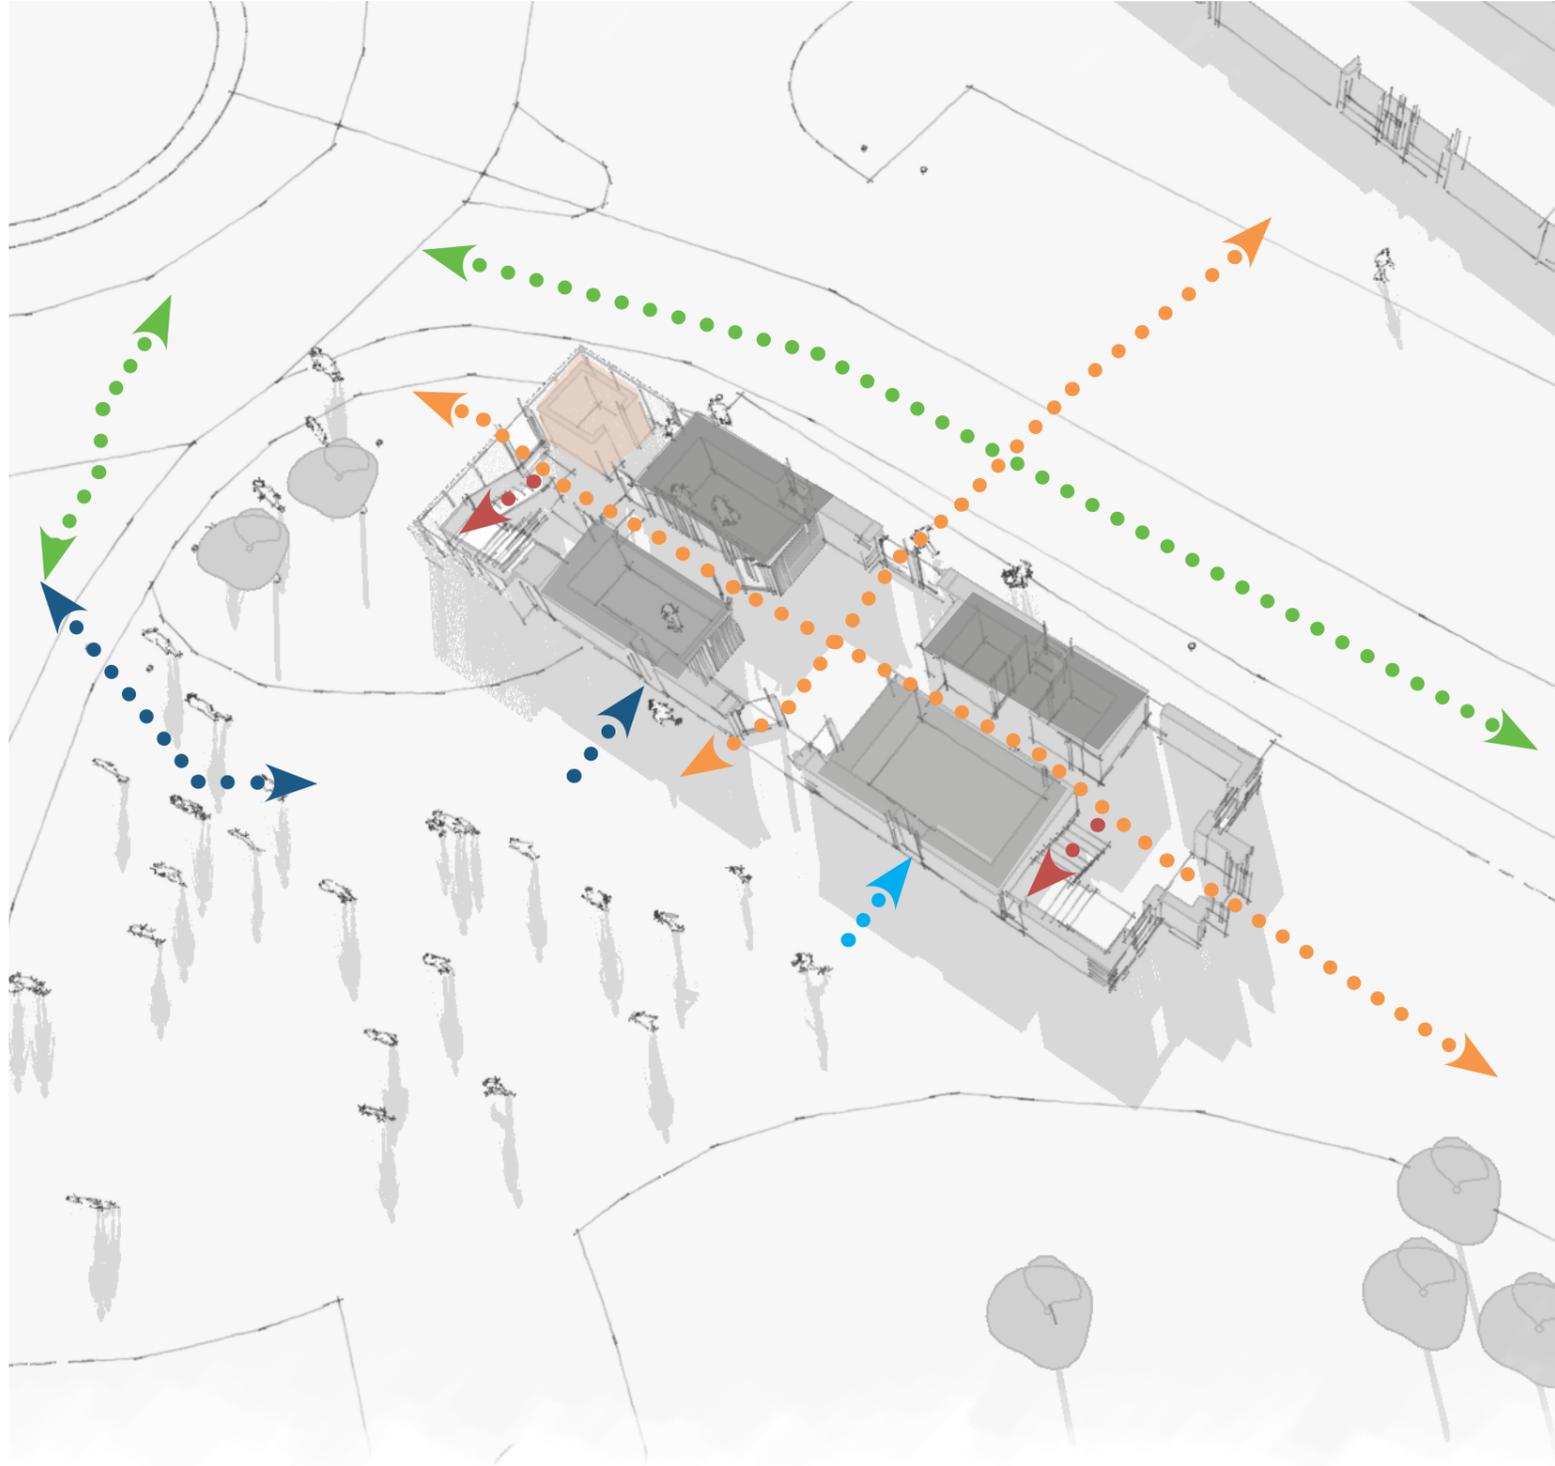
- ● ● ● PEDESTRIAN ACCESS
- ● ● ● RESTRICTED ACCESS TO CHANGING PLACES FACILITIES
- ● ● ● CAR ROUTES
- ● ● ● SERVICES ROUTE

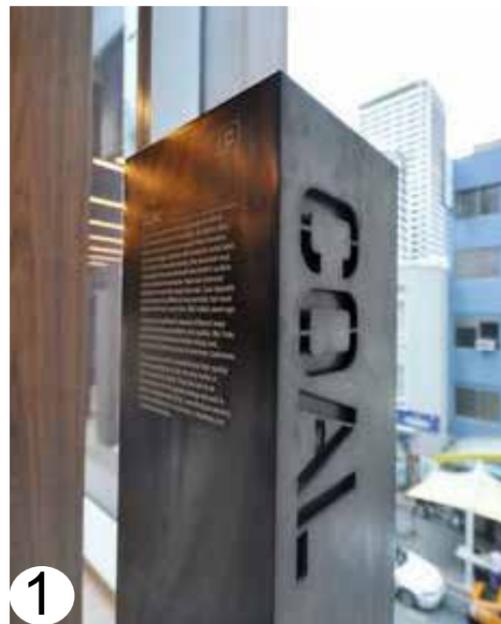
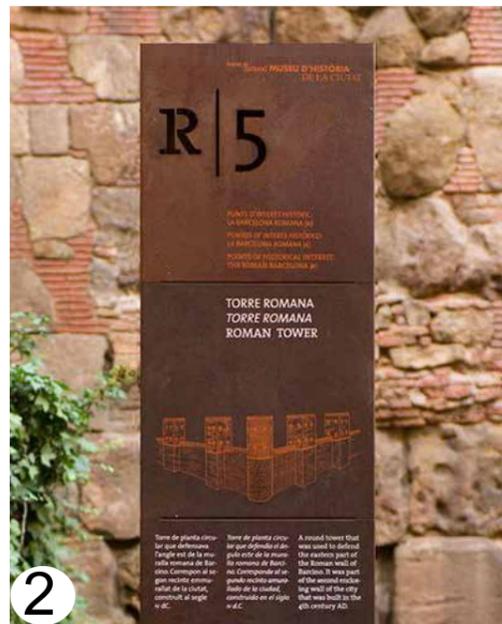
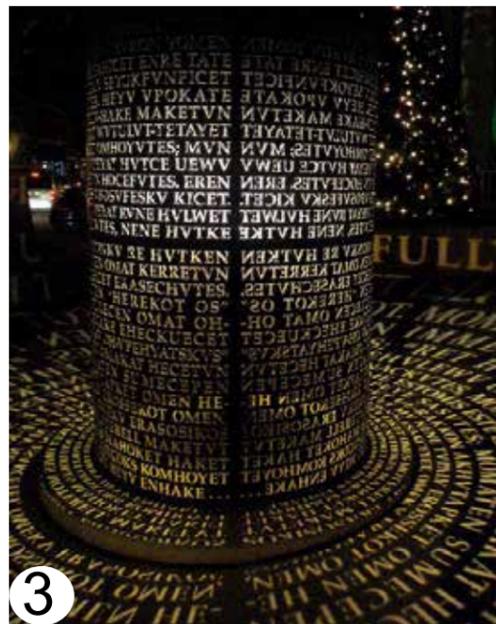
1. Example of laser Cut Signage on proposed new extension
2. Example of information Sign on building heritage
3. Example of laser Cut Signage on proposed new extension at Night

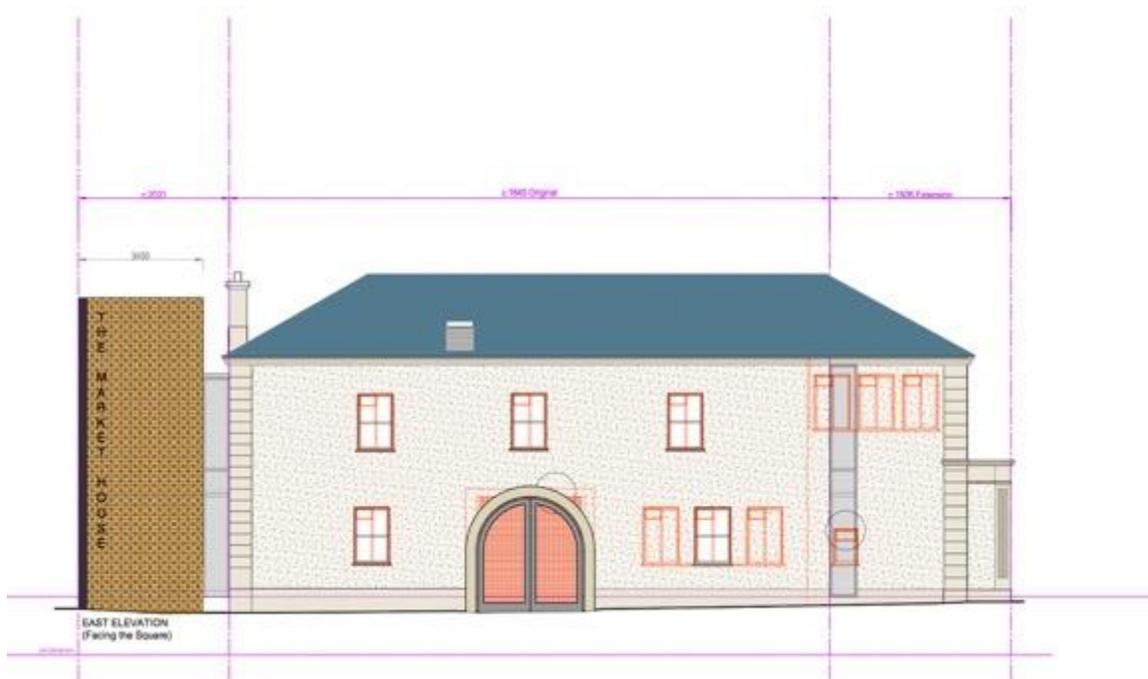
**Fig. 3.** Proposed Market House Design

The aim of this scheme is to breathe new life into the former Market House and to preserve and restore the historic fabric. The restoration will include the repair and upgrade of the fabric, to improve the thermal performance and resistance to damp penetration. The installation of new mechanical and electrical services throughout will protect the fabric from further damp whilst making the building more useable. It is proposed to open up and restore the former Market House arches to face out onto the streets and square and make the building more open and inviting.

It is proposed to remove and replace the 1925 timber stair to the north of the building and replace it with a fully compliant staircase. This means that the former Court of Petty Sessions can be reinstated in full on first floor. This space will become a room for the community of Castlepollard. It is proposed to retain the external stair with metal stair folded over to ensure compliance. A new lift is proposed to the South of the building, for full accessibility. The old stair and lift will be enclosed in a perforated curtain screen. The two stairs and lift means the Market House will be fully accessible. On the ground floor, there will be further community spaces, accessible unisex toilets, ancillary support spaces and changing places as well as accessible toilet and shower room for visitors to Castlepollard. The development will mean that the ground floor and first floor can be accessed independently.

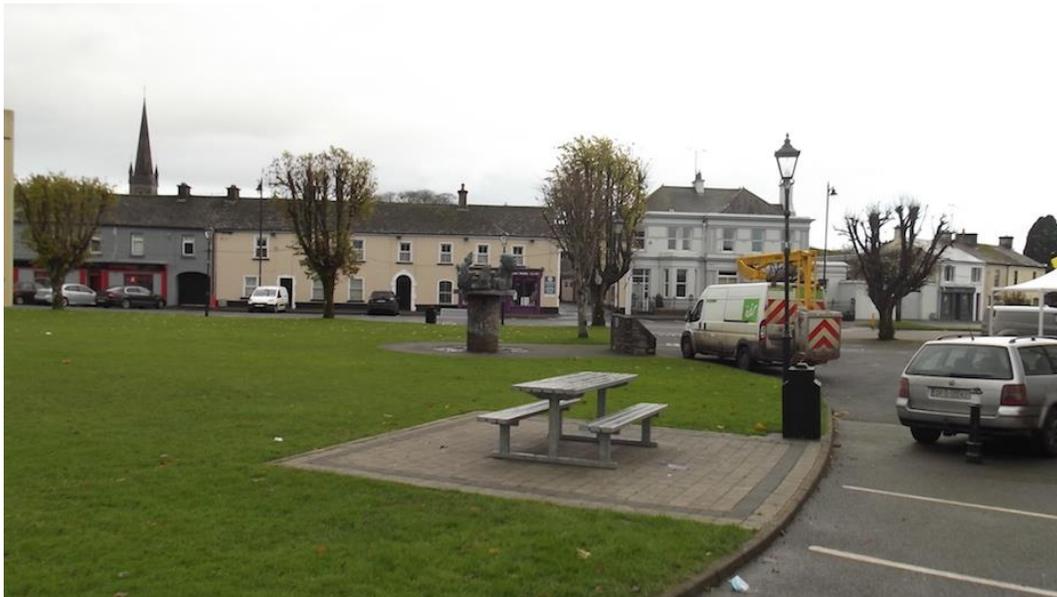
**Fig. 4** Amenity grassland and hard-surfaced area of green to east of Market House.

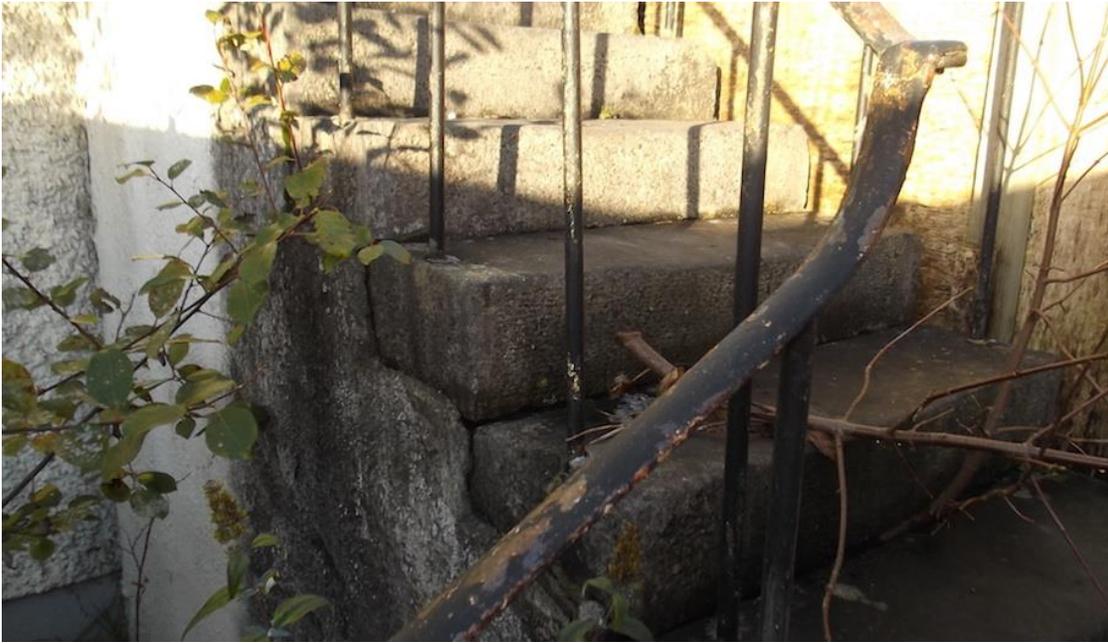
**Fig. 5.** Willow and Sycamore seedlings on southern gable of Market House.

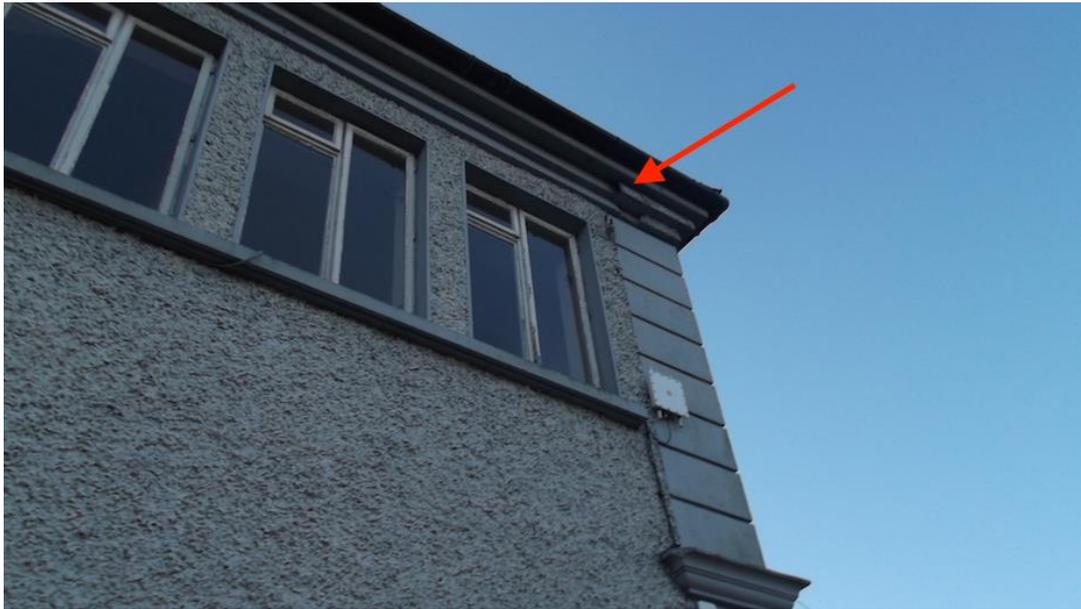
**Fig. 6.** Reported Swift nest site on north-eastern corner of Market House.

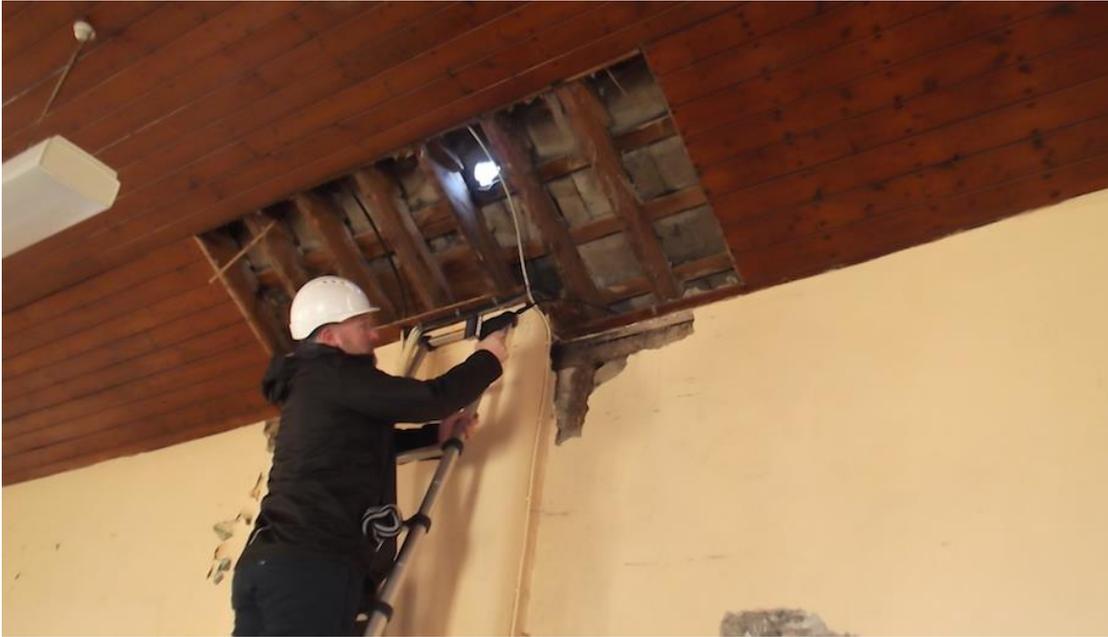
**Fig. 7.** Ecologist using endoscope to look for evidence of roosting bats in gap in roof-space.

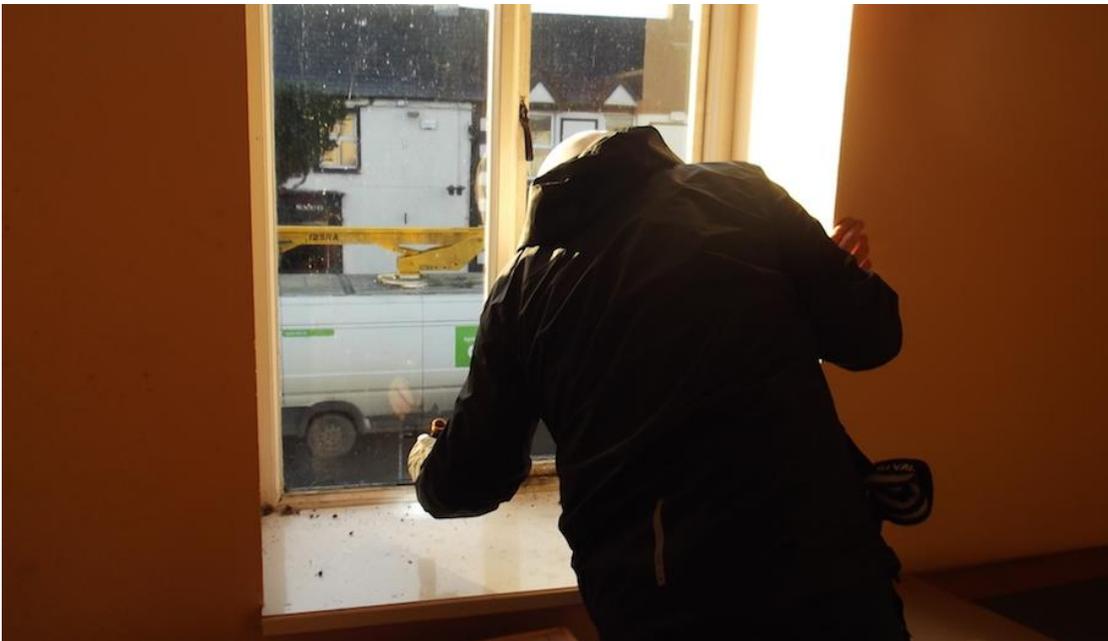
**Fig. 8.** Searching for evidence of bat habitation.

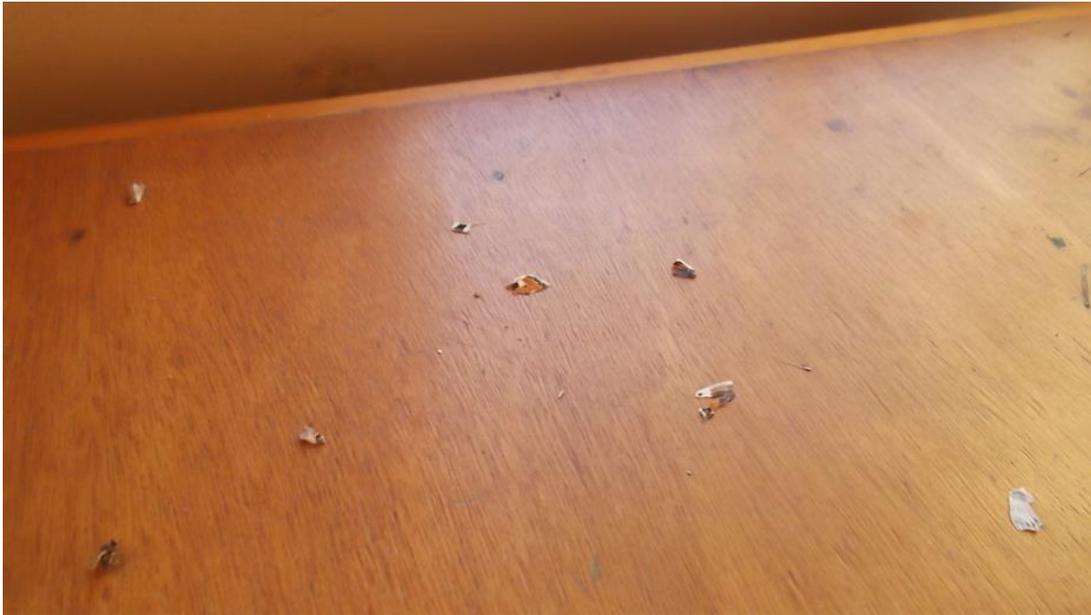
**Fig. 9.** Wing fragments (of Peacock Butterfly) – evidence of bat feeding.

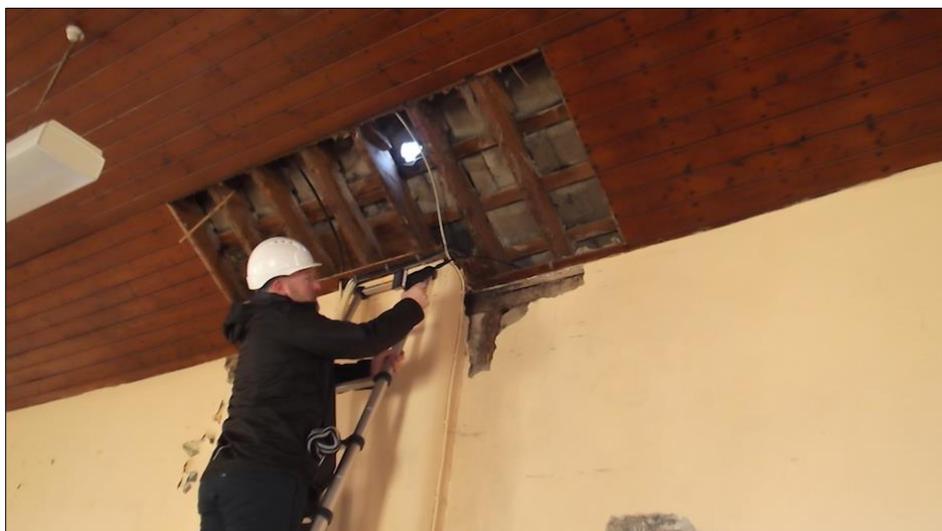
**Figure 3.** *Ecologist using an endoscope to check area around access point in slate roof.*

There is a gap in the roof slates on the east facing side of the building, with the gap being of sufficient dimensions to enable bat access. The ceiling timber board have been removed, permitting examination using an endoscope (Figure 3). No evidence of bats was found at this location.

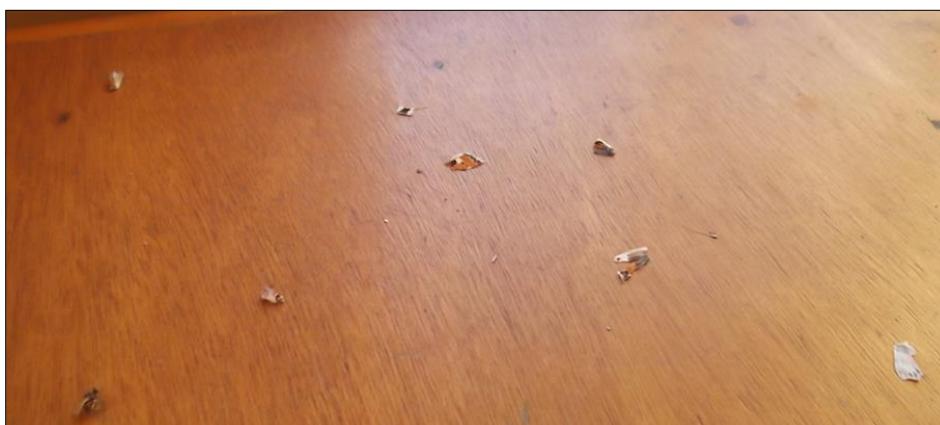
**Figure 4.** *Discarded moth and butterfly wings on office desk in upstairs office*

A small number of bat droppings were found on furniture in the open plan space on the upper storey and some discarded butterfly wings were also found on a windowsill and furniture in one of the office rooms adjacent to this open plan area (Figure 4) The shape and size of the bat droppings and the discarded butterfly wings are indicative of brown long-eared bat.

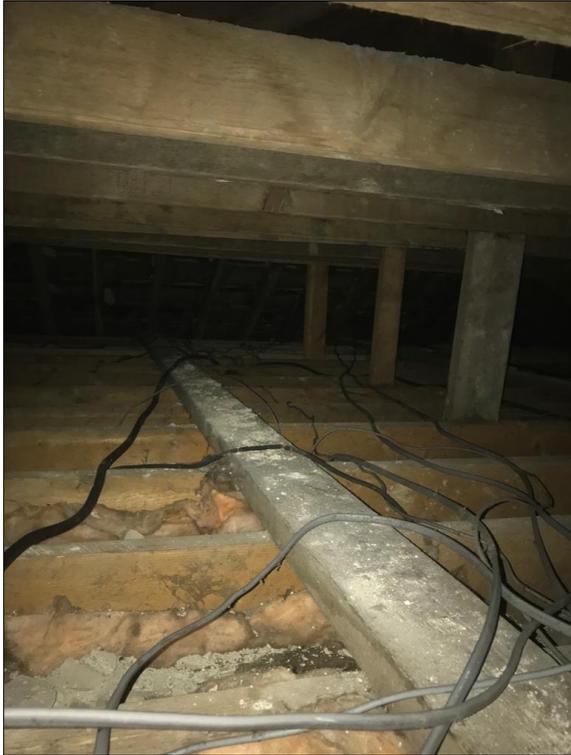
**Figure 5.** *View inside the roof space.*

The roof space in the building is low and cluttered with rafters and joists, Figure 5. No daylight was observed entering into the dark roof space and no obvious access points of potential use by bats were noted. No bat droppings were found.

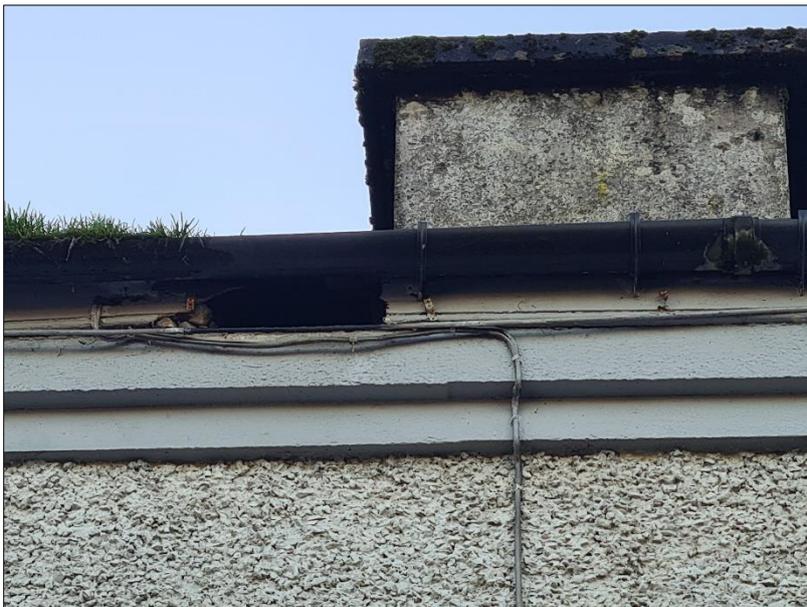
Externally, there are some decayed sections of fascia and soffit boards that may permit bats to enter the building, Figure 6.

**Figure 6.** *Possible access point into the roof space of the building*

Possible mitigation includes allowing bats to continue to access the roof space of the building via suitably designed roof slates / bat bricks. Bats, especially in small numbers, will not cause any damage within attic spaces. They do not build nests or chew wiring. The project ecologist / bat specialist can discuss this option with the development design team to see if such a measure is possible.

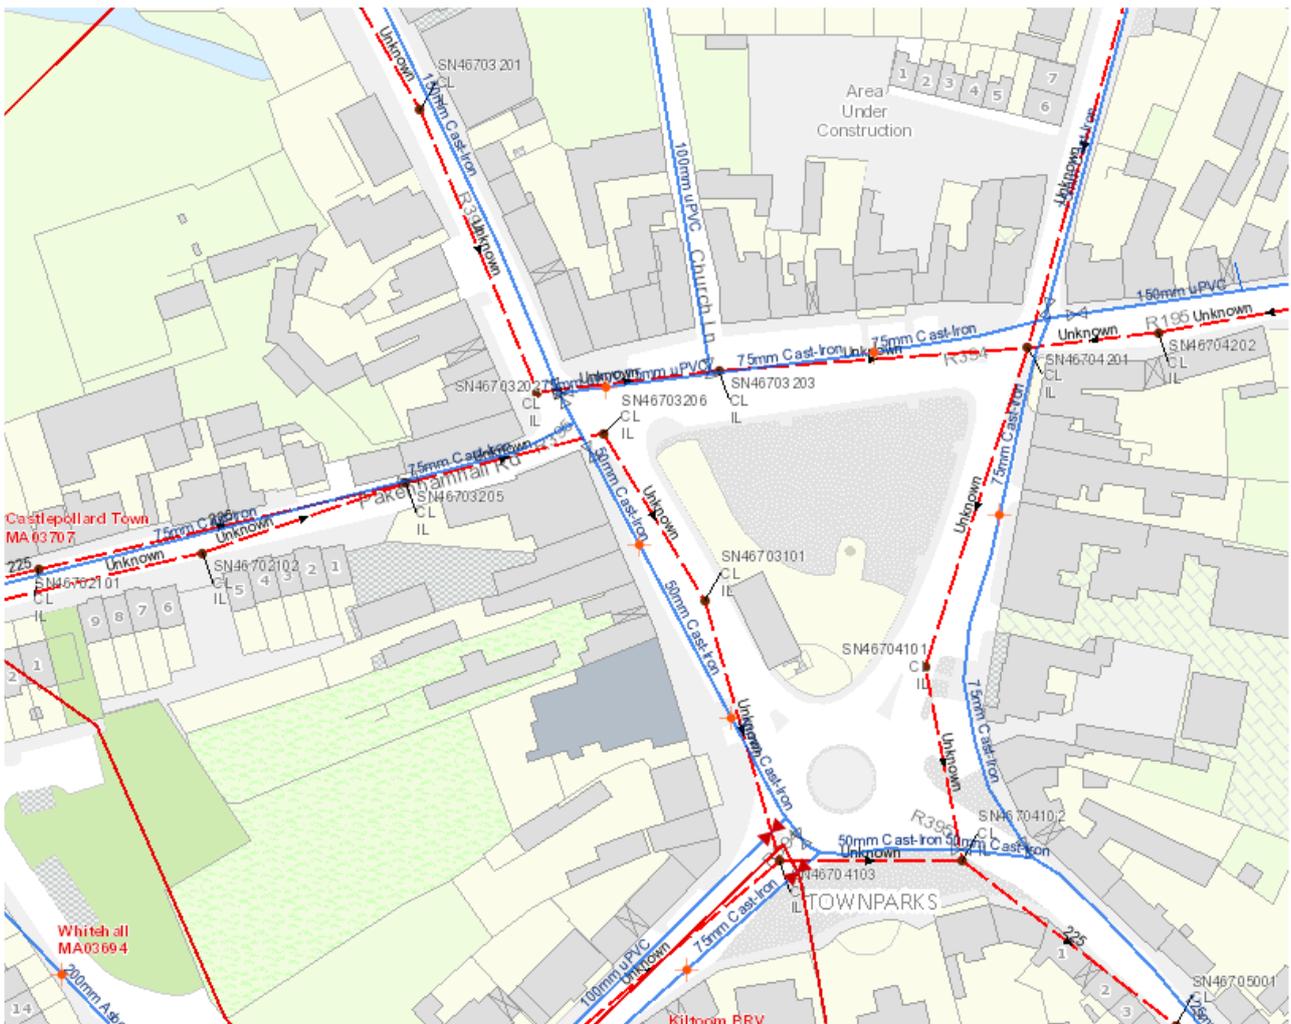
Castlepollard Irish Water Utilities 1-1

Provided below is the underground water and wastes drawings provided by Irish Water. This map and its legend can be viewed in higher resolution attached as appendices to this document.

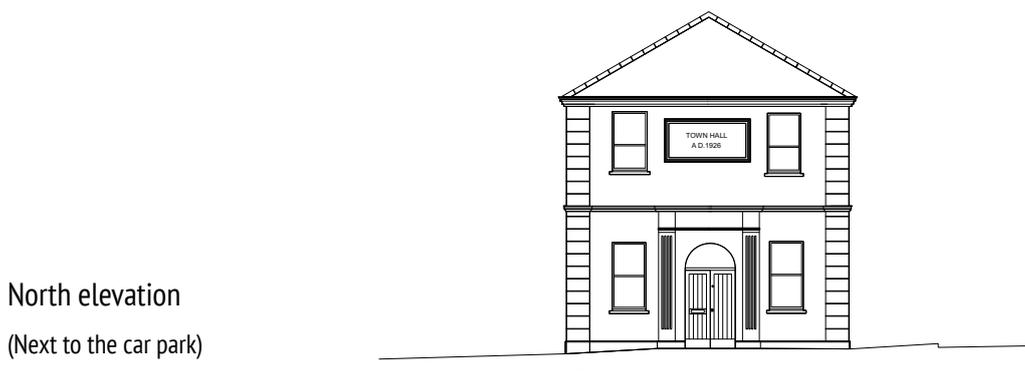
4.3 Survey Drawings

Former arcaded entrance

Due to the ever evolving use, alternations and additions have been made over the years to accommodate the purpose. During opening up works evidence was found that the building originally had arcaded entrances on the east, west and south elevation; as is found at the majority of Irish market houses, and there is some surviving evidence of blocked arches to the interior. It is speculated that the northerly section along with the flat roofed porch was built after the fire damage in 1921 and that the original Market House was of symmetrical proportions. It is also expected that the sliding sash windows and timber frame doors, wainscoting and flooring dates back to c. 1926. Internally the wainscoting and timber work is the buildings most significant feature.

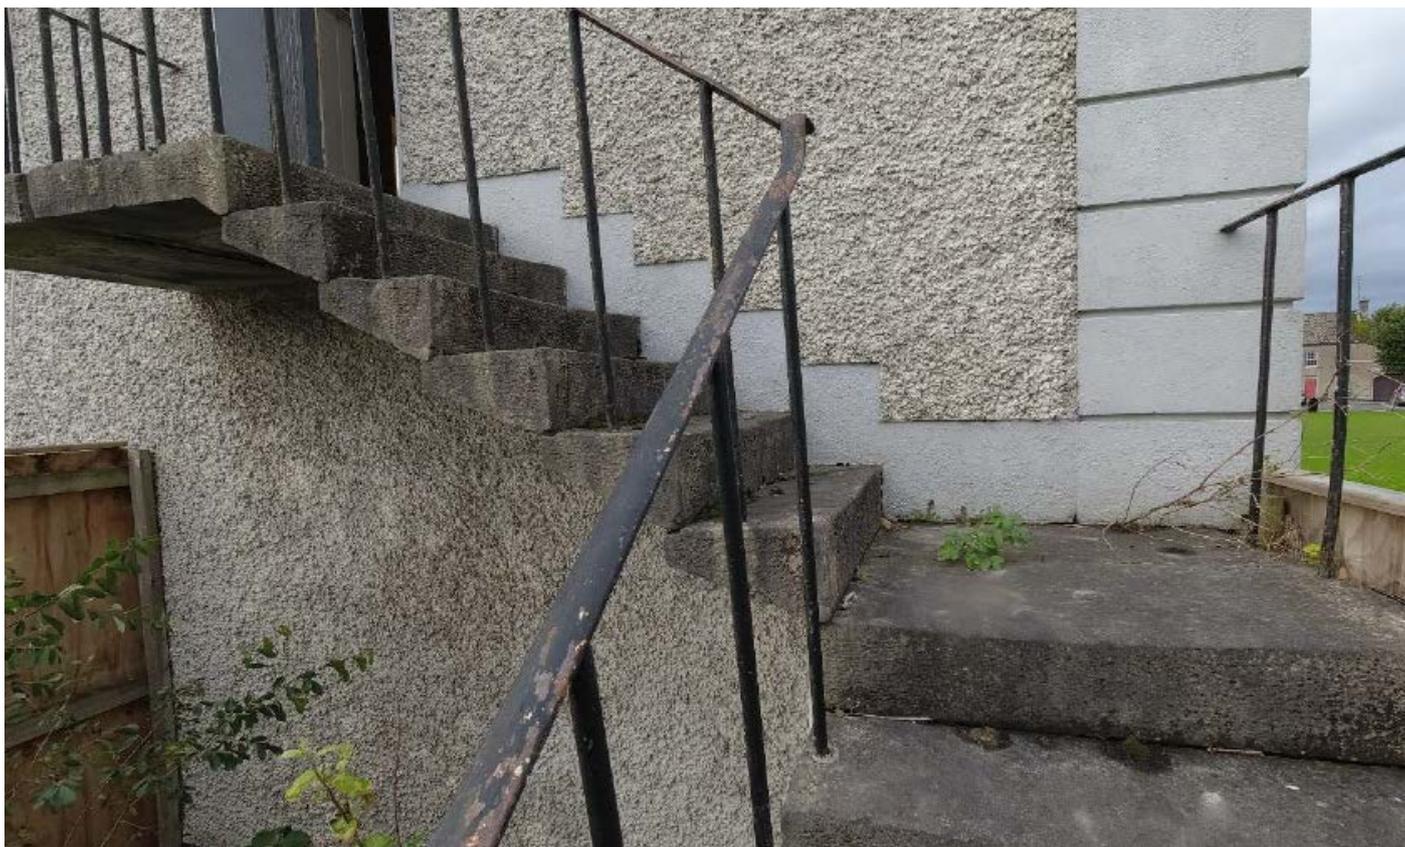
South Elevation D: Original external steps c.1815
