# The Market House Castlepollard

Architectural Design Statement  
Planning Report

February 2022

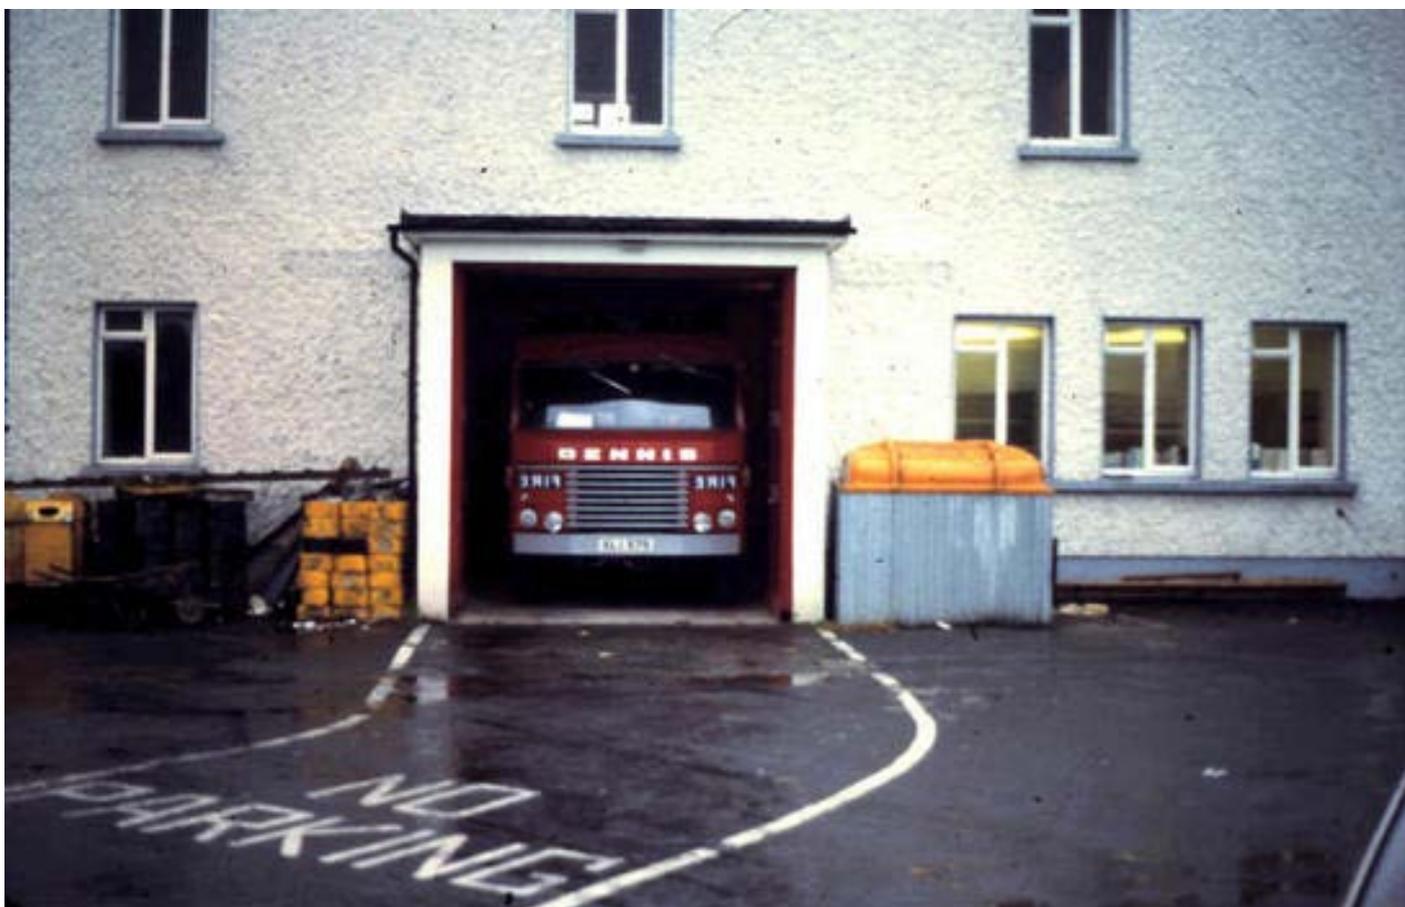
East elevation C Vehicular entrance porch added c.1977 to convert the use to a Fire Station

Note: Shallow projecting square-headed carriage arch to the centre of the east-facing elevation, constructed c.1977 formerly giving access to fire station.

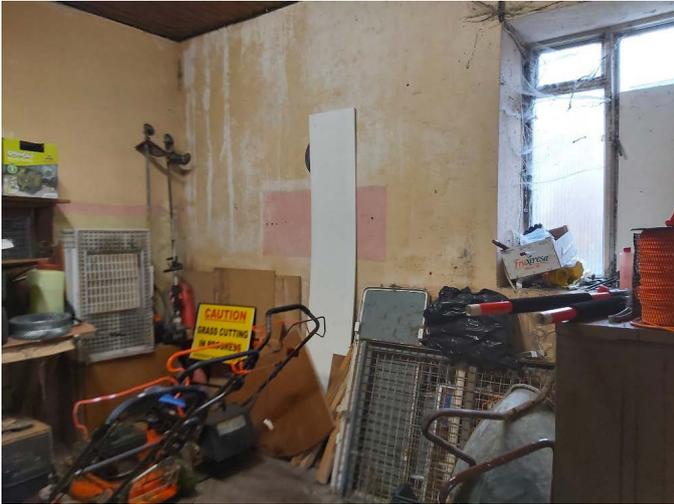
Currently in use for the storage town maintenance equipments such as Christmas lights, lawnmowers etc.

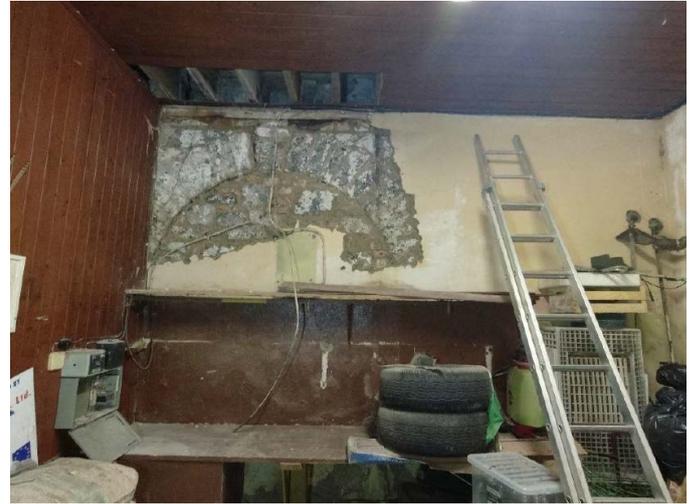
Floor to ceiling tongue-and-groove wainscoting and ceiling Boards Note the evidence of the original entrance archway and stone quoins visible internally.

Due to the ever evolving use, alternations and additions have been made over the years to accommodate the purpose. During opening up works evidence was found that the building originally had arcaded entrances on the east, west and south elevation; as is found at the majority of Irish market houses, and there is some surviving evidence of blocked arches to the interior. It is speculated that the northerly section along with the flat roofed porch was built after the fire damage in 1921 and that the original Market House was of symmetrical proportions. It is also expected that the sliding sash windows and timber frame doors, wainscoting and flooring dates back to c. 1926. Internally the wainscoting and timber work is the buildings most significant feature.

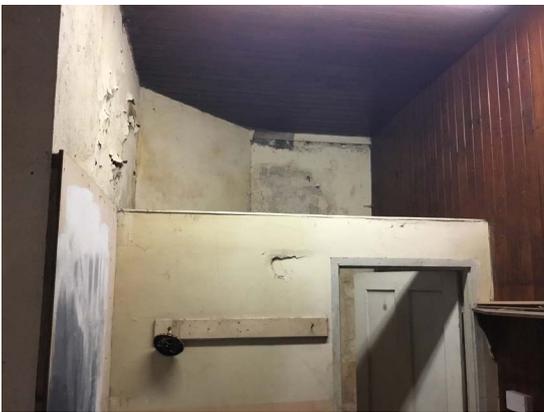
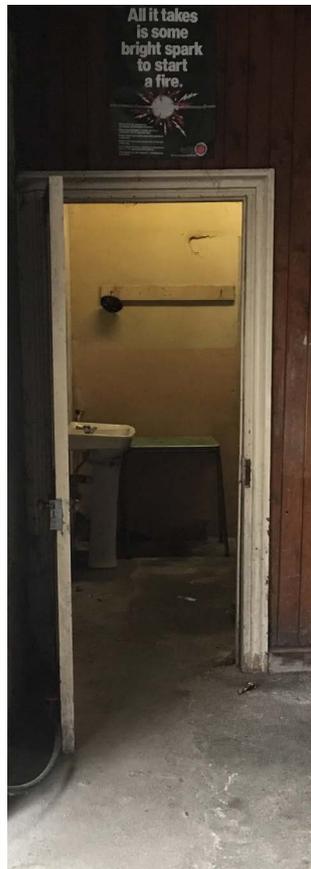
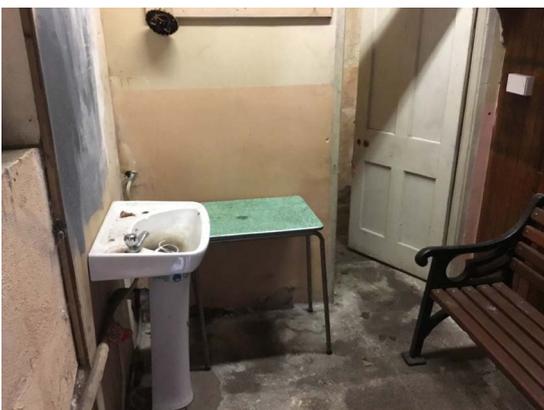
A 2.2m stud partition forms a WC cubicle within the room. Segmental-Headed Doorcase with Timber Panelled Doors and original timber casing surrounding doorcase. Floor to ceiling tongue-and-groove wainscoting and ceiling boards

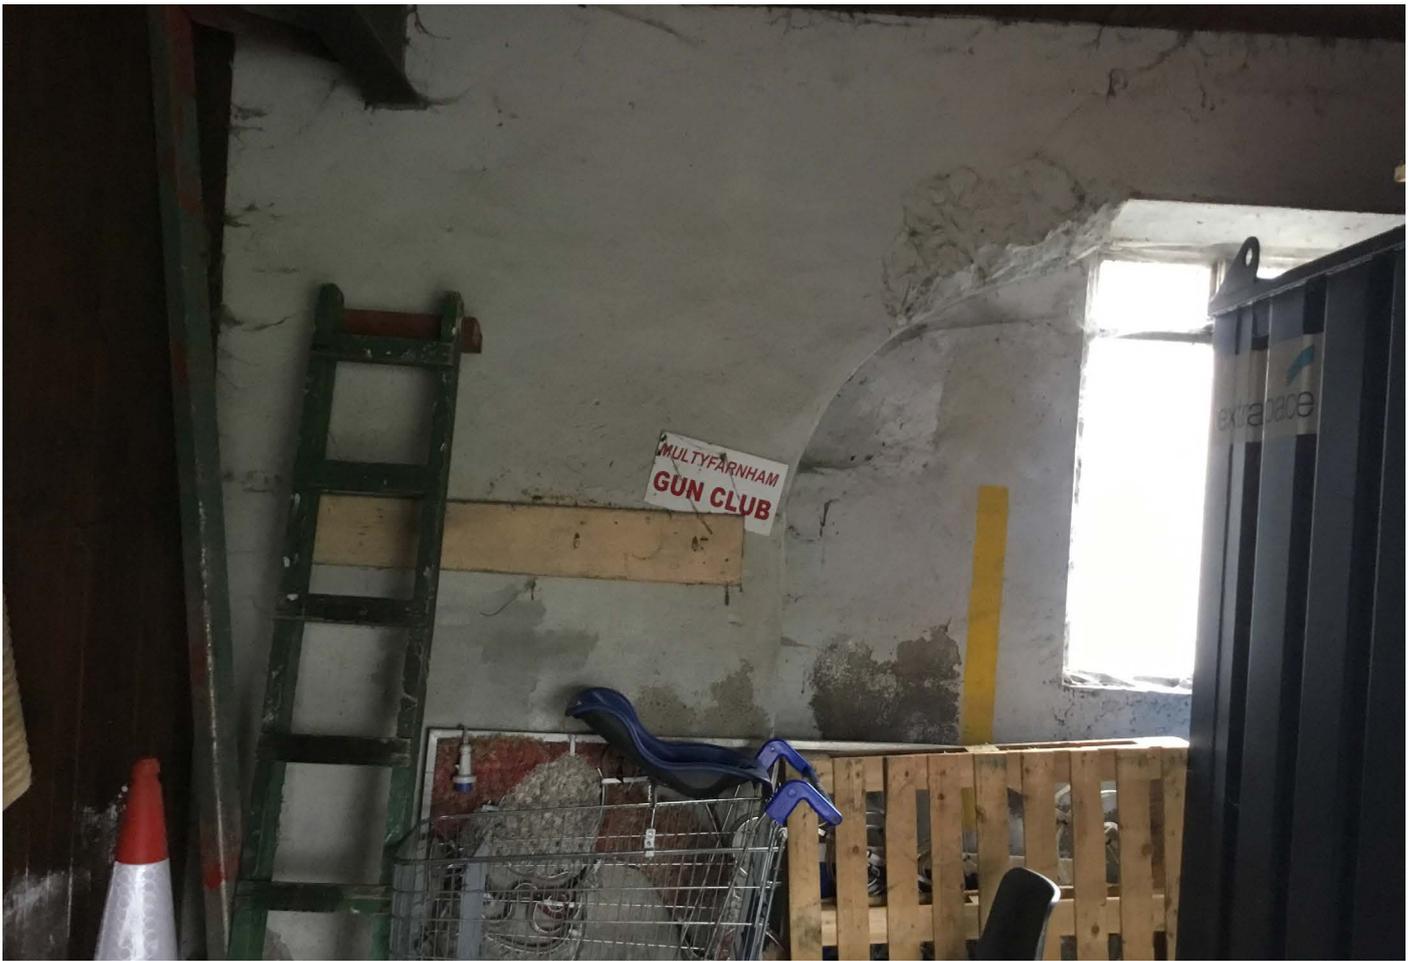
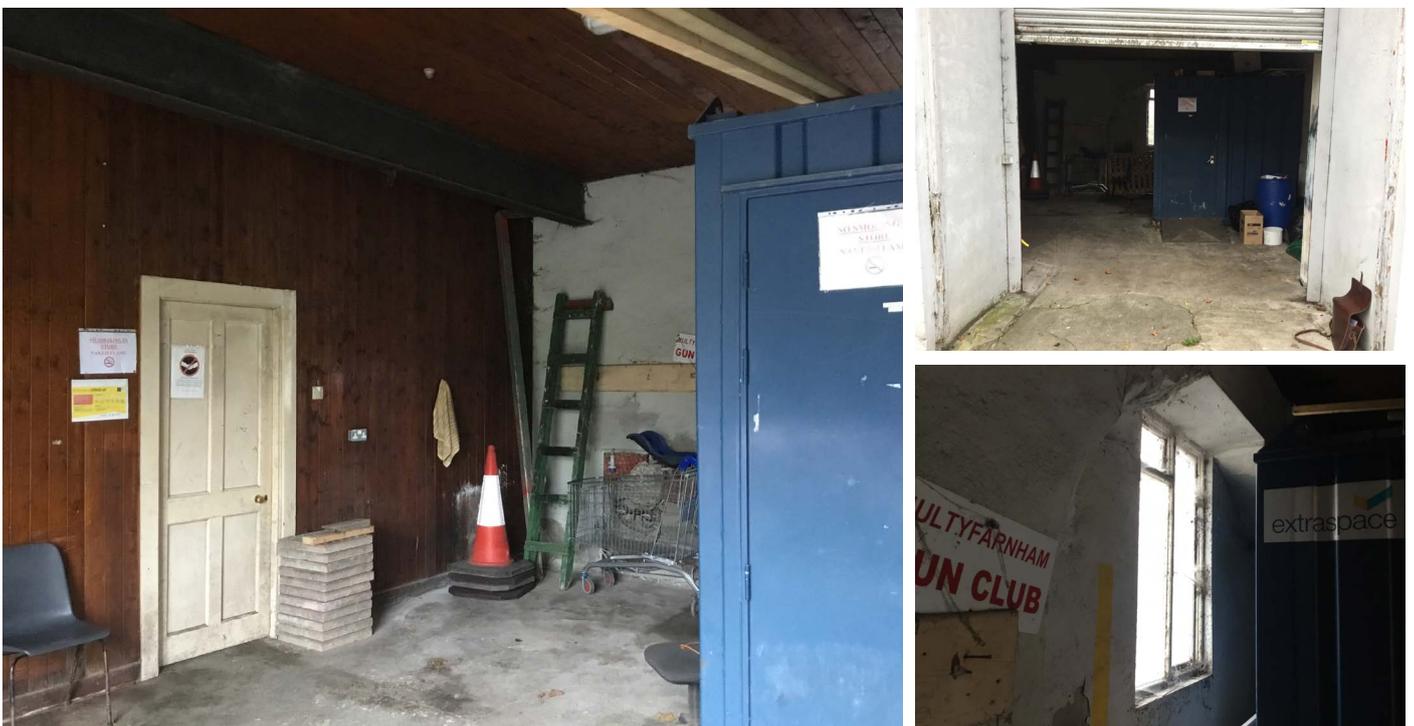
## Room 3

This room would have been very important when the building was operating as the Market House as it was the main entrance / exit. The photograph at the top highlights where the former arch was located. The shallow projecting square-headed carriage arch to the centre of the east-facing elevation was constructed c.1977 formerly giving access to fire station; this is the location of the former second arch. The original floor to ceiling wainscoting and ceiling boards are in good condition.

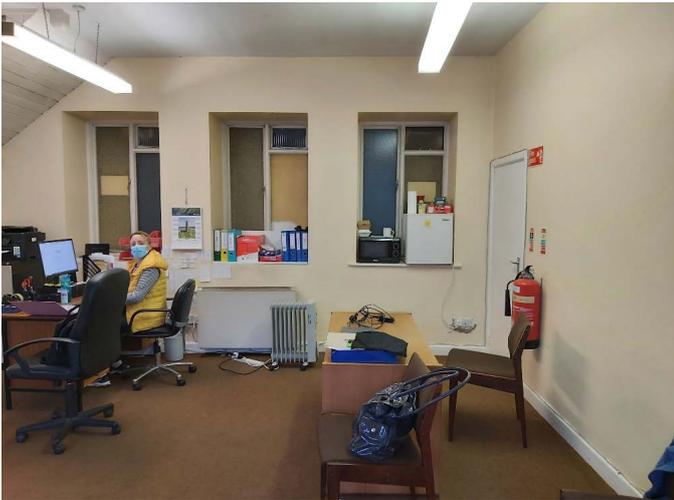
Internal elevation C:

This is the only room in the building that is still in full time use. Note the painted tongue and groove ceiling boards on the underside of the stair.

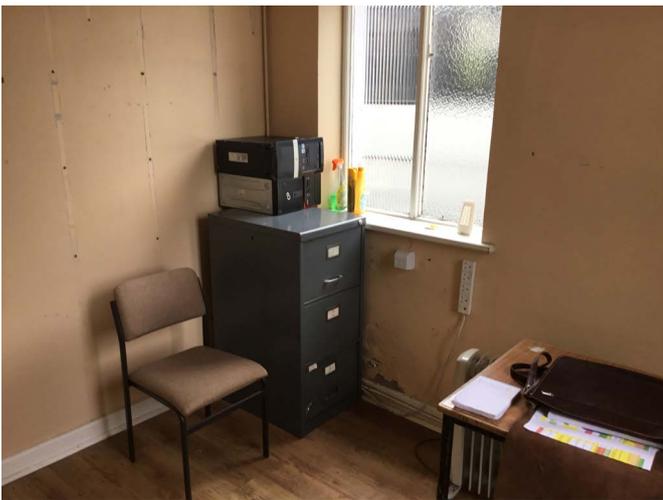
A recent laminate floor has been installed. Note the evidence of rising damp on the external wall

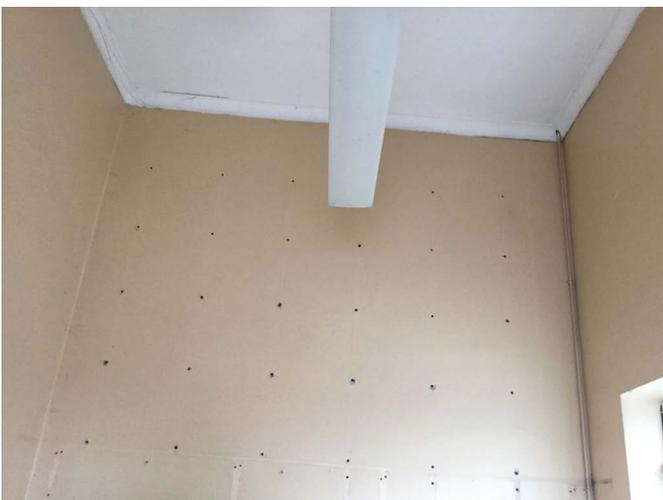
Internal elevation D: The lime plaster and cement based skim coat has been damaged to fixings which now has been removed.

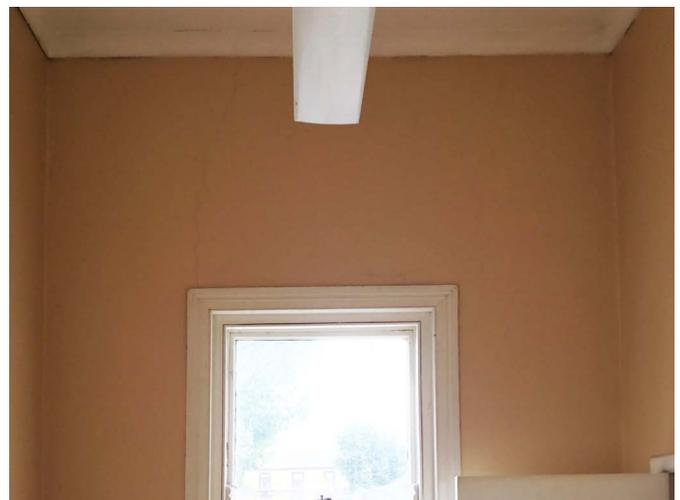
Internal elevation B: Original timber casing surrounding the sliding sash window. Also note the presence of moulding around the ceiling.

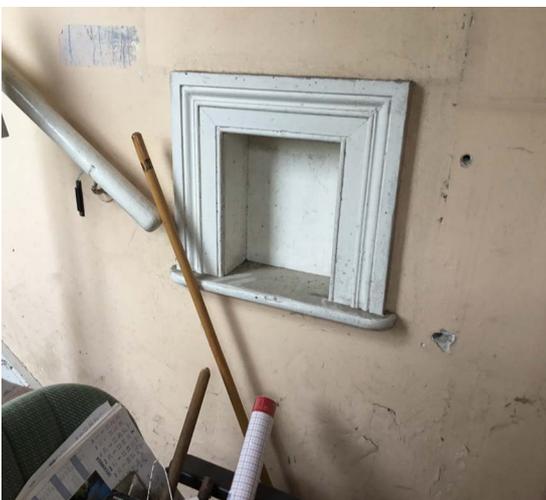
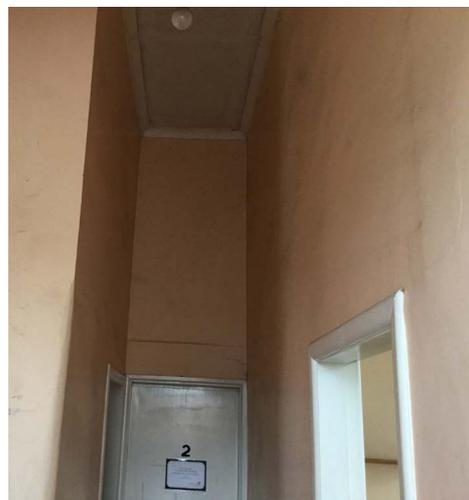
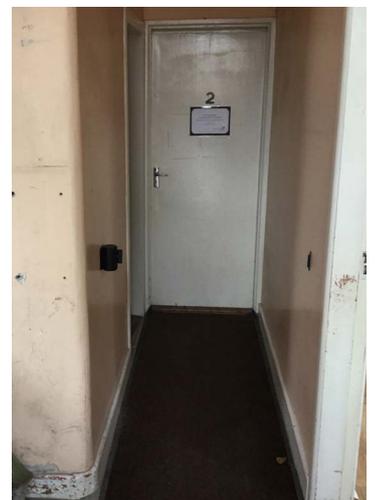
Internal elevation B: Arched segmental-headed doorcase with double timber panelled doors. Original tongue-and-groove wainscoting.

Ground floor hall: High coved plasterboard ceilings with a painted lime plaster and cement based skim coat. Note the original timber cased ticket hatch

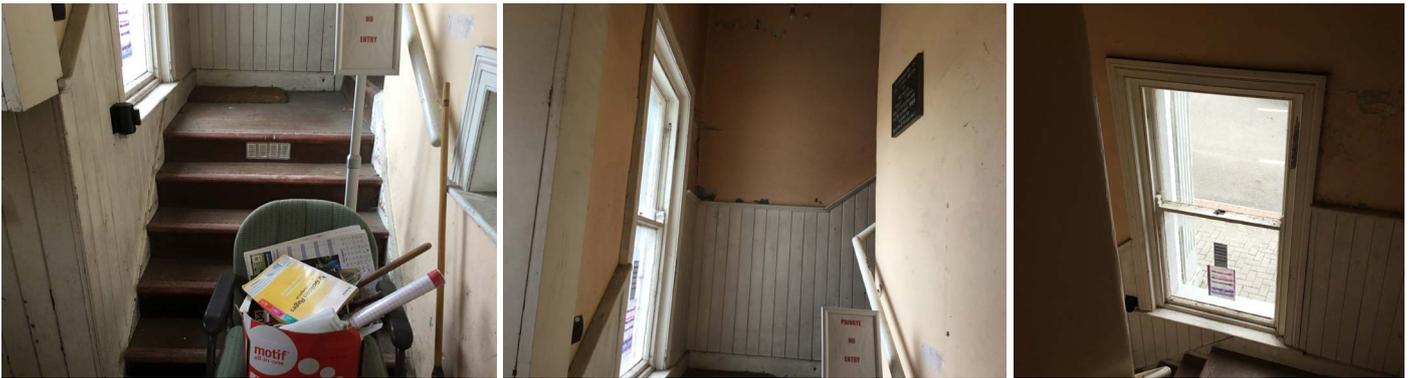
Flight number 1: Low level tongue-and-groove wainscotting located on the external wall (left hand side) and a circular timber handrail is on the right

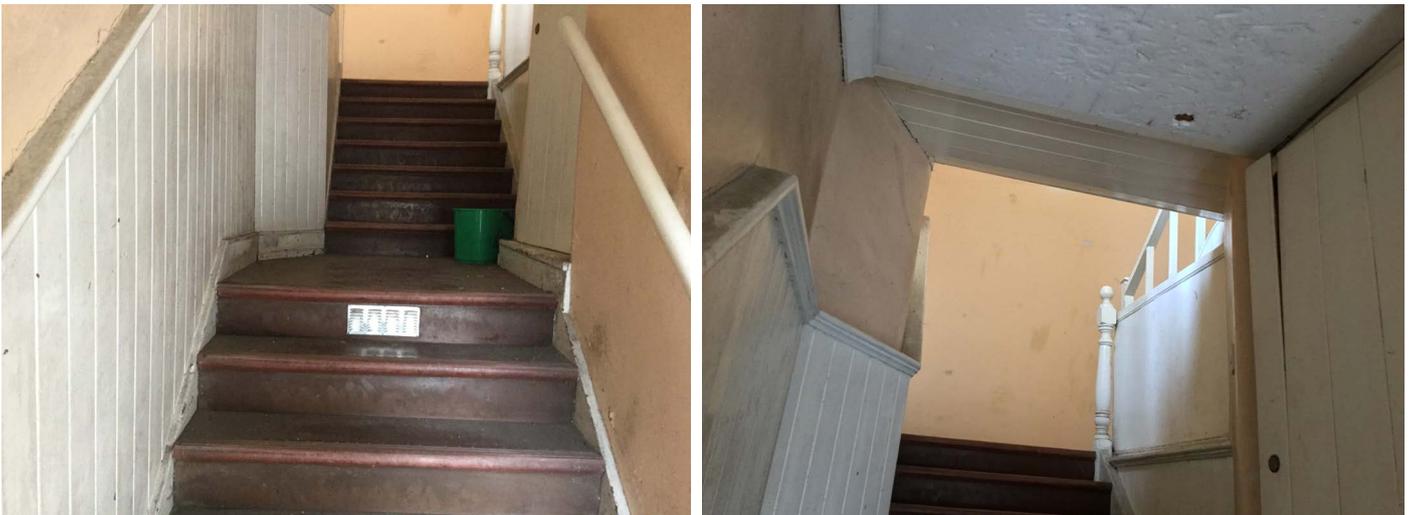
Flight number 2: Low level tongue-and-groove wainscotting located on the external wall (left hand side) and a circular timber handrail on the right up to the landing; There is no handrail beyond this. Note the step in the wall which expresses the extension that took place in c.1926

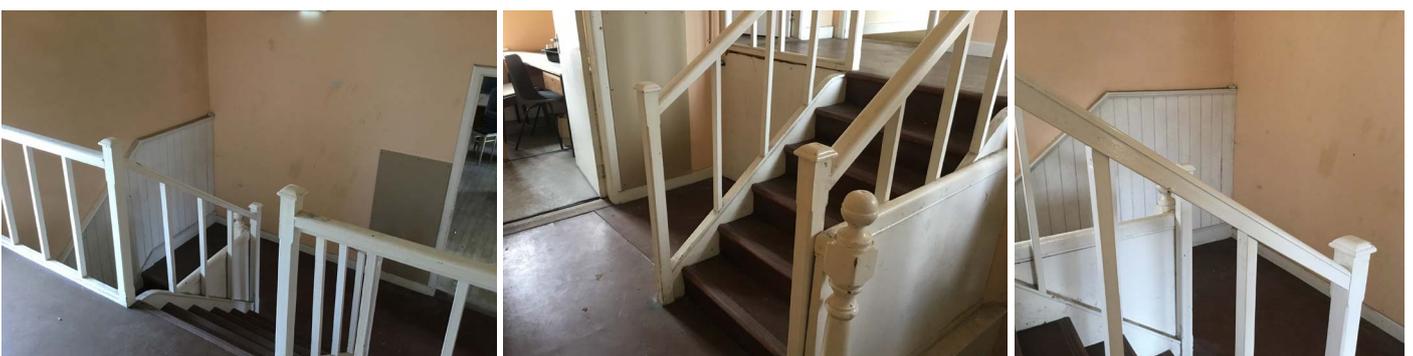
Plasterboard ceiling with moulding (left), 1 No. moulded newel post with an eggcup capping located at the top right hand side of the third flight (right).

Widely spaced painted square balusters, with 6 no. simple painted square newel posts.

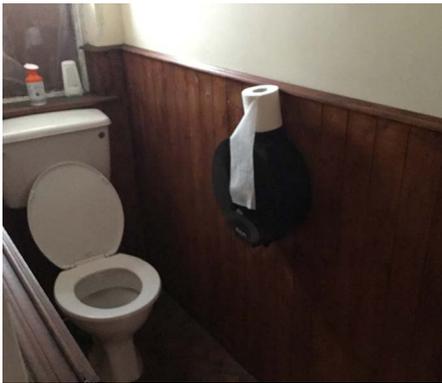
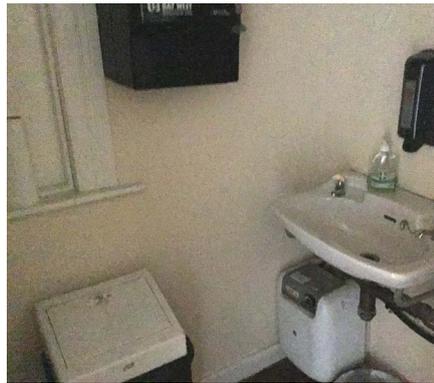
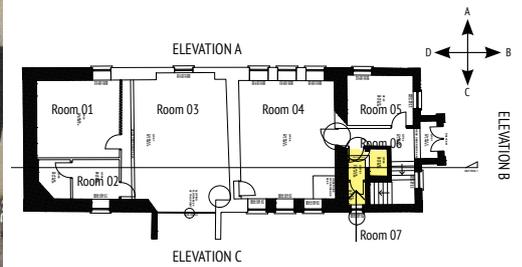
## Room 7

Stained tongue-and-groove wainscoting with a painted lime plaster and cement based skim coat above, tongue and groove painted ceiling boards and vinyl flooring. Note the original timber casing surrounding the ticket hatch next to the stair.

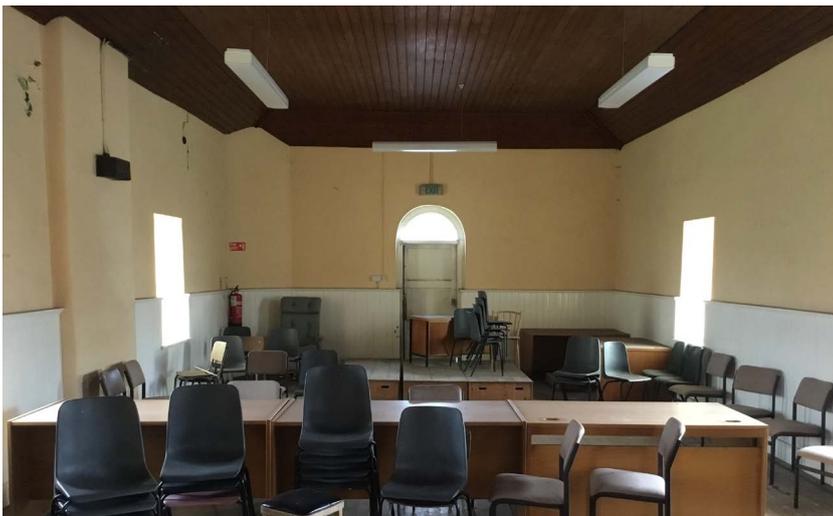
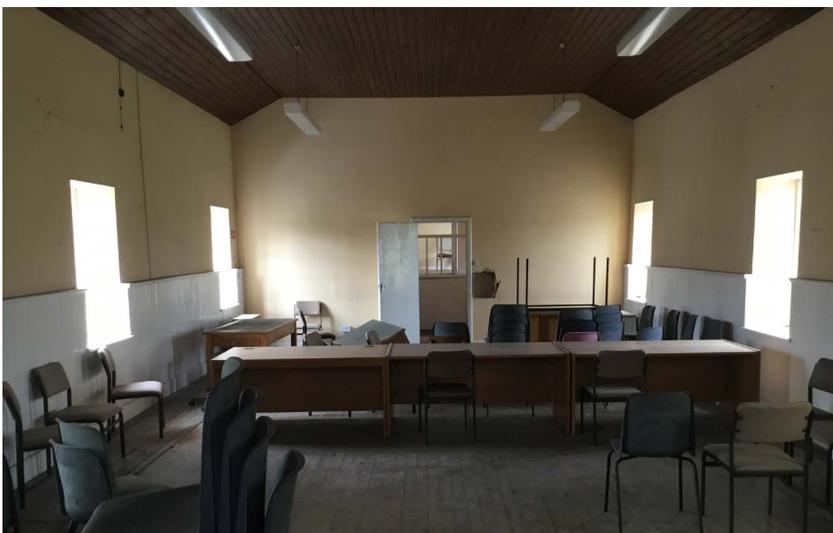
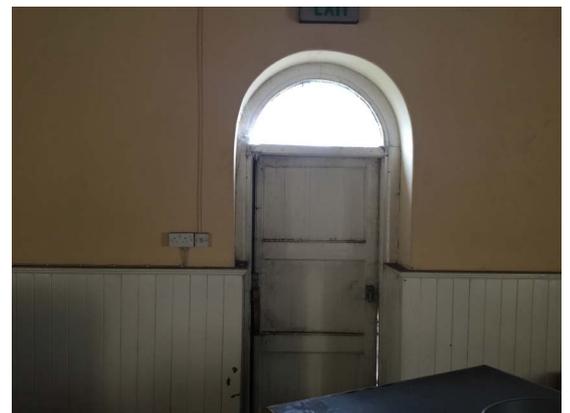
### Room 10

and cement based skim coat above. Original timber floorboards. Elevation A (bottom left): A partially sloped ceiling finished with tongue and groove stained ceiling boards (see bottom right).

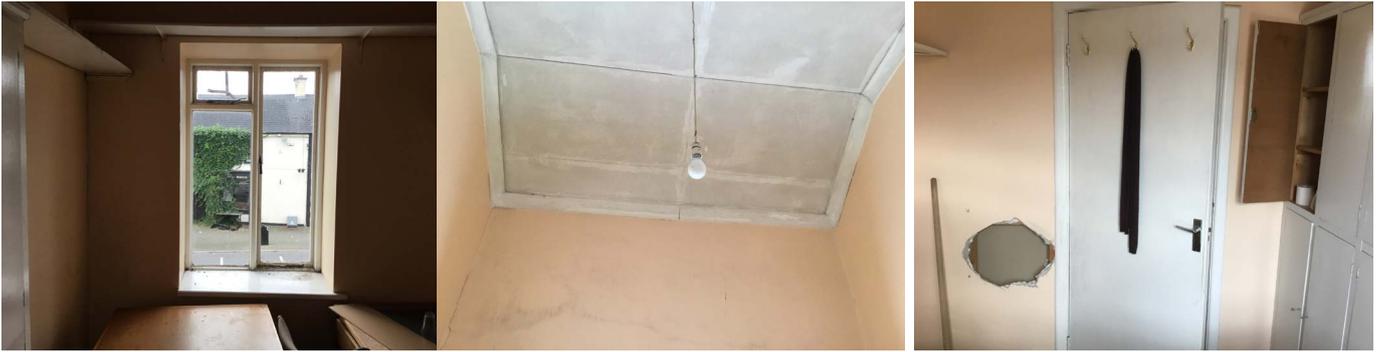
### Room 11

The sloping plasterboard ceiling and mouldings are in poor condition as shown in the middle image. Note right hand image - opening up works revealed a timber stud wall finished with plasterboard and skim.

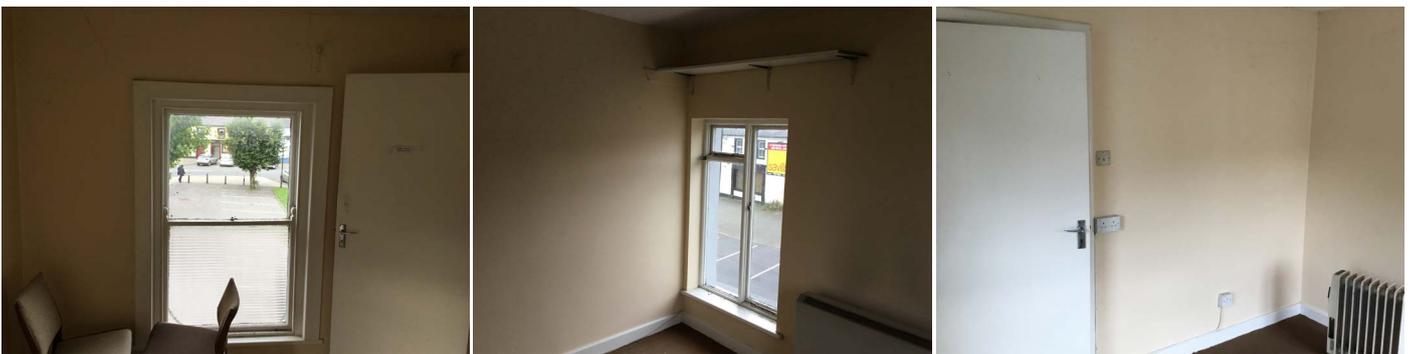
### Room 13

Elevation B: Original sliding sash window

Elevation A (along window)

Elevation C

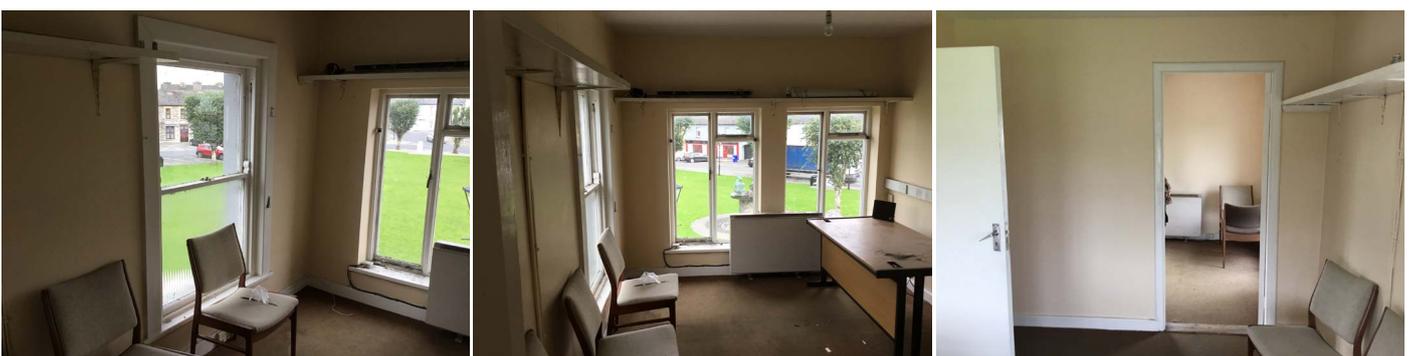
### Room 14

Elevation B: Original sliding sash window

Elevation C: View over the square

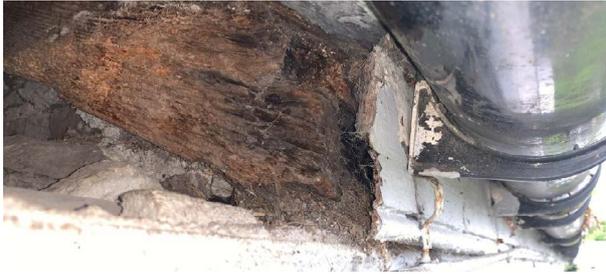
Proposed Change	Justification Ref:	Impact on Fabric, Character, or Setting	Impact Rating
<p>Roof: Repair rafters, rafter tails and wall plate; splice where necessary due to evidence of woodworm and water damage</p>	<p>J1,J2,J3,J7</p>	<p>The proposal outlined in the architect's report allows for the maximum retention of existing sound slates and timbers and replacement of non-original slate. It is in line with conservation best practice and abides by the conservation principle of minimum intervention.</p>

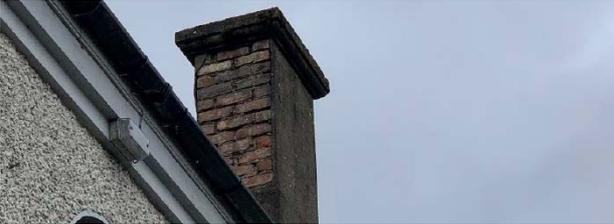
<p>Chimney stacks: Replace the sand and cement render, pointing to brickwork, chimney flues to be capped and localised repairs, where needed,</p>	<p>J1,J2,J3,J7</p>	<p>The proposal to carry out localised repairs to the chimney stacks using a correctly specified lime-based render and mortar follows the principle of minimum intervention. This will not only restore the architectural character but prevent water ingress therefore preserving the historic fabric</p>

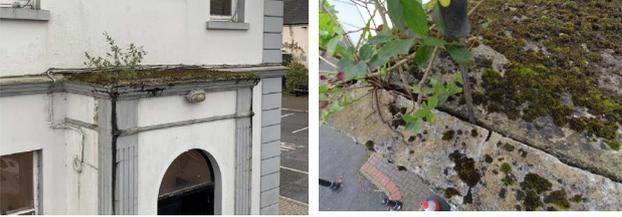
<p>Positive</p>
<p>Roof: Replace artificial slate with natural slate to match existing and install insulation</p>	<p>J2,J3,J7</p>	<p>The existing insulation has dislodged from the underside of the slates; the replacement of the insulation will not have a visual impact but will improve the thermal efficiency and ensure longevity of the former Market House.</p>	<p>Positive</p>
<p>Flat Roof: The condition of the concrete slab to be inspected further due to the appearance of cracks. The fall of the roof to be increased to an appropriate level.</p>	<p>J1,J2,J3,J7</p>	<p>The appearance of cracks, vegetation and an inadequate fall is allowing water to sit and penetrate the slab.</p>

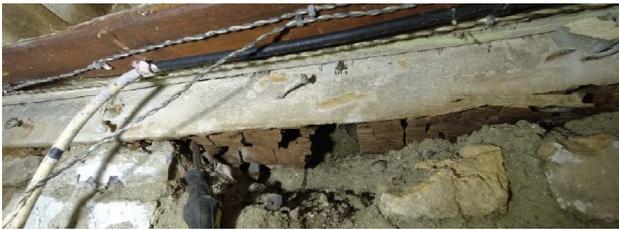
Timber Floor Joists and timber wall plate along the south elevation to be repaired and sliced or replaced where necessary	J1,J2,	Significant structural decay due to water ingress through external defects has been located in the joist ends and timber wall plate; these have been embedded within the rubble wall along the south elevation. The architects proposal ensure the health and safety of the users and longevity of the building	Positive

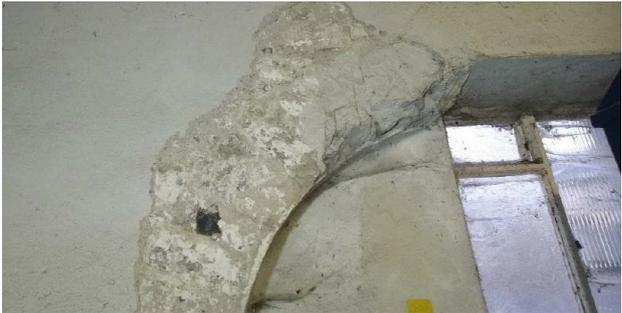
<p>J2, J6</p>	<p>The most distinguished feature in any market house in Ireland are the arches located on the ground floor, reinstating these will restore its special architectural character.</p>

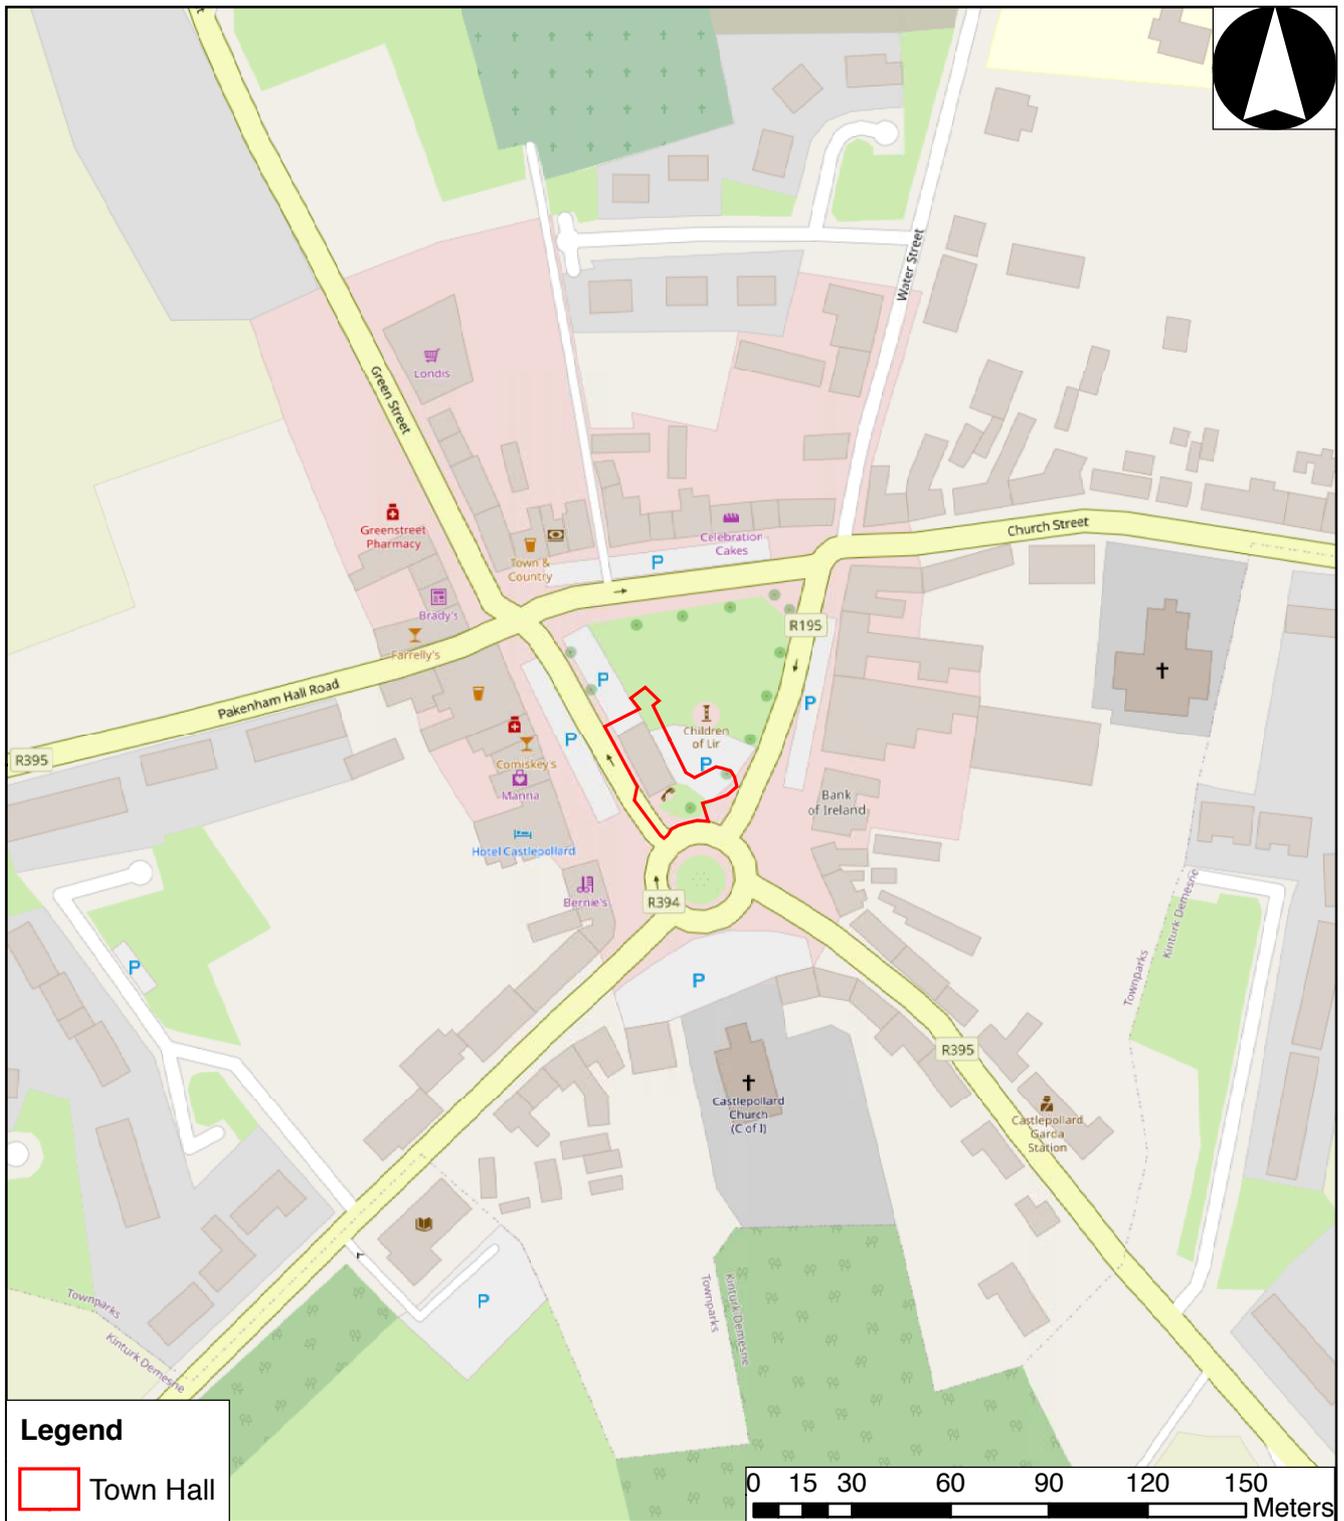
Figure 2: Proposed Castlepollard Town Hall Development: Detailed site location

5.1 The proposed regeneration project is located in the centre of the town of Castlepollard which is located 17km north of Mullingar and 34km south of Cavan between Lough Derravaragh and Lough Lene (figs. 1 & 2).

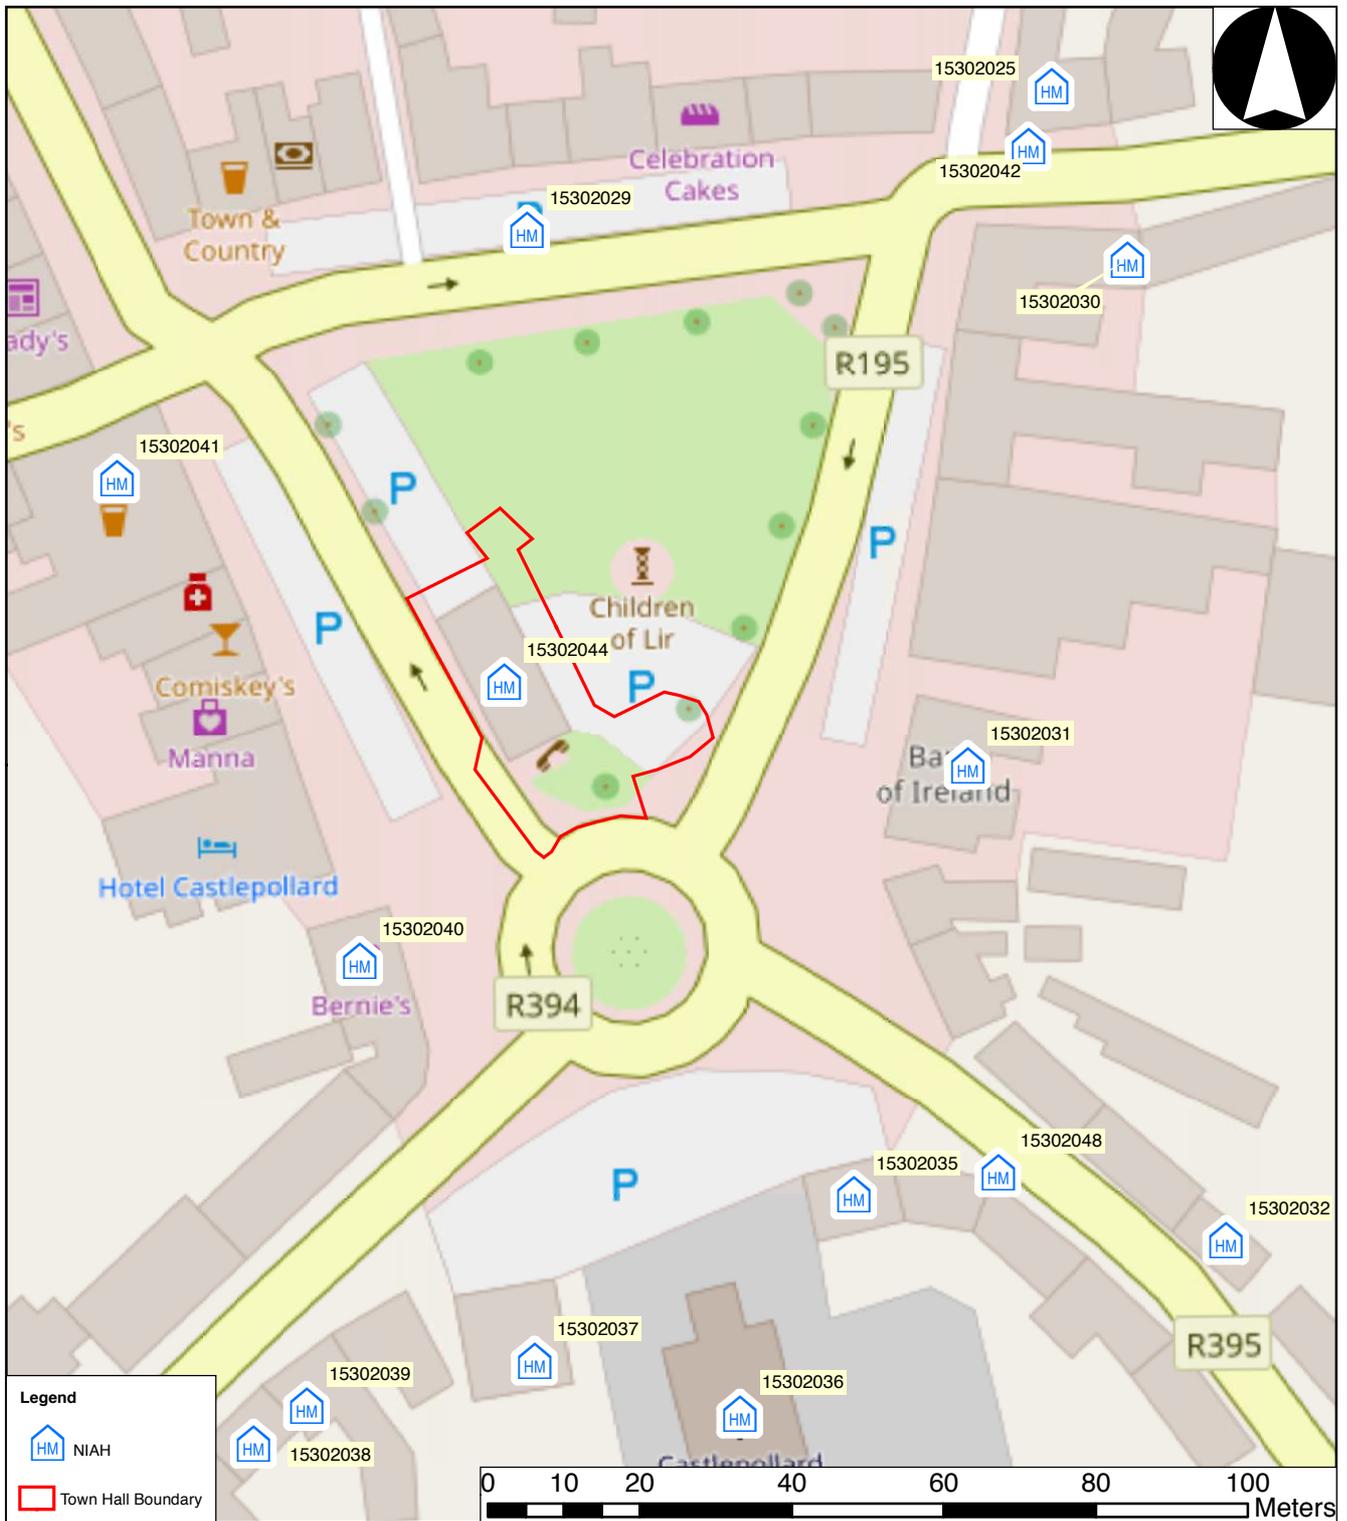
Figure 5: Location of recorded NIAH Record / Recorded Structures within 100m of proposed development

- 10.2.2 Within the immediate environs of the proposed development are 15 recorded structures of regional importance on the NIAH within 100m of the PDA (fig. 5; Table 2). These structures are located within the town of Castlepollard and many date to the extensive remodelling of Castlepollard and its redevelopment around a central market square c.1815, the majority of which are also afforded Protected Structure status.

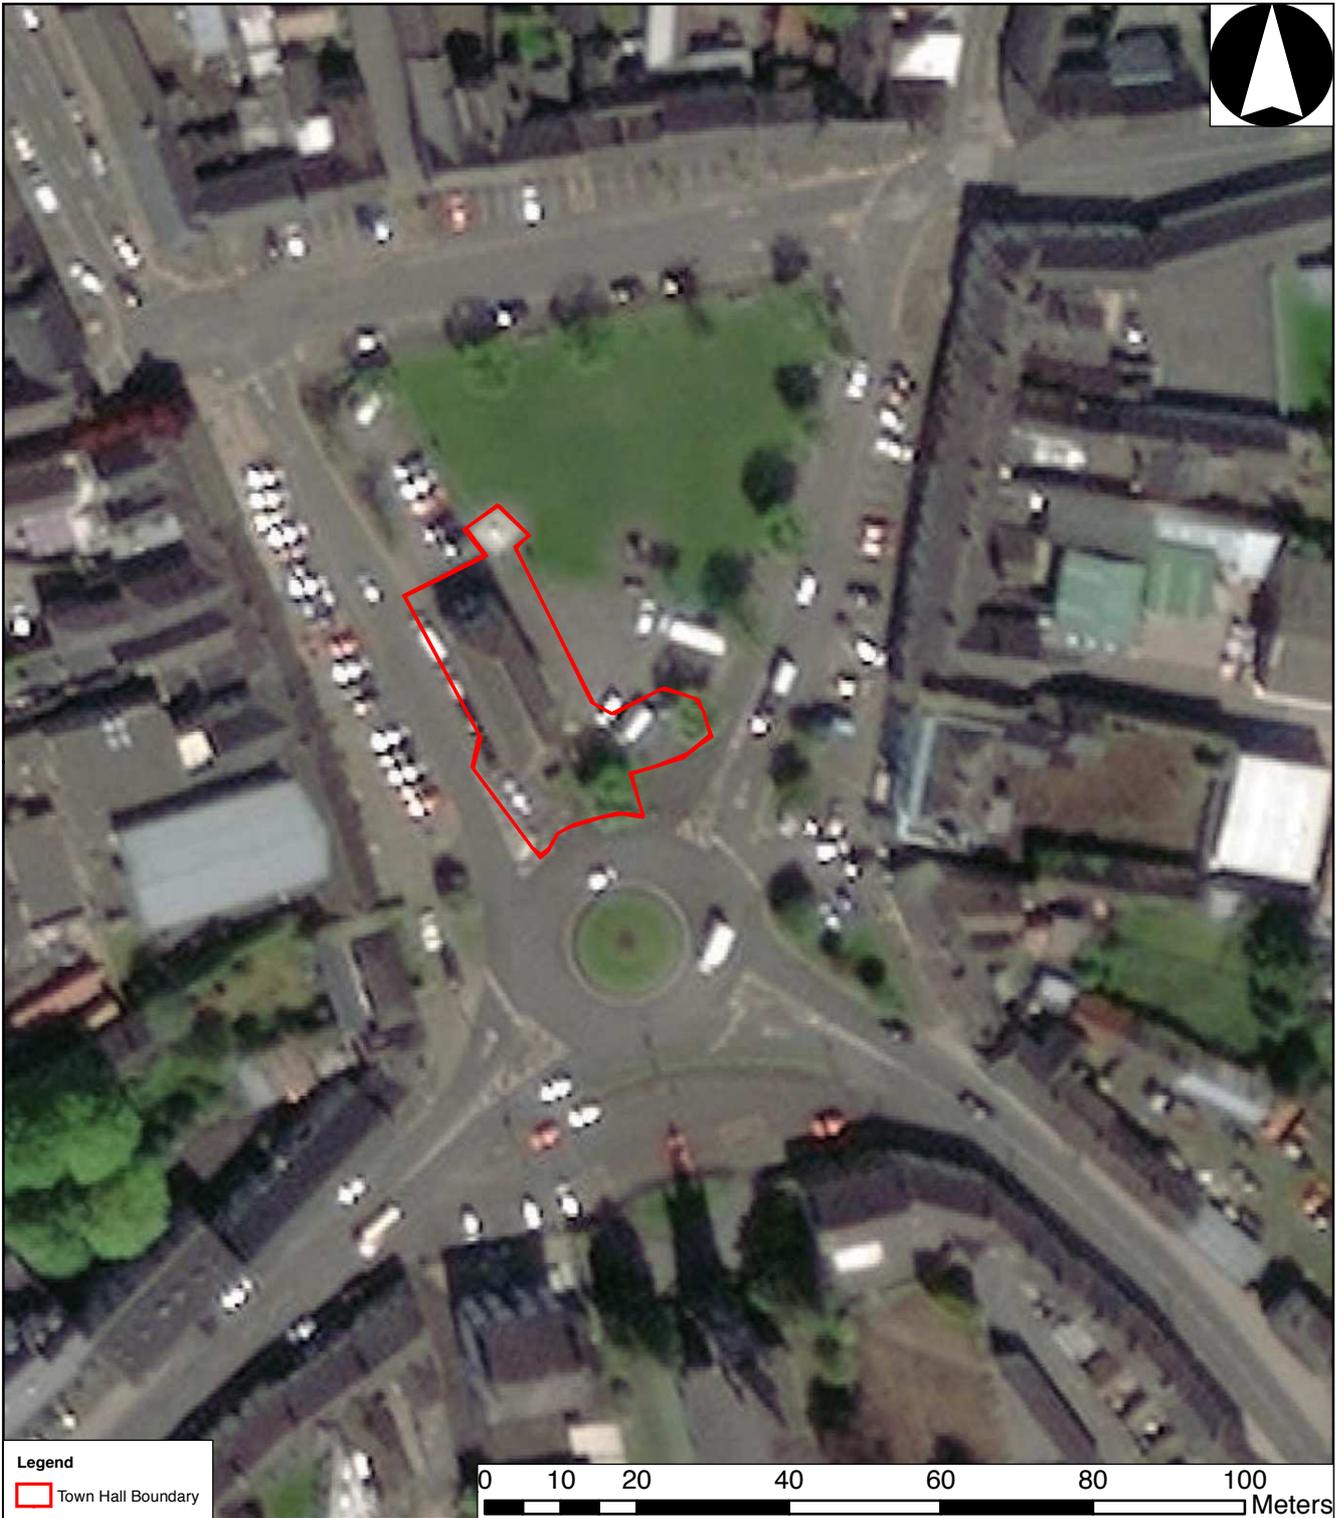
Figure 7: Aerial photography showing modern landuse of PDA

- 10.5.1 Aerial photographs (fig. 7) have been examined to trace the modern development of the PDA and identify any potential unknown archaeological features in the landscape.
- 10.5.2 The aerial photograph shows the PDA to be centred at Market Square. The Market Square of Castlepollard is triangle shaped with roads along each side and a roundabout at the southern point. The roads are lined with houses, shops and the Church of Ireland Parish Church. The central area of Market Square contains a tree lined grass area, carpark and the Market House.
- 10.5.3 No previously unknown archaeological features were identified in the aerial photographs.

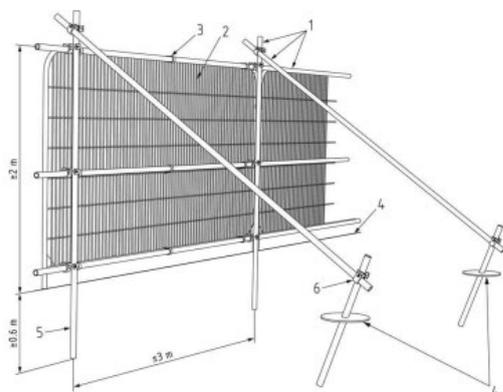
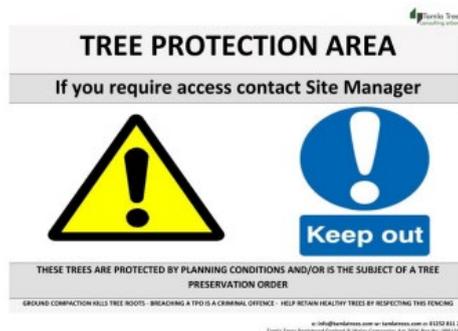
To be effective fencing must be robust and clearly signed

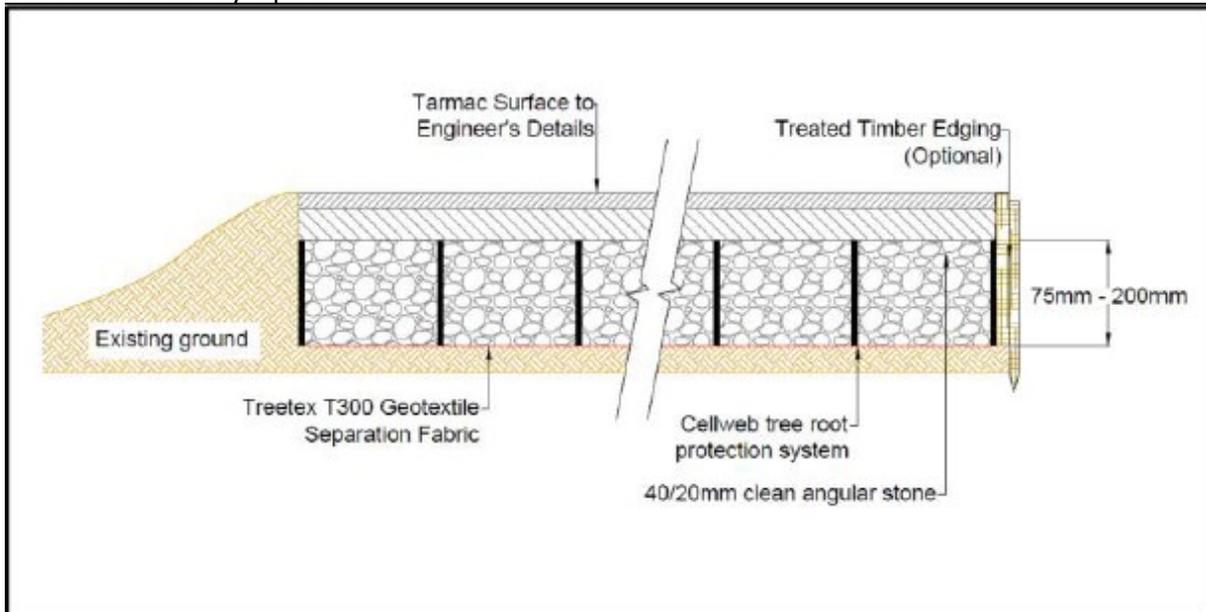
Cross sectional drawings of a suitable product can be seen below (figure 6)
