# The Market House Castlepollard

Architectural Design Statement  
Planning Report

February 2022

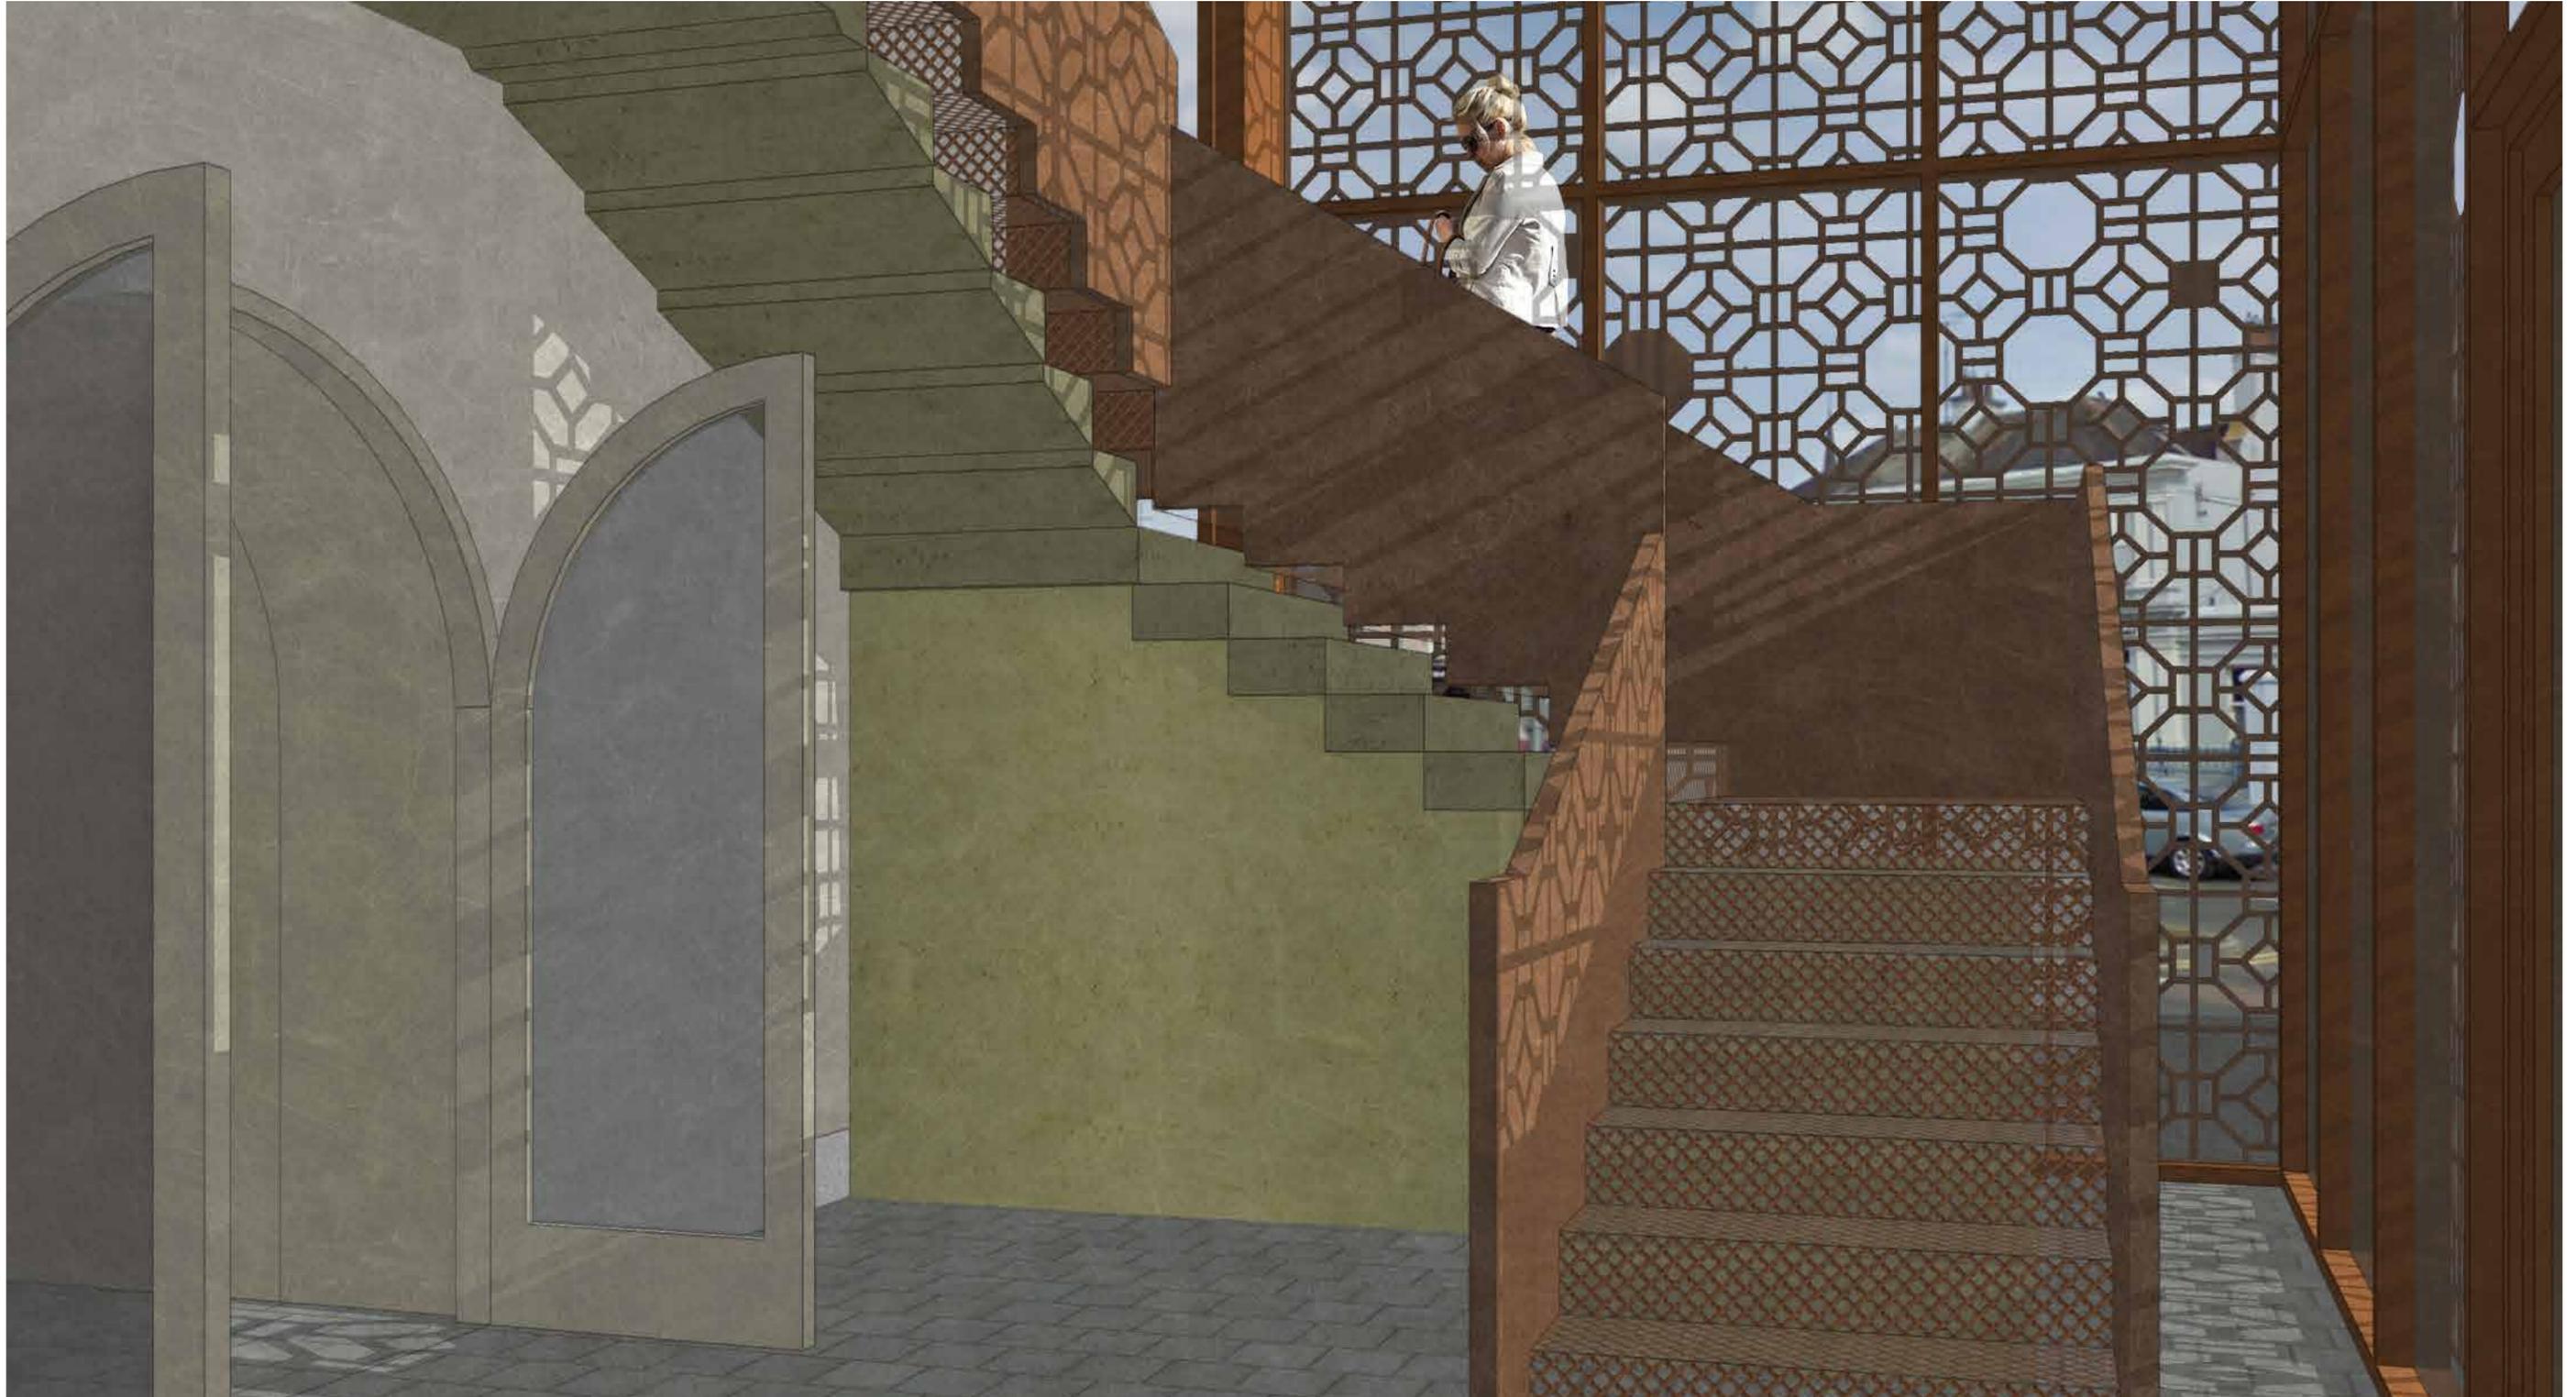
# Artistic Impression - View from the Ground Floor of the Proposed Extension

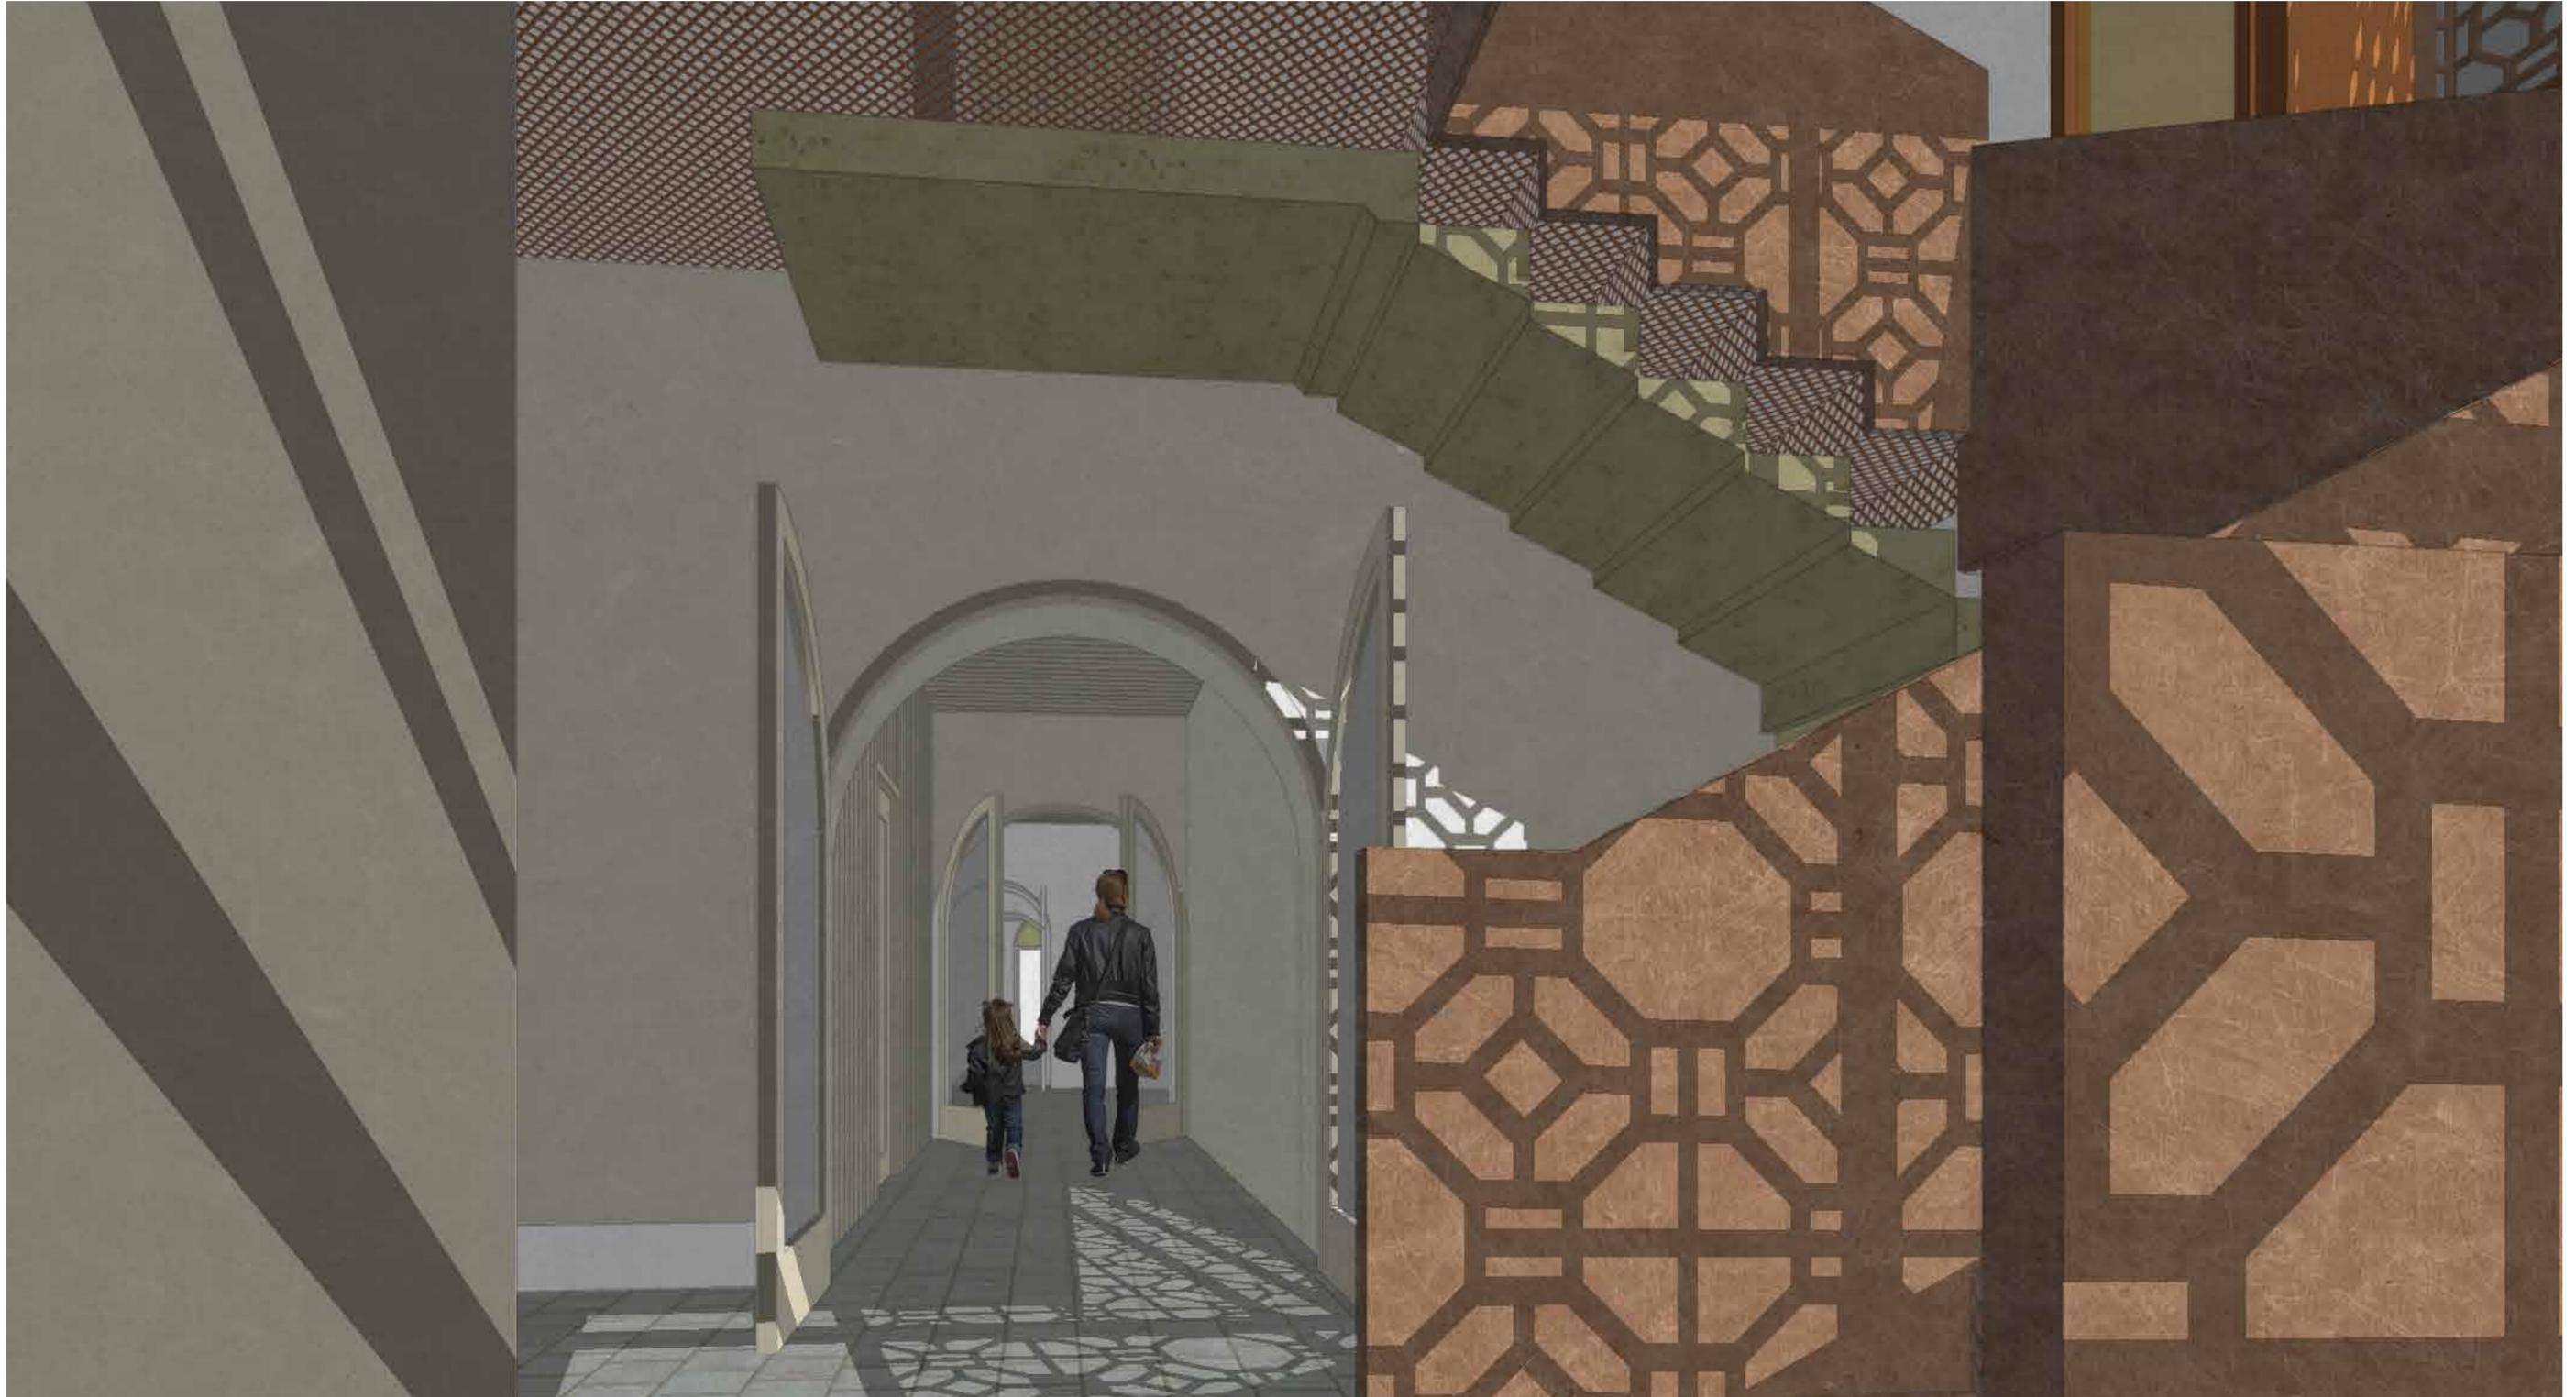
# Artistic Impression - View from the Proposed Extension to Existing Main Entrance
