**STAGE 2A REPORT – STRUCTURAL AND CIVIL  
APPRAISAL AND REPORT FOR REDEVELOPMENT OF:**

**Athlone Castle  
Athlone, Co Westmeath**

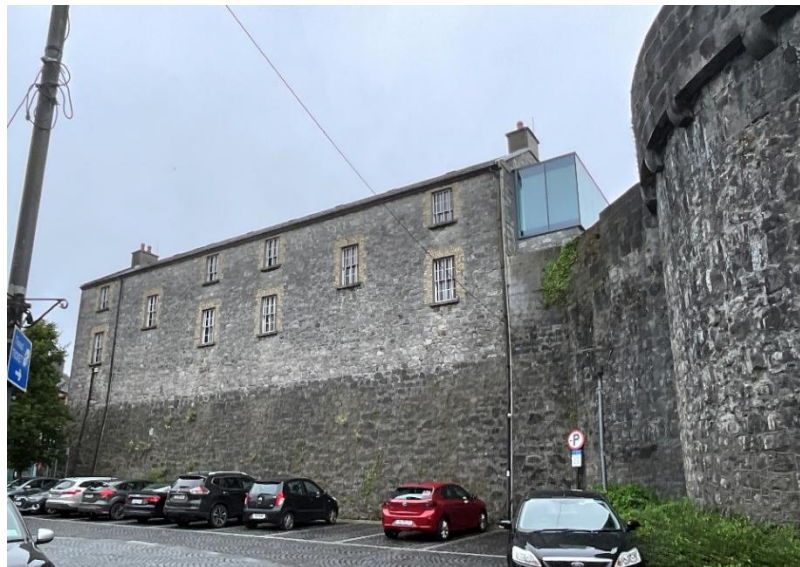
**Figure 4: View of Barracks and 2012 Gable from Main Street**

There are considerable level changes from each road, with the castle and its buildings situated much higher than Main Street and The Quay. The battered masonry walls are retaining an approximate 9m level difference.

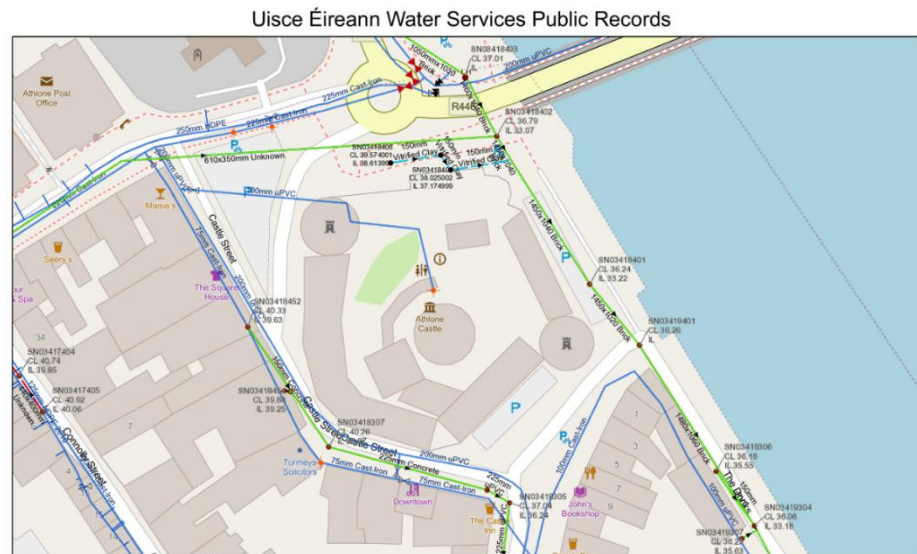
**Figure 5: Uisce Eireann Water Services Drawing**

The water supply is shown in blue in figure 5 below. There is a fire hydrant within the grounds of the castle, adjacent to the entrance gate.

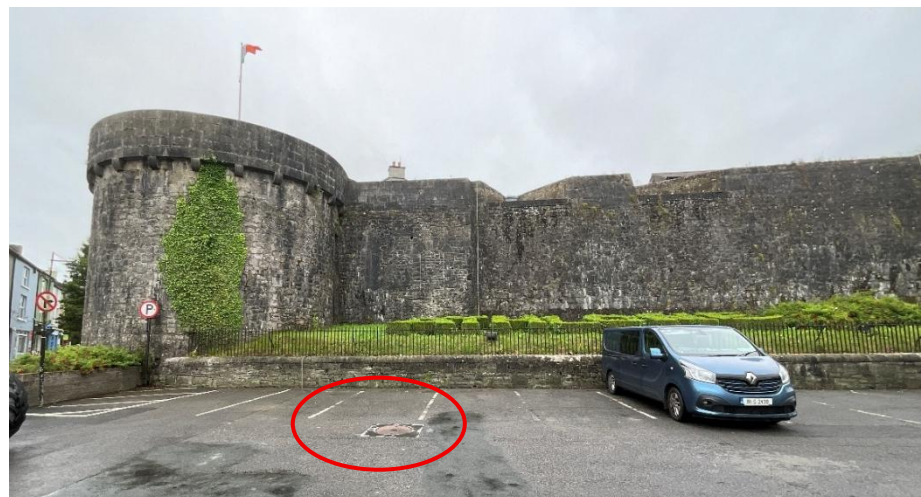
**Figure 6: Public Sewer manhole circled**

The public combined sewer runs north to south under The Quay, to the east of the castle. The existing drainage system within the castle grounds appears to have been redeveloped in the 2012 works. From civil drawings from the 2012 works, there is an existing combined manhole within the castle grounds, adjacent to the Barracks extension. This is connected to the public sewer manhole in The Quay parking area.

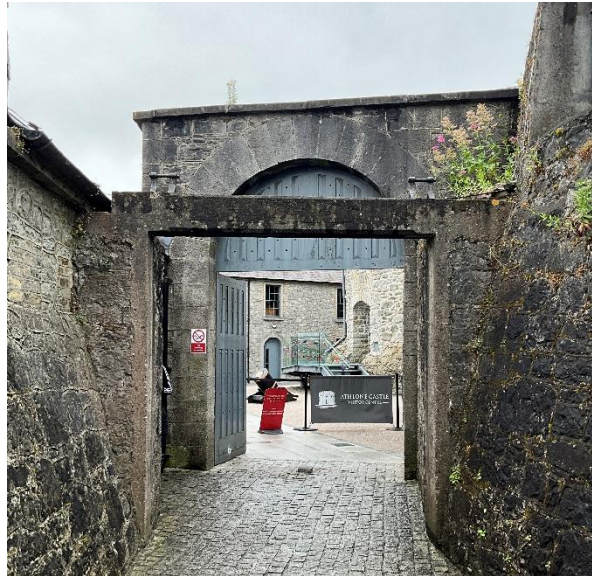
**Figure 9: Entrance to castle grounds**

On entrance to the castle, there is 2no. archways. The first is a cast in situ concrete frame. This has been cast into the battered limestone masonry walls. Following the concrete frame is a semi-circular cut stone arch which frames the gate into the grounds.

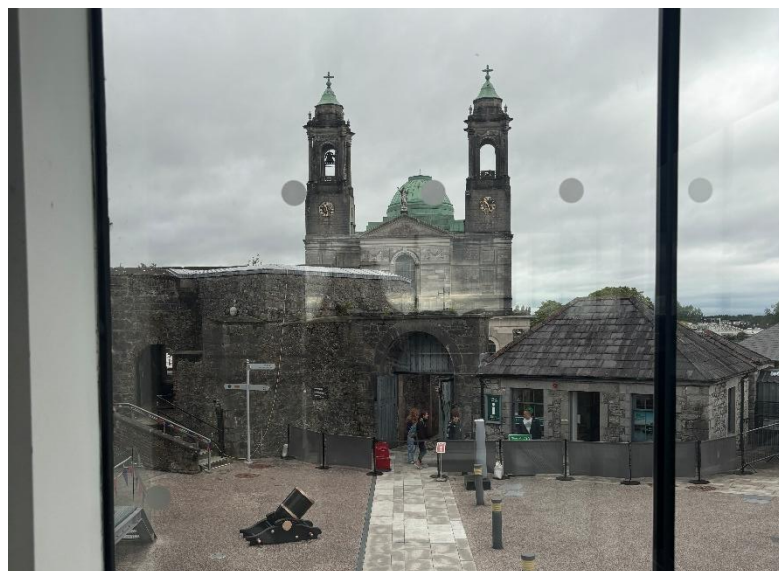
**Figure 10: View of courtyard and gate building**

The castle grounds are surrounded by masonry boundary walls. The castle has 3no. turrets. Currently, 2no turrets can be accessed by the public, the southeast and northwest turret. The northeast turret is not accessed by the public and is being utilised as back of house storage. Adjacent to the northeast turret is the gate building. This is being used as an information desk. There is an office and toilet block to the south of the northeast turret. There is outdoor plant adjacent to this block.

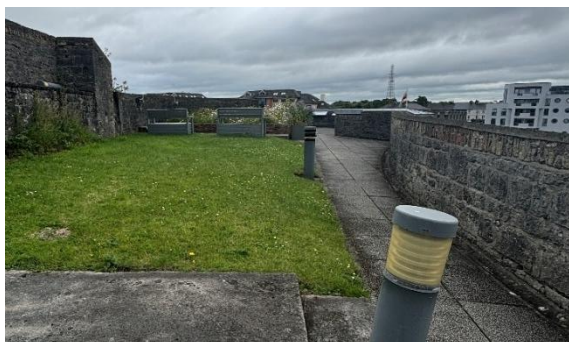
**Figure 20: Terrace and Garden**

The terrace is a combination of paving stones and soft grass landscape and planting. There are existing stones steps which facilitate access to an existing water tank and to the wall tops.
