Client
GII

Site Address
1-9 Belvedere Orphanage
Tyrrellspass, Co. Westmeath

Drawing Title:
MUL1383_GII_Tyrrellspass

METROSCAN
UTILITY LOCATING

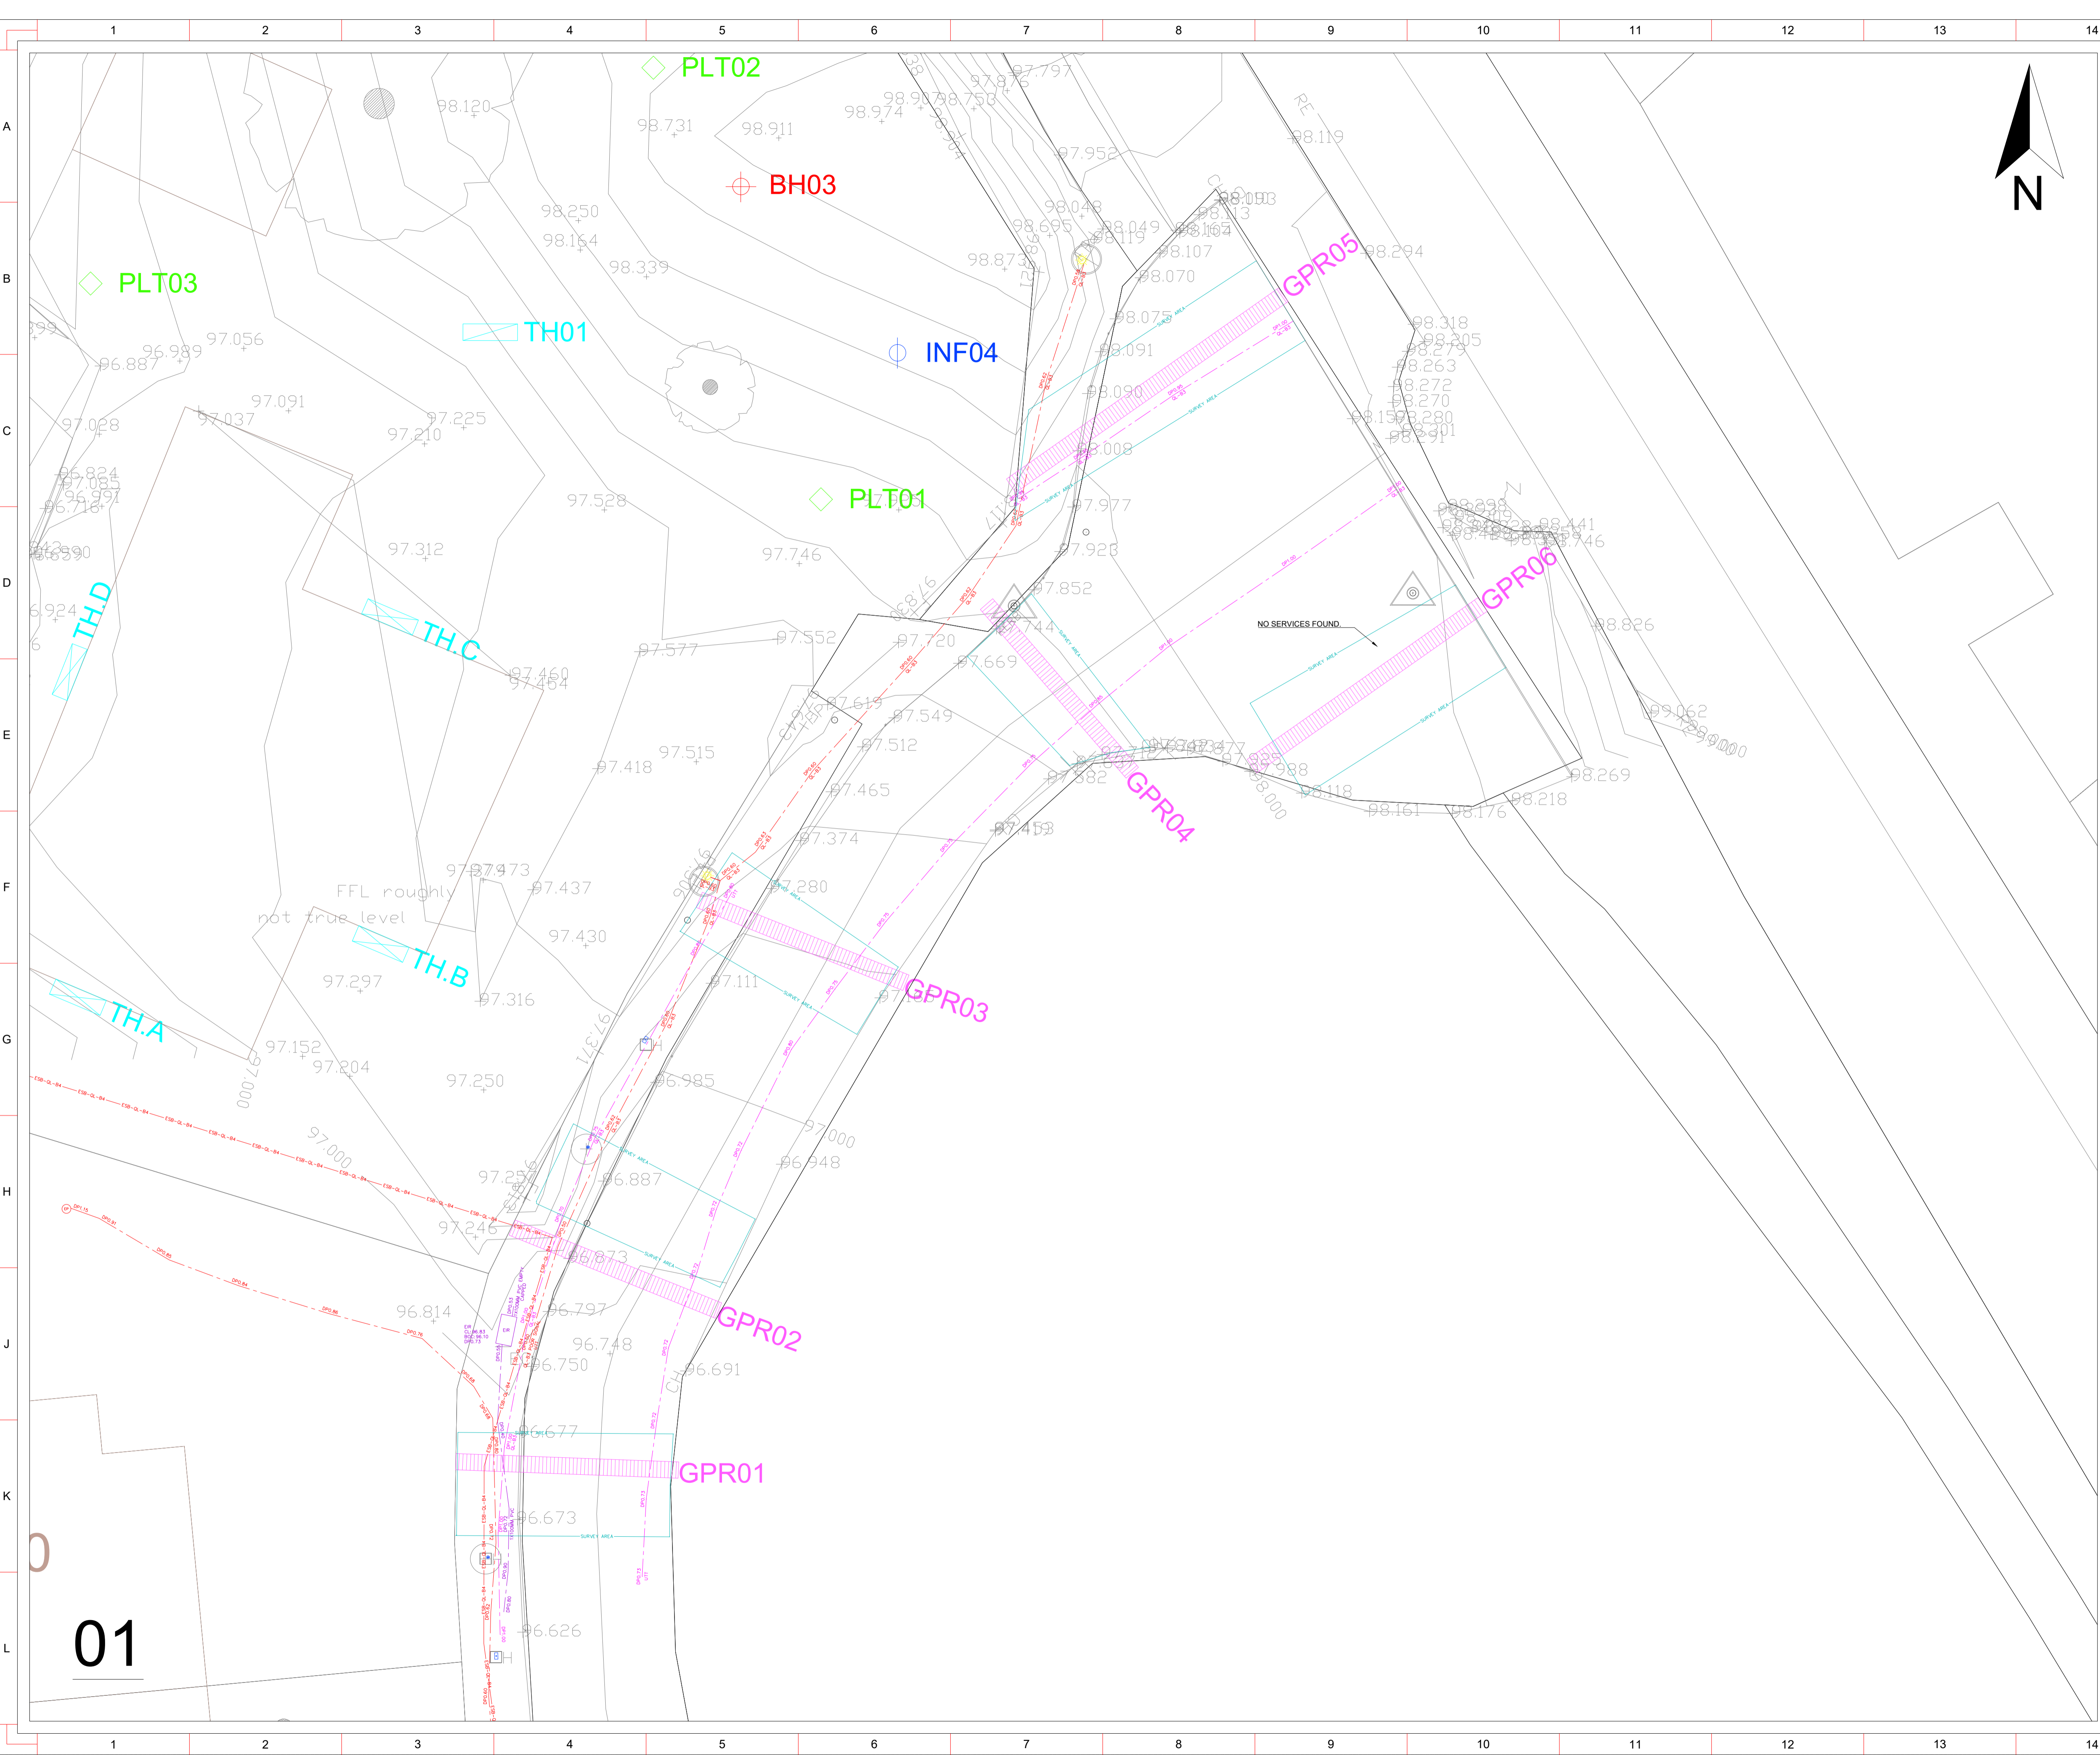
Drwg No: 1
Sheet No: 01
Rev No:

- ### Notes
- GPR equipment :
Detector Duo, DS2000,
Stream C, Mala EL Core
scanning frequency 250 and 700 mhz
Depth of investigation 2.5m, self calibrating.
 - Radio detection equipment:
Vivax Metrotech VLoc Pro3 / RD7000
 - GPR scanning limited to smooth surfaces only no obstruction.
Survey area marked on drawing
 - All depths stated are an indication of depth
caution required when excavating.
 - All Utilities are classified QL-B2 unless noted otherwise.

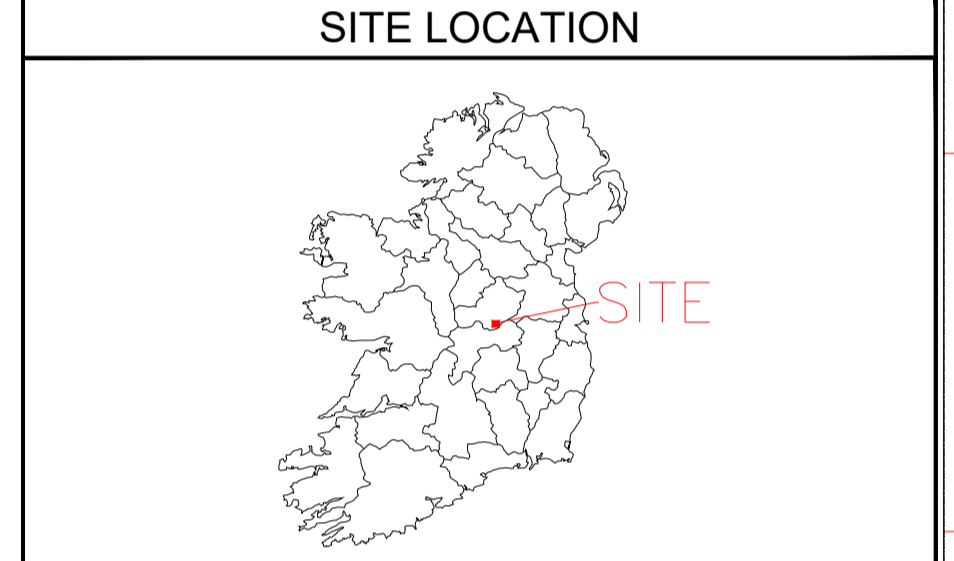
Please note that the absence of services on this drawing is not solid proof that these services are not present in the ground. While every method of underground utility locating has been adhered to in this survey, some services may lie outside the range of the GPR and electro-magnetic locator signal. Poor ground conditions and/or services situated underneath other services can also prove impossible to locate. Due to the fact that not all Utility Service Plans were provided to MetroScan by the contractor MetroScan cannot be held responsible for any services that have not been identified. The contractor should not assume that all services have been identified and must exercise a duty of care when excavating. Hand / vacuum excavation is advised to determine exact depth and position of services prior to excavation commencing. Please note that the drawing provided is valid for 90 days from date stated below. Drawing is intended solely for use of the contractor named below.
